The implications for the New Zealand power system from the 28 September 2016 South Australia outage and black start

28 March 2017

South Australia Black Start Event

System Operator

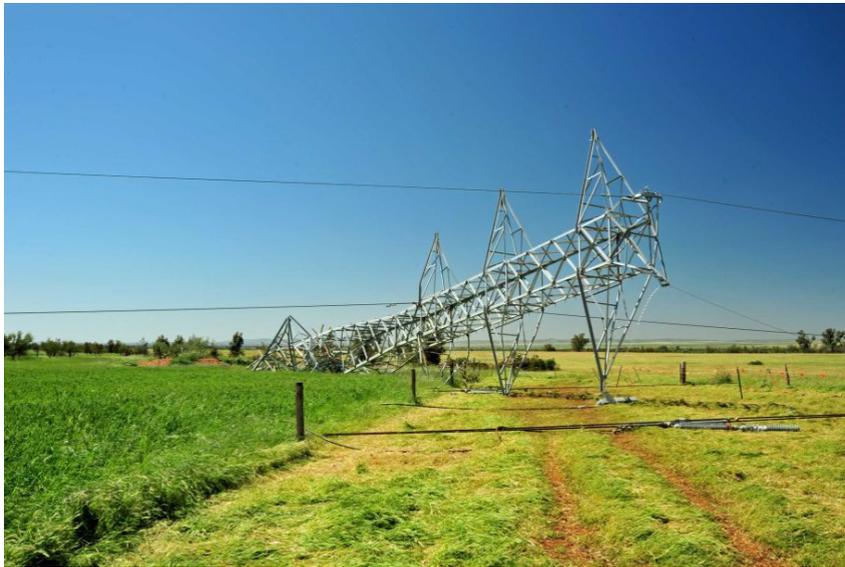
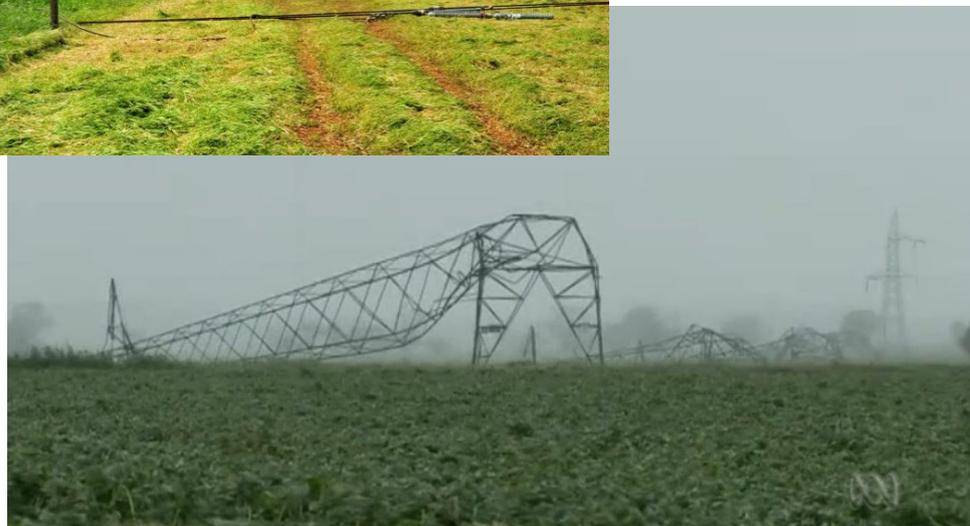
The power system cascade failure event occurred over a period of less than three minutes. It was triggered by multiple faults (momentary electrical short circuits on transmission lines each resulting in a sudden dip in system voltage) during a weather event over a short period within South Australia. The series of faults resulted in a halving of wind generation output. The power system was kept in balance by an immediate increase in the electricity imported on the main interconnector to Victoria, which overloaded it and threatened the stability of the entire eastern Australian system. This potential instability resulted in the main interconnector being automatically disconnected.

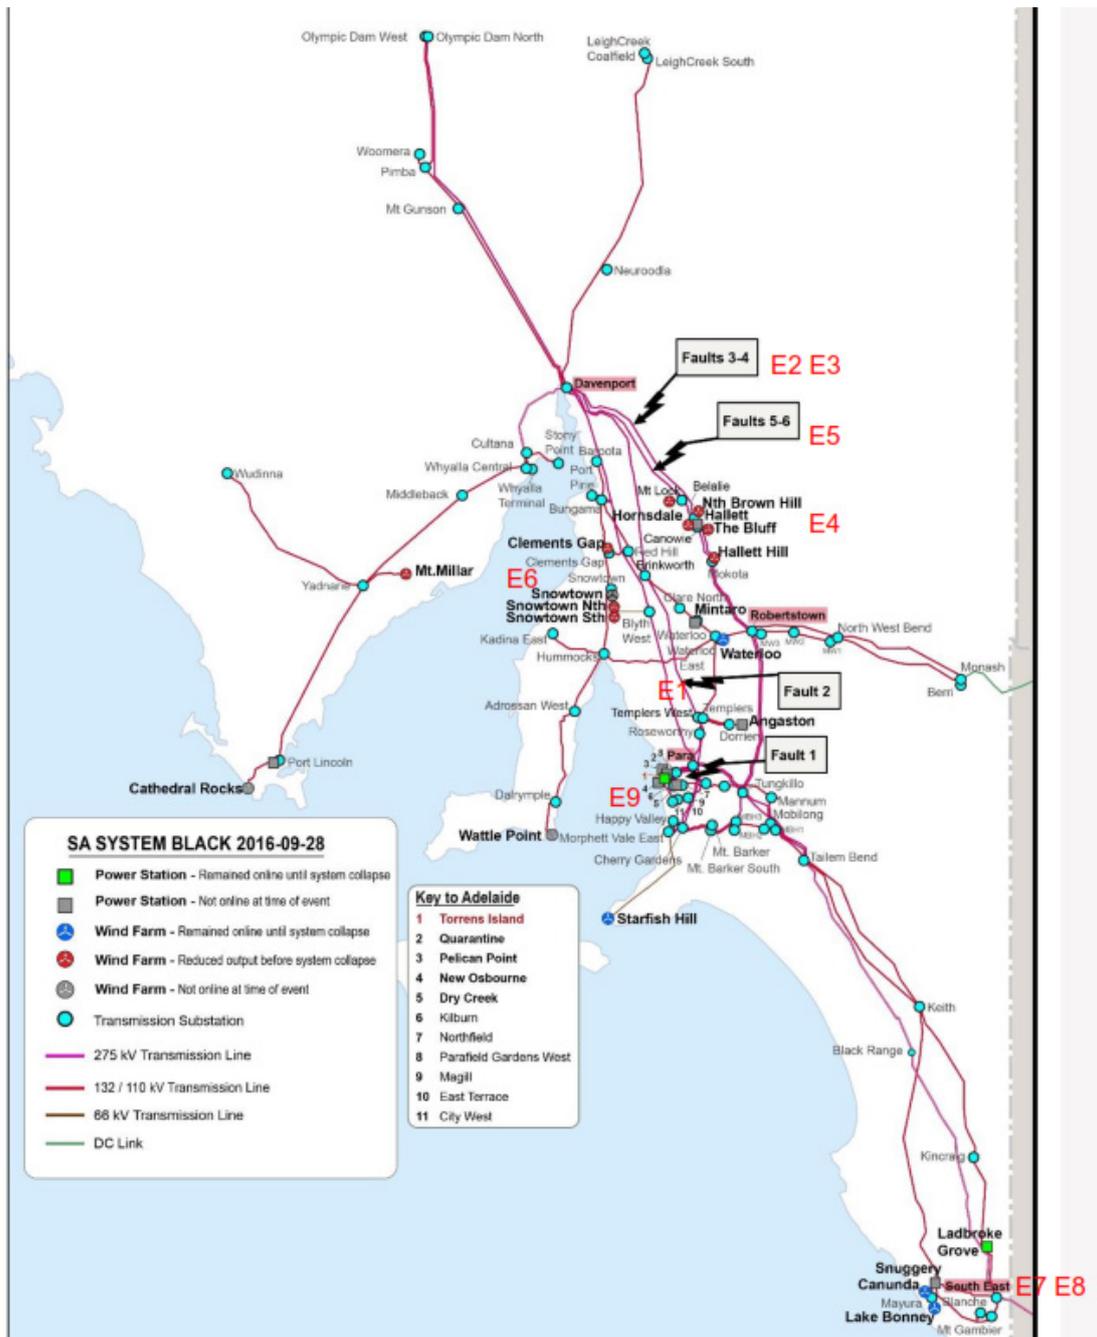
Demand for electricity was now two and half times that able to be supplied by the thermal and remaining wind generation within the State and through the smaller of the two interconnectors to Victoria. An automatic system to rebalance the power system by rapidly shedding demand (under frequency load shedding) was unable to respond effectively and the remaining generation and interconnector disconnected resulting in a black system.
