# Report: Review of Generator Protection Performance

**13003045 Under-Frequency Event of 23 October 2025  
Tauhara (TAB) and Te Huka (TAC) Geothermal Generation**

Transpower New Zealand Limited

28 August 2026

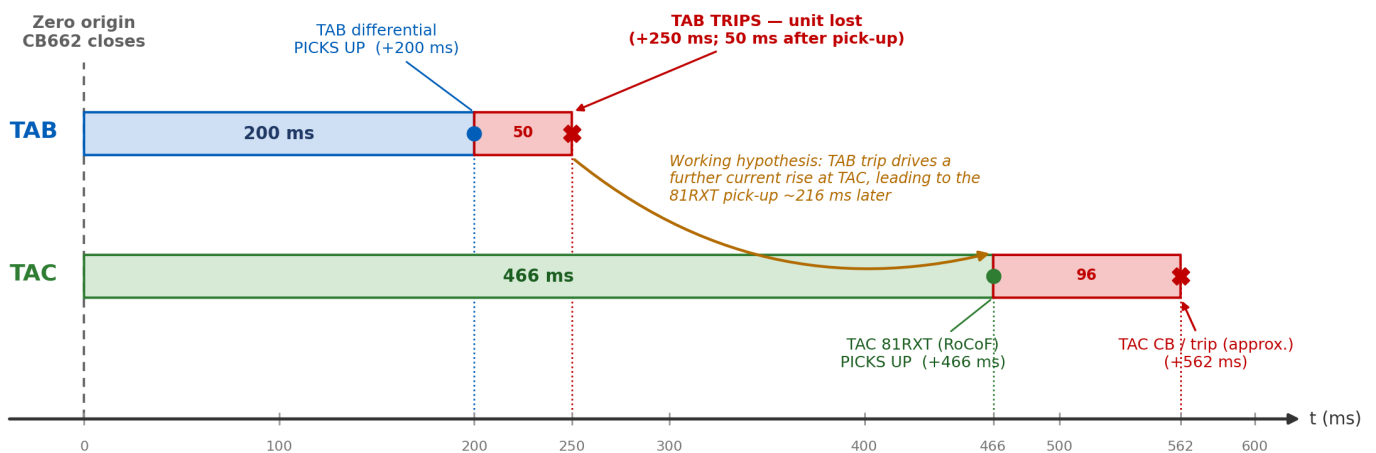
Note: relay internal clocks are not a common reference (TAB and TAC differ by ~3 s). All times are relative to a common zero origin defined by the CB662 closure disturbance. Causation (TAB trip → TAC behaviour) is a working hypothesis limited by missing data (see report §6).

The relative timing of the operations at the two sites is summarised in Figure 10. The upper table lists the raw relay timestamps recorded at each site for three reference points — the closure of circuit breaker CB662 (taken as Time 0), the protection pick-up, and the approximate circuit-breaker/trip — together with the corresponding offsets from the zero origin. Because the relay internal clocks do not share a common reference (the TAB and TAC records differ by approximately three seconds for the same event), the timeline beneath the table re-expresses these events on a single common axis, with the zero origin defined by the onset of the CB662 closure disturbance in the recorded waveforms.

On this common basis, the Tauhara (TAB) generator differential element picks up at approximately +200 ms after closure and trips approximately 50 ms later, at approximately +250 ms, at which point the Tauhara unit is lost. The Te Huka (TAC) 81RXT (rate-of-change-of-frequency) element picks up later, at approximately +466 ms, with the associated circuit-breaker/trip at approximately +562 ms. The interval between the TAB trip (+250 ms) and the TAC 81RXT pick-up (+466 ms) is approximately 216 ms. GHD's working hypothesis, indicated by the arrow in the figure, is that the loss of the Tauhara generation on the TAB trip produced a further increase in current and continued frequency fluctuation at Te Huka, which in turn led to the pick-up of the TAC 81RXT element. As set out in Section 6, this causal relationship is consistent with the observed sequence but cannot be established conclusively from the data provided, owing to the absence of circuit-breaker operation data and the short gap in the TAC record.

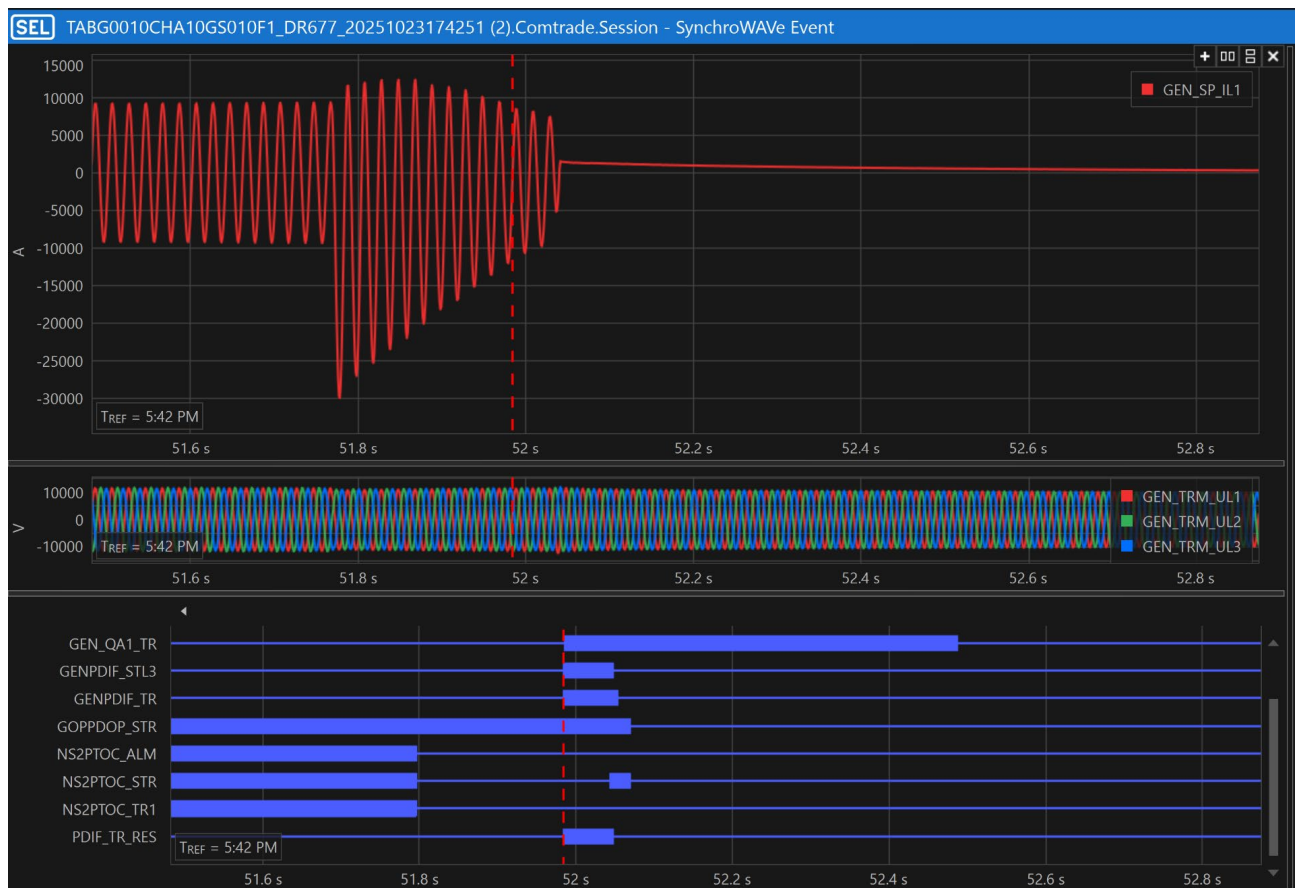
Figure 1 TAB GEN\_SP\_IL1

TAB GEN\_SP\_IL1 illustrative star-point current GEN\_SP\_IL1 (upper trace, context only; IL1 is not the operating phase). The lower digital panel shows the differential element start on phase L3 (GENPDIF\_STL3) and the differential trip (GENPDIF\_TR) asserting at the cursor, indicating operation at that instant with no intentional delay.

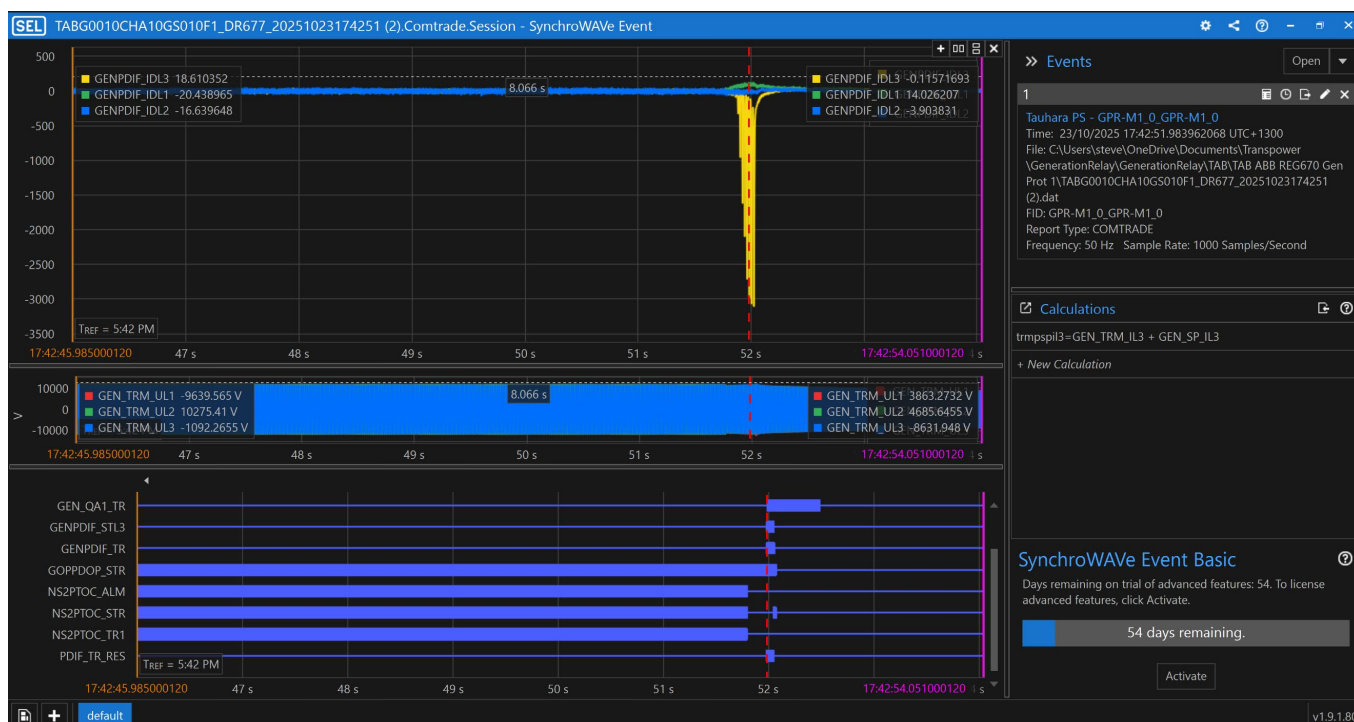
Figure 2 Differential current on L1, L2, L3 and differential pickups

The reconstructed differential current TRMSPIL3 remained at approximately zero throughout normal operation and during the initial part of the surge, then developed a large, unidirectional excursion at the instant of operation. The corresponding quantities on the white and blue phases (IL1 and IL2) remained flat at approximately zero throughout and are therefore not reproduced here. The appearance of a genuine differential current on the IL3 phase only is consistent with the differential element starting and operating on phase L3 alone (GENPDIF\_STL3), and not on the other two phases.

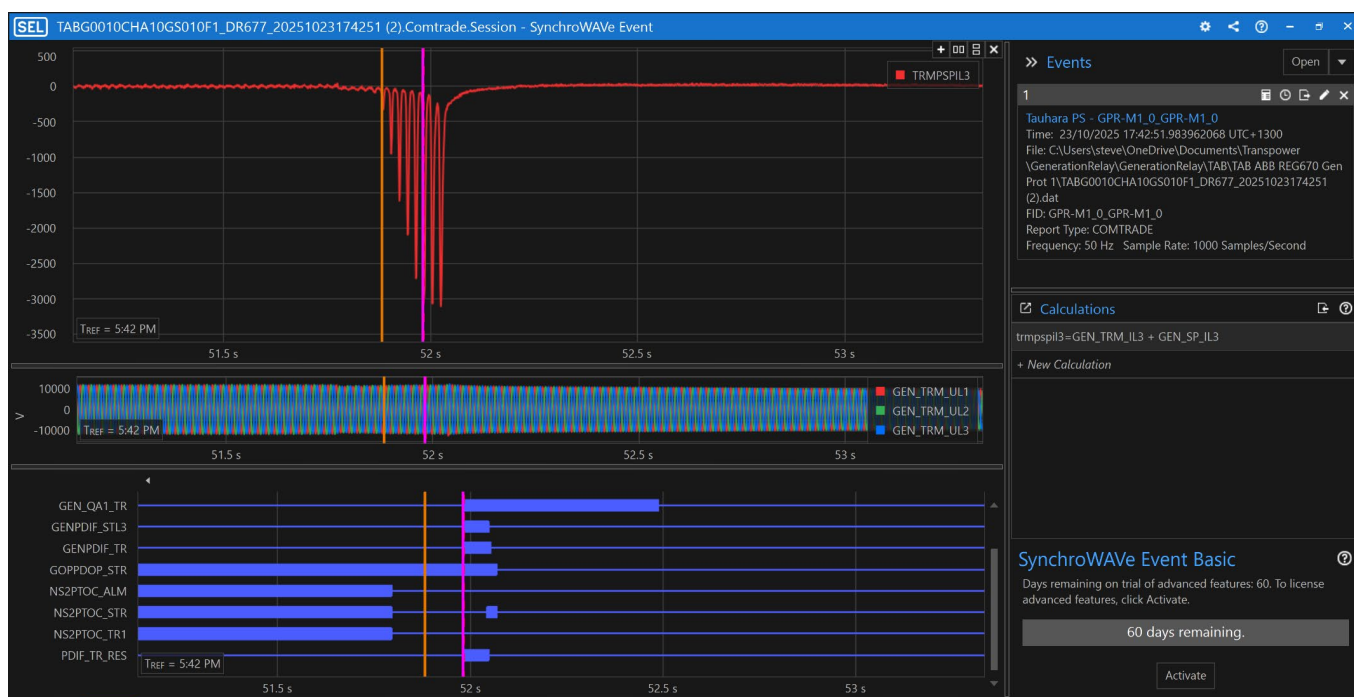
Figure 3 TAB reconstructed 87G

TAB reconstructed 87G: Operate current on the IL3 phase,  $TRMPSPIL3 = GEN\_TRM\_IL3 + GEN\_SP\_IL3$ . The differential remains at approximately zero during normal operation and then develops a large excursion at the instant of operation. The equivalent quantities on phases L1 and L2 were flat ( $\approx 0$ ) and are omitted.

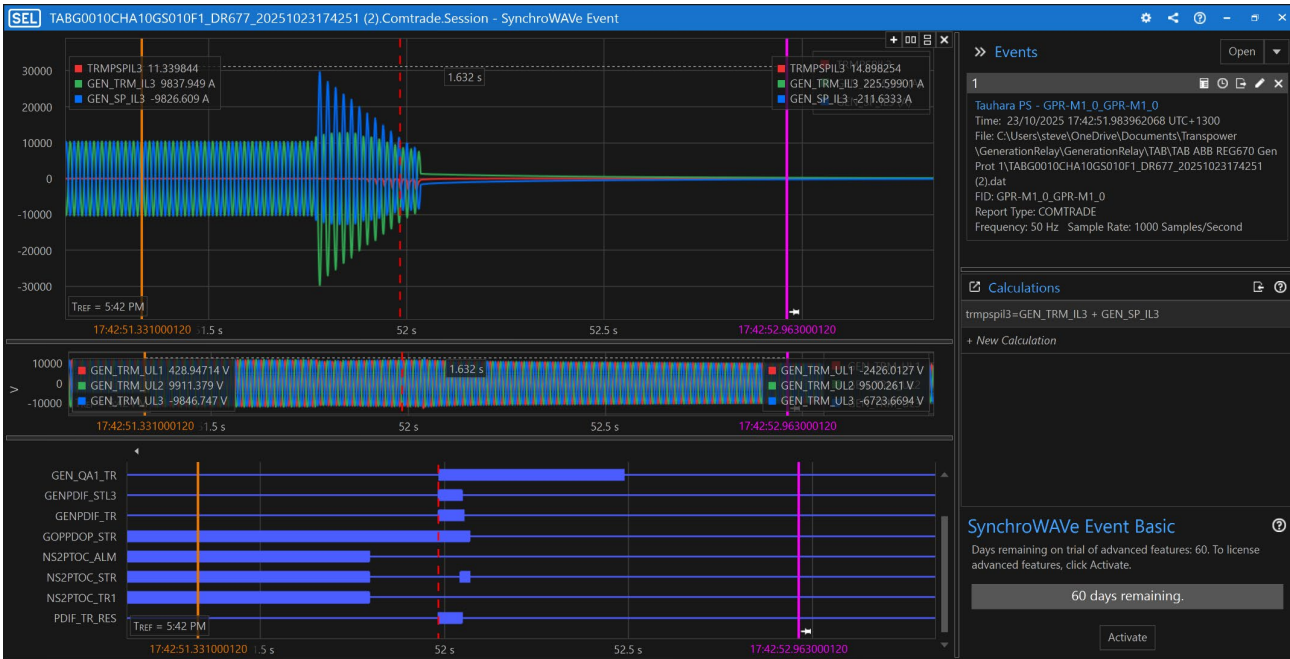
Figure 4 TAB Current 87G and IL3 overlay

Overlaying the two CT inputs to the differential element on phase 3 the terminal-side current ( $GEN\_TRM\_IL3$ ), the star-point-side current ( $GEN\_SP\_IL3$ ) and their difference ( $TRMPSPIL3$ ) shows the two currents tracking one another during the surge, so that their difference remains near zero, and then diverging. It is this divergence between the two CTs

one CT measuring the current as expected and the other not that produces the false differential current seen by the relay. Such divergence is the characteristic signature of current transformer saturation, in which one CT ceases to faithfully reproduce its primary current while the other continues to do so.

TAB the two current transformer inputs to the differential element on phase L3 (terminal-side and star-point-side), together with their difference (TRMPSIL3) and the associated event sequence. The two currents track during the surge (difference  $\approx 0$ ) and then diverge, producing the differential current that operated the relay the characteristic signature of CT saturation.

This observation is consistent with the position reported by Contact Energy, namely that one of the current transformers on the TAB generator differential scheme reached saturation, producing a false differential current, while the neutral-side CT did not saturate. The recorded magnitude of the current experienced by the generator during the surge was of the order of twice the nominal current a magnitude below that expected for a close-in system fault, and one at which a generator-protection CT would not ordinarily be expected to saturate.

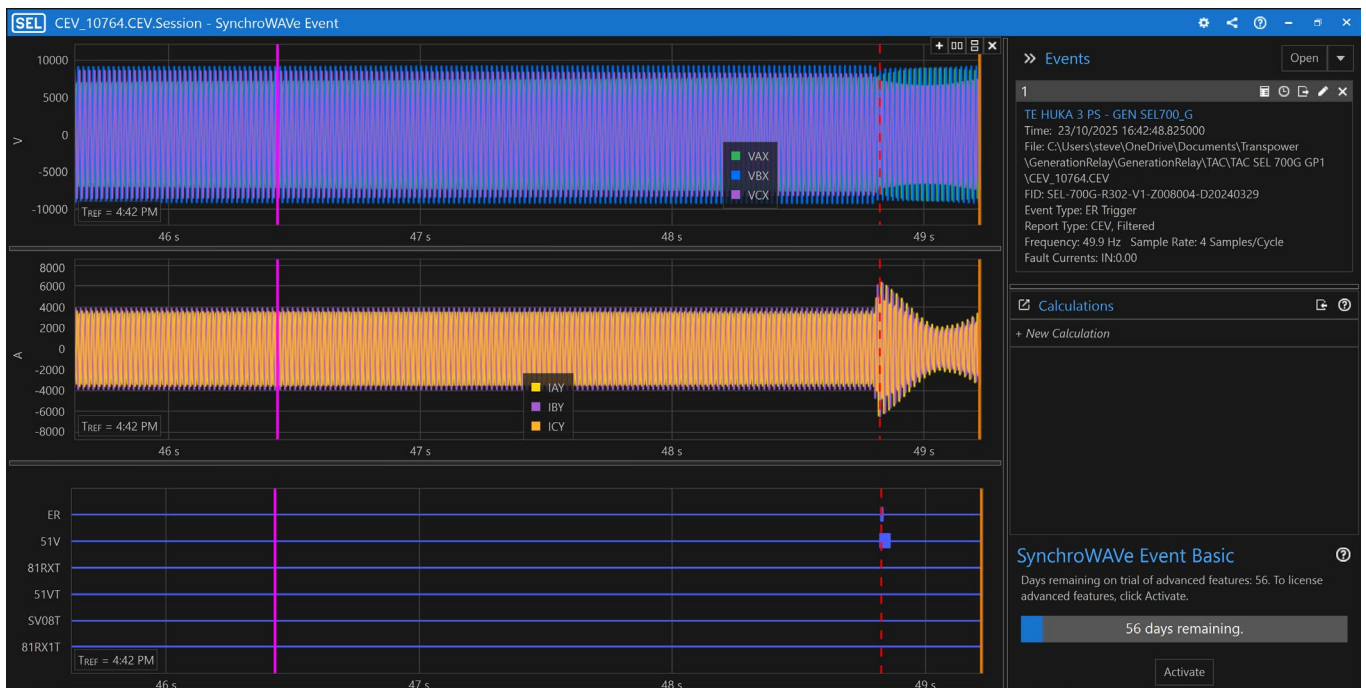
Figure 6 TAC Event Capture ER Flag and 51V Operation Voltage and current

At the first ER event, the ER flag is asserted together with 51V, while the 81RXT (RoCoF) element and OUT301 are not asserted. The analogue traces show a rise in current accompanied by a slight dip in voltage. This combination (elevated current with depressed voltage) is the condition that the voltage-restrained overcurrent element (51V) is designed to detect: the voltage restraint increases the element's sensitivity when the voltage falls, as occurs for a disturbance in the vicinity of the generator. GHD is not able to confirm from the data whether the current rise and voltage dip met the 51V operating threshold as a numerical comparison against the setting; however, the 51V element is observed to have picked up (asserted), so it is reasonable to conclude that the threshold was met. There is no intentional pick-up delay applied to the 51V element in the relay. Importantly, the 51V element picked up (asserted) but did not itself trip and the associated 51V trip (51VT) did not assert.

Figures 5 show wide view of the first ER event (x axis approximately 45–49.25 s). The frequency drop occurs with the ER flag and 51V asserted, and without operation of the 81RXT (RoCoF) element or the 51V trip (51VT).

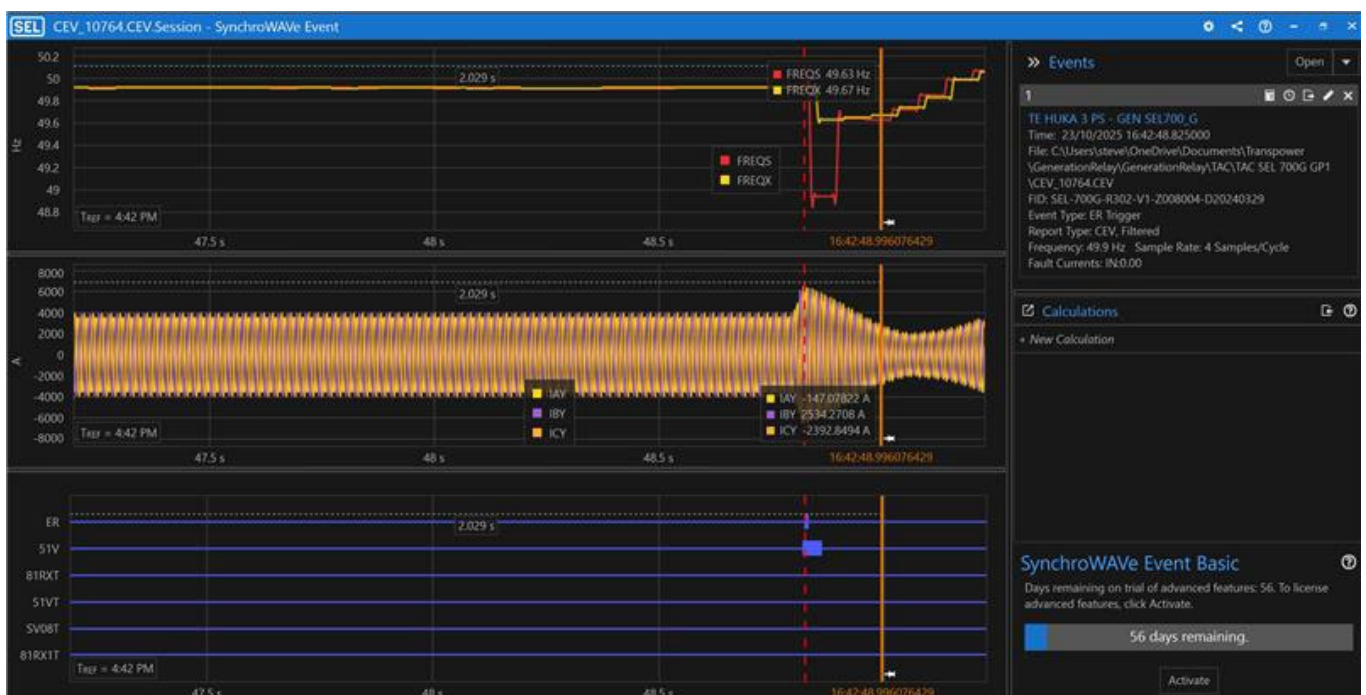
Figure 7 TAC Event Capture ER Flag and 51V Operation Current and Frequency

TAC — first ER event (x axis approximately 47–49 s). The frequency drop is shown with the voltage in the centre panel; the ER flag and 51V are asserted while the 81RXT (RoCoF) element and the 51V trip (51VT) are not. TAC — first ER event (approximately 47–49 s) with the current in the centre panel. 51V is active and the 51V trip (51VT) is not active, ER is active, and the frequency drop coincides with an increase in current — the current-rise / voltage-dip signature that operates the 51V voltage-restrained overcurrent element.

This 51V pick-up is corroborated by the two Te Huka 3 PS protection event logs (Appendix B). Both the SEL-400G and SEL-700G logs record the 51V element asserting at approximately 16:42:48.82 on 23 October 2025; neither log records an assertion of the 81RXT (RoCoF) element.

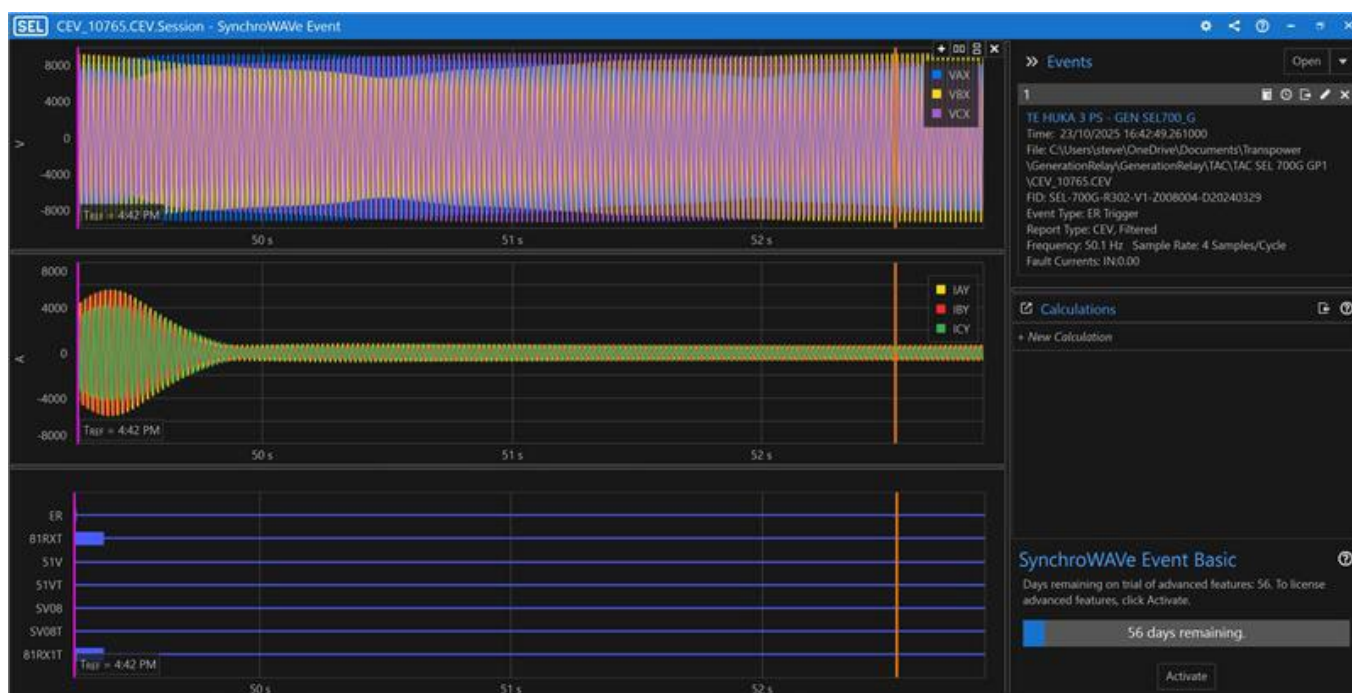
Figure 8 TAC second ER event (x axis approximately 49–53 s).

Following the 51V event, the relay record contains a second, later ER event, in which the 81RXT (RoCoF) element operated. This second operation is not recorded in either protection event log. The event captures show the 81RXT element asserting during the angular disturbance, with the associated currents and the frequency ramp. It should be noted that the operation of 81RXT was over 450ms after the switching event and was around 200ms after the tripping of TAB. GHD notes that the recorded rate of change of frequency associated with this second event appears slower than would ordinarily be expected to operate a RoCoF element; nevertheless, the 81RXT element was triggered. Whether this reflects the element's setting responding to the change in frequency caused by the loss of TAC, or operation on the underlying angular disturbance, cannot be resolved further from the data provided.

A further ER flag is raised, this time by operation of the 81RXT (RoCoF) element, with 51V not asserted. This operation is not recorded in the protection event logs.

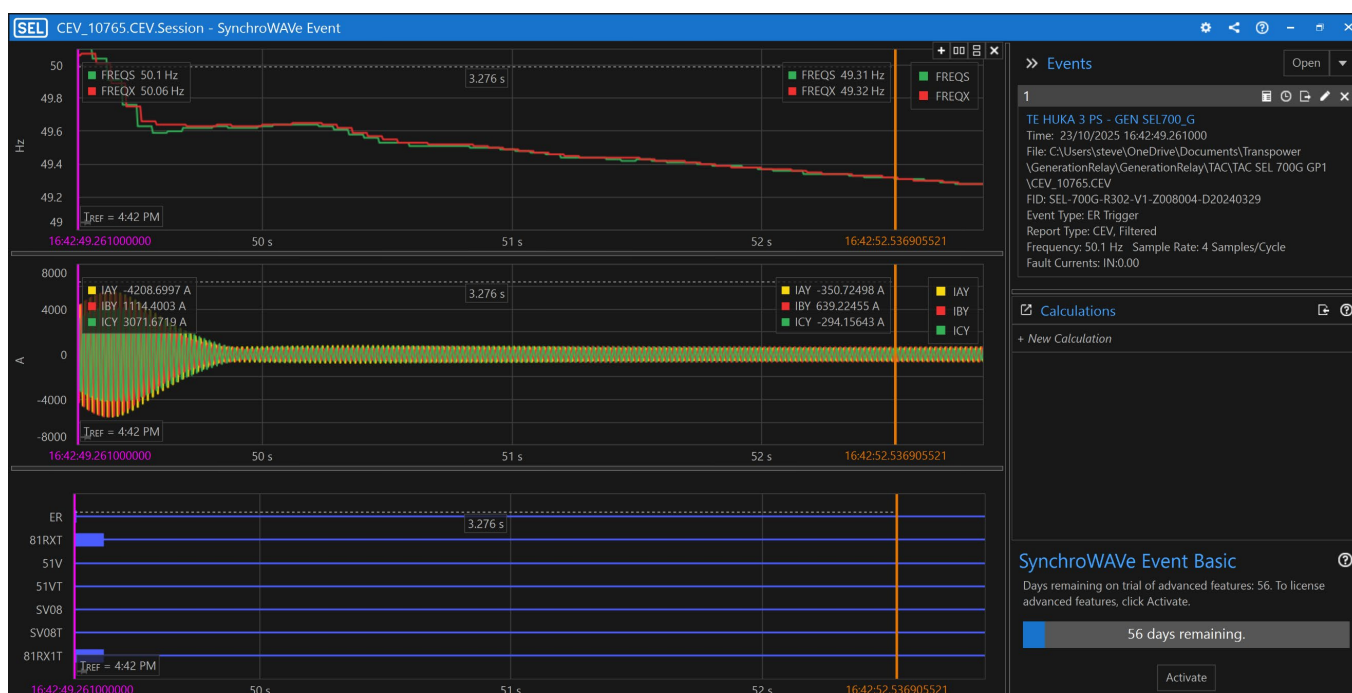
Figure 9 TAC second ER event (x axis approximately 49–53 s).

Second ER event (approximately 49–53 s) with the currents in the centre panel and the frequency ramp shown. The 81RXT (RoCoF) element operates although the frequency rate of change appears slower than would ordinarily operate RoCoF; the element is nevertheless triggered.
