# Causation Report

### Under-Frequency Event

System Operator Event 4686  
06 May 2026

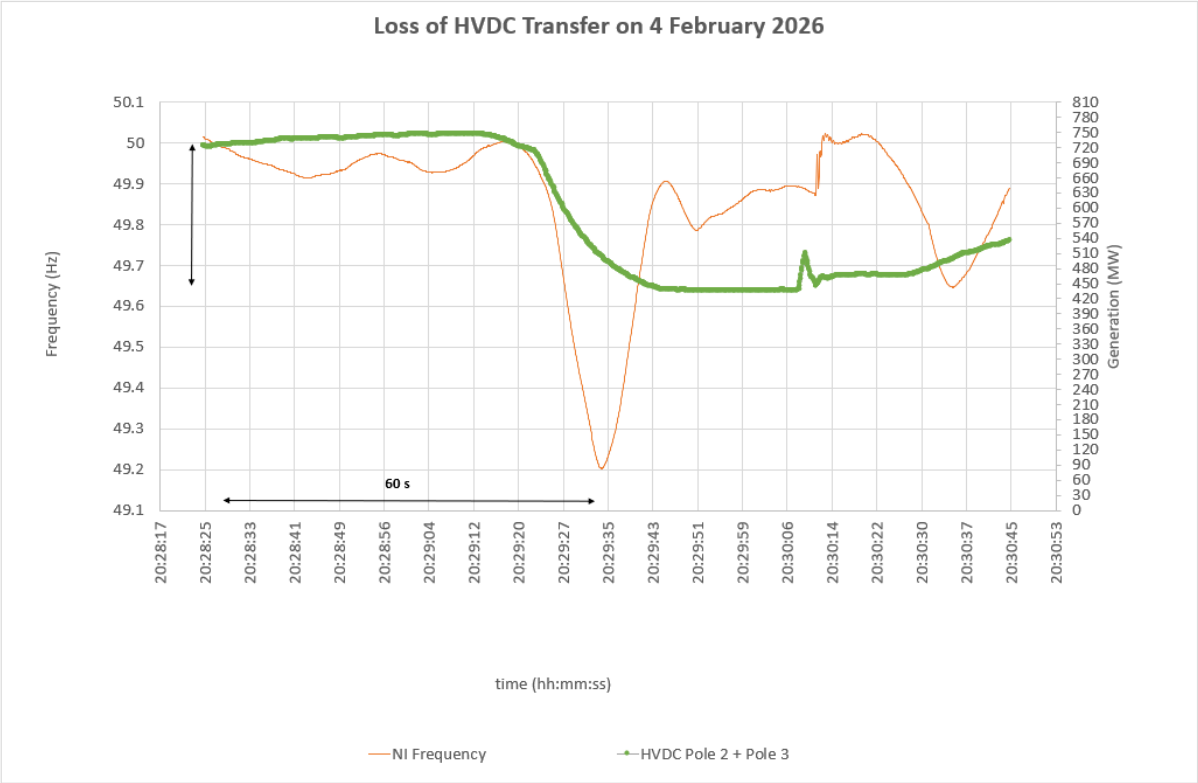
North Island Frequency

At 20:29:13, the HVDC Pole 3 suddenly ramped down as a result of a current limit being applied, reducing transfer into the North Island power system from 373 to 34 MW.

The Grid Owner confirmed that the current on Pole 3 was limited due to a failure of the cubicle power supply of the blue-phase converter transformer at Benmore, which resulted in the loss of transformer cooling capability.

Consequently, Pole 3's transfer was reduced to its minimum operational level. This reduction in transfer created a power imbalance between the islands: the North Island frequency dropped to 49.20 Hz, while the South Island frequency increased to 51.03 Hz. As Pole 3 was current-limited rather than fully tripped, Pole 2 was not released to its overload capability (where it would have increased its pre-event transfer from 386 MW up to 700 MW from Benmore), meaning that the system did not benefit from the additional northward transfer normally available during a single-pole contingency.

Following the under-frequency event Pole 3 subsequently tripped at 20:30:11 by which time the North island frequency had recovered to 49.94 Hz.

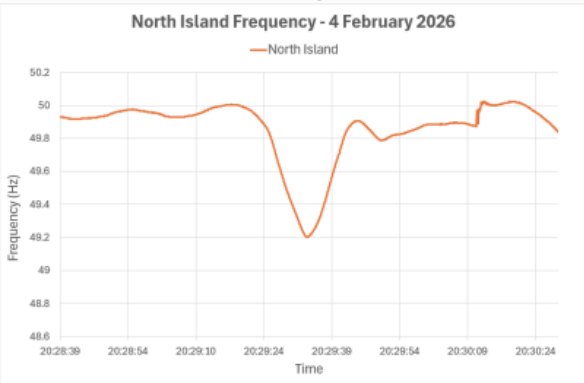
North Island Frequency - 4 February 2026

| <b>North Island Minimum Frequency:</b> | 49.20 Hz |
| <b>Time (start of UFE):</b> | 20:29:33 |
| <b>Time (of min. frequency):</b> | 20:29:34 |

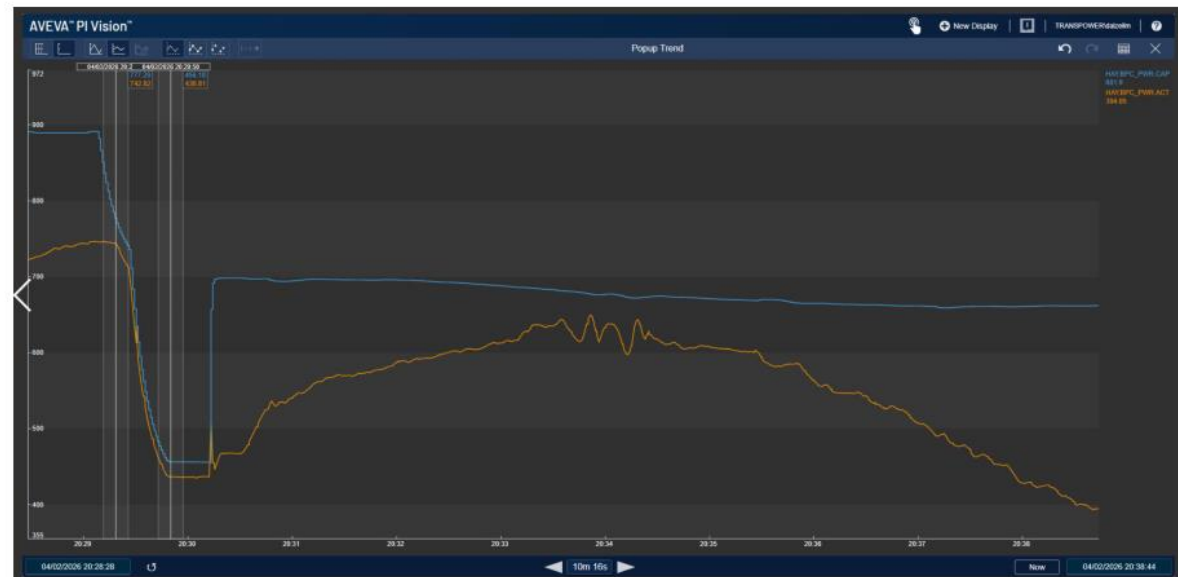
## Appendix B – Screenshot from PI Vision

| System Operator Questions | Grid Owner's Response | |
|---|---|---|
| <b>Confirmation or alternative data for MW loss:</b><br>Our preliminary assessment of SCADA/PI data indicates a loss of approximately 300 MW at HAY2201 during the event. | 4. Could you please confirm this value based on your site-specific data. | Transient Fault Recorder (TFR) triggers did not capture the start of this event so high-resolution data for the whole event is not available. From analysing lower resolution PI data from the HVDC controls we get 306MW lost at HAY2201 over a 32 second interval. |
| | 5. If your data indicates a different value for the MW loss, please provide the alternative figure and any supporting information or logs. | Refer to Appendix B - Screenshot from PI Vision. |
