# Causation Report

### Under-Frequency Event

System Operator Event 4636  
13 February 2025

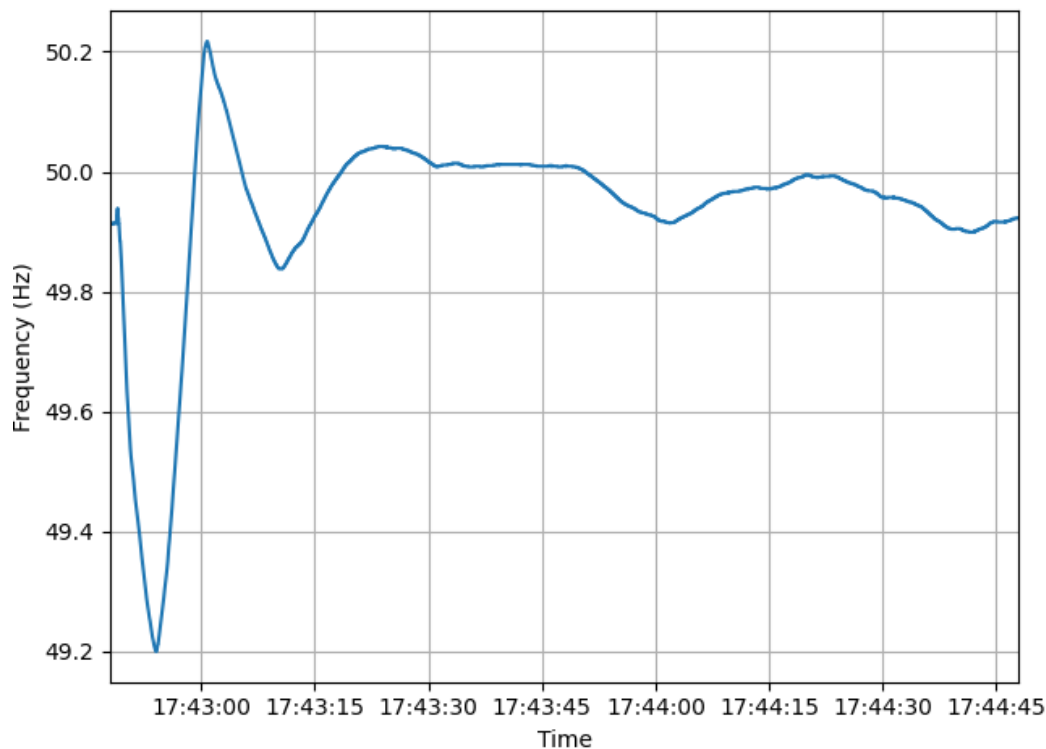
##### North Island Frequency

Very shortly after CB662 was closed TAB and TAC both tripped, causing the system frequency to drop to a minimum of 49.2Hz. The frequency was restored to normal by 17:43:00.

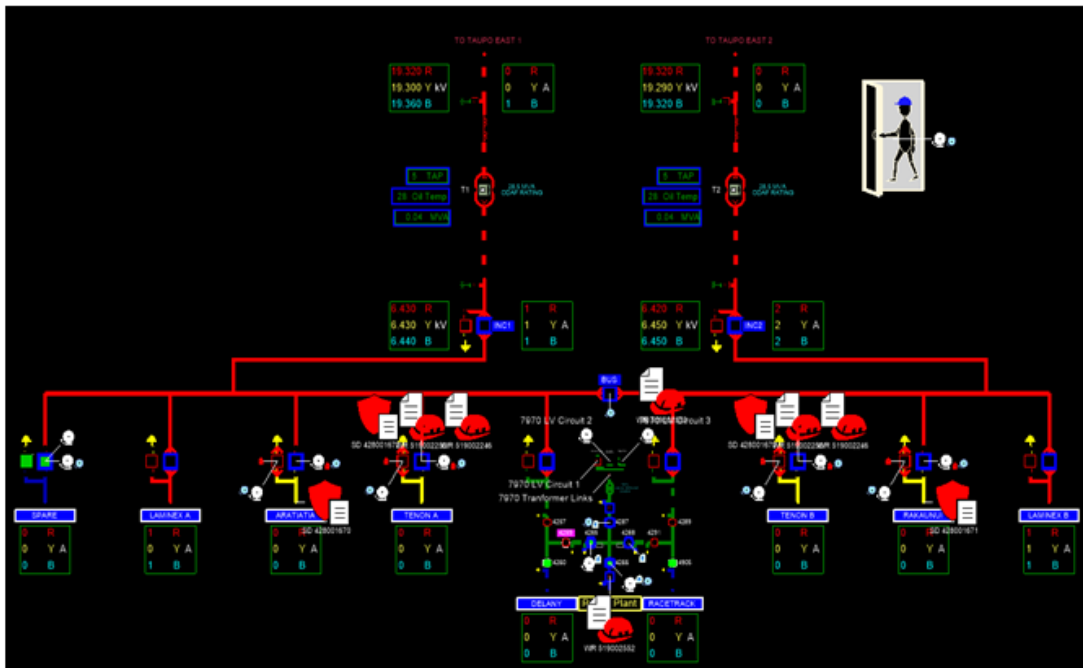
No event recordings or SER's for Taupo East.

Taupo East ZS SCADA Tile to indicate no load connected:

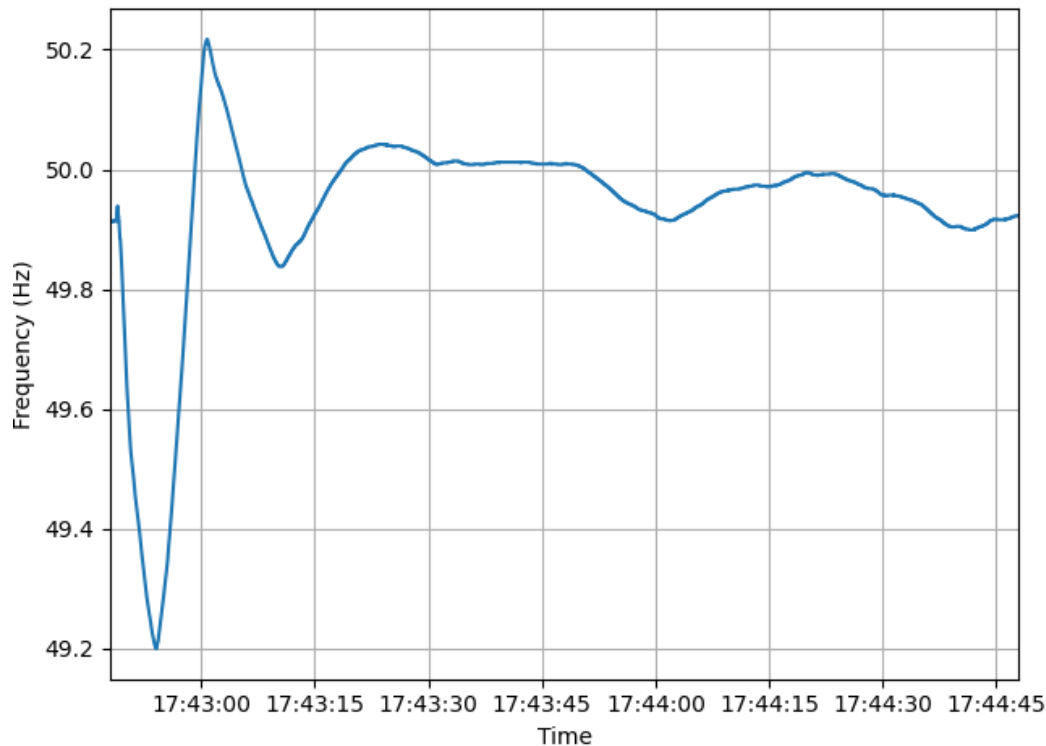
Figure 1: WRK PMU Measured Frequency

| Time | Description | Source |
|---|---|---|
| 17:42:53.26 | Frequency drops below 49.25Hz | WRK PMU |
| 17:43:00 | Frequency restored to normal band | WRK PMU |

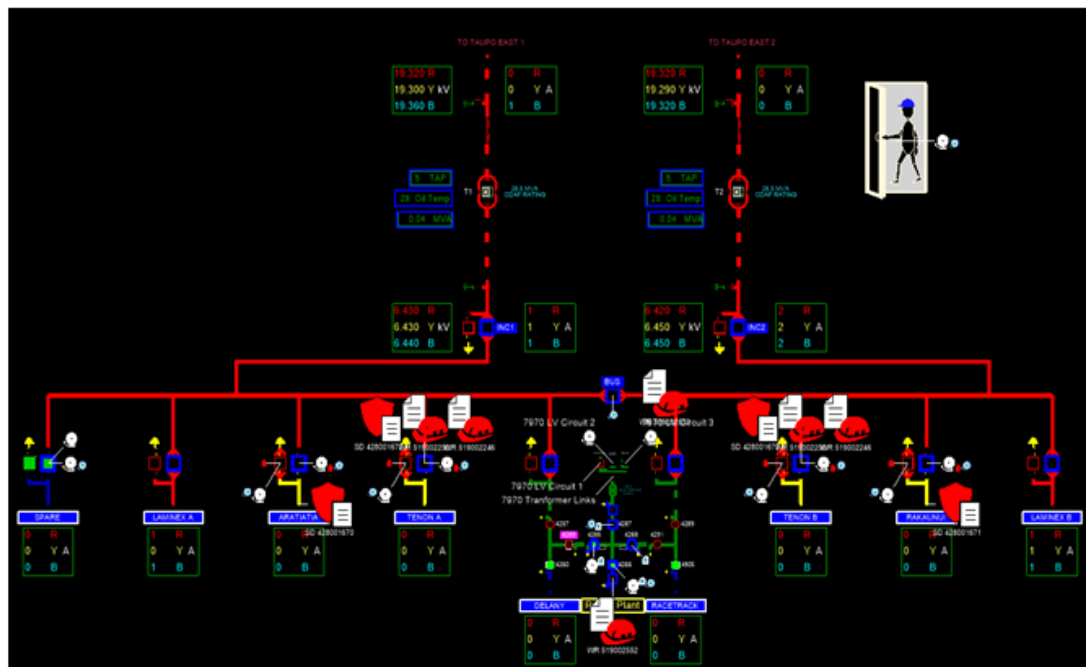
No event recordings or SER's for Taupo East.

Taupo East ZS SCADA Tile to indicate no load connected:
