# **Draft determination of causer: 23 October (5.42pm) 2025 UFE**

## **Consultation paper**

3/08/2026

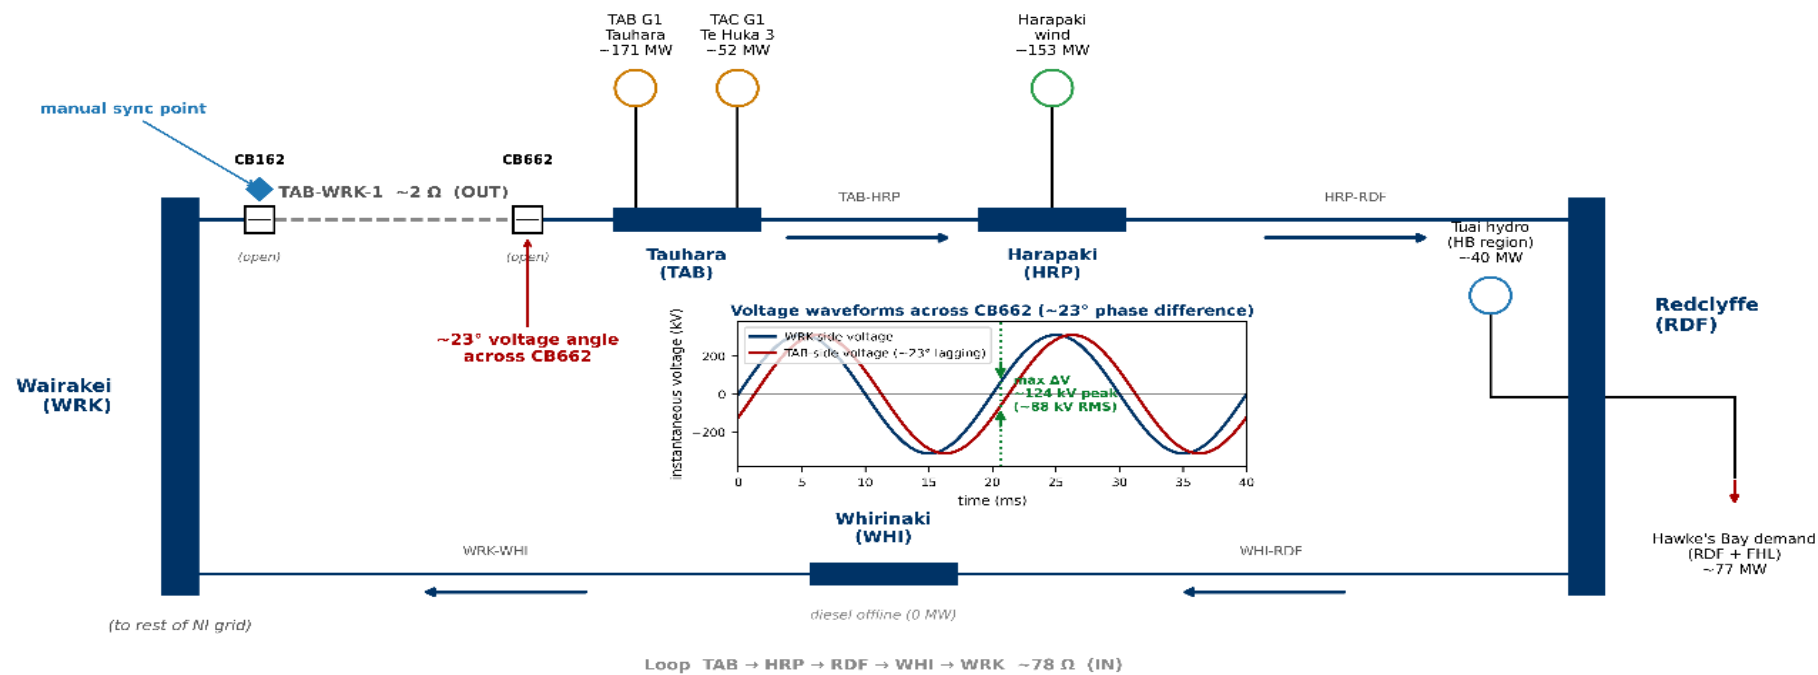
- (a) immediately prior to the UFE, the Tauhara-Wairakei-1 (TAB-WRK-1) circuit was out of service on planned outage
  - (b) with TAB-WRK-1 out of service, the impedance between TAB and WRK through the parallel Hawke's Bay loop was approximately 78 ohms, but with TAB-WRK-1 in service it is approximately 2 ohms

- (d) at approximately 5.42pm, TAB-WRK-1 was ready to be returned to service
  - (e) the breaker at the Wairakei end (CB162) was closed, energising the circuit, and then the breaker at the TAB G1 end (CB662) was closed

- (f) immediately before CB662 was closed, the voltage angle across the open breaker contacts was approximately 23 degrees
  - (g) within seconds of CB662 closing, TAB G1 and TAC G1 both tripped, causing the system frequency to drop to a minimum of 49.2Hz

- (h) the frequency was restored to normal by 5.43pm.
- 3.5 The Authority has produced the diagram in Figure 1 to show the double circuit line and the circuit affected by this UFE.
