**ELECTRICITY INDUSTRY PARTICIPATION CODE  
DISTRIBUTOR AUDIT REPORT**

**THE LINES COMPANY  
NZBN: 9429038879517**

Date audit commenced: 2 December 2021

Date audit report completed: 31 March 2022

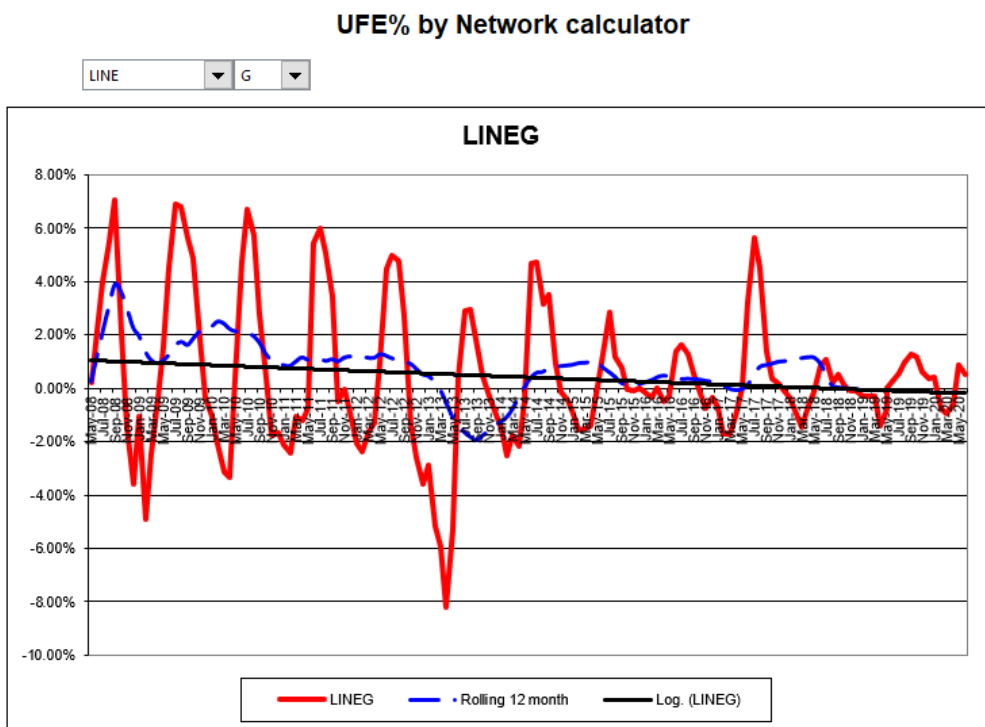
I was provided by the Electricity Authority the reconciliation losses by for the Lines Company network. The chart below indicates losses for the network are tracking within the +/- 1% threshold.

The review of loss factors is still in progress and is expected to be in place by June 2022.
