**ELECTRICITY INDUSTRY PARTICIPATION CODE  
DISTRIBUTOR AUDIT REPORT**

**VECTOR LTD  
(NZBM# 9429039215109)**

Prepared by: Ewa Glowacka of TEG & Associates

Date audit commenced: 1 September 2022

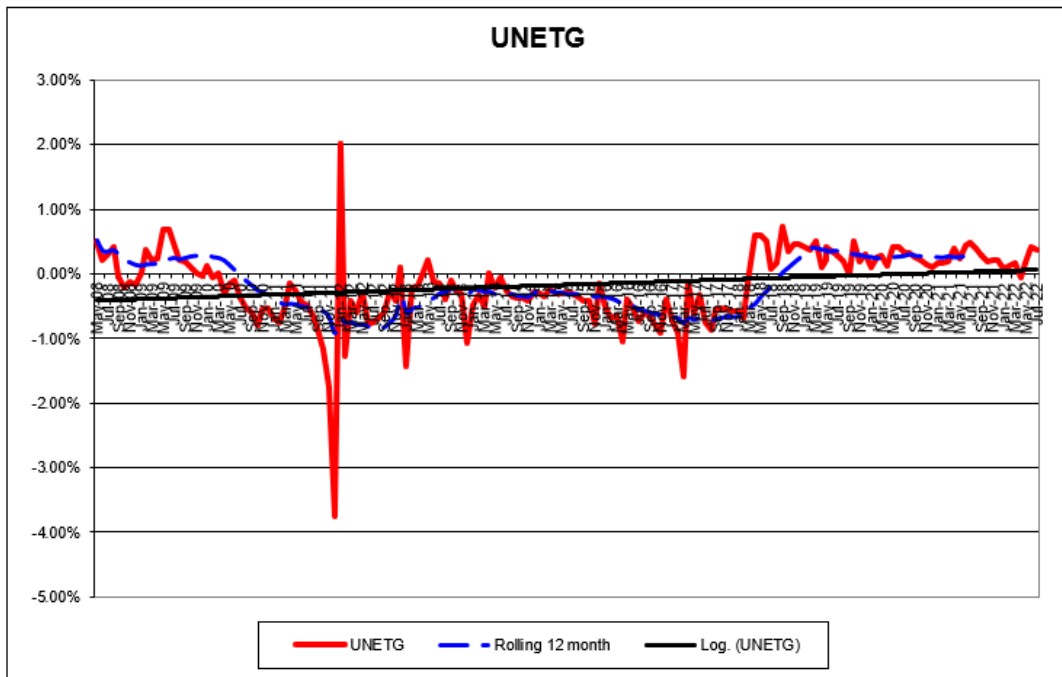
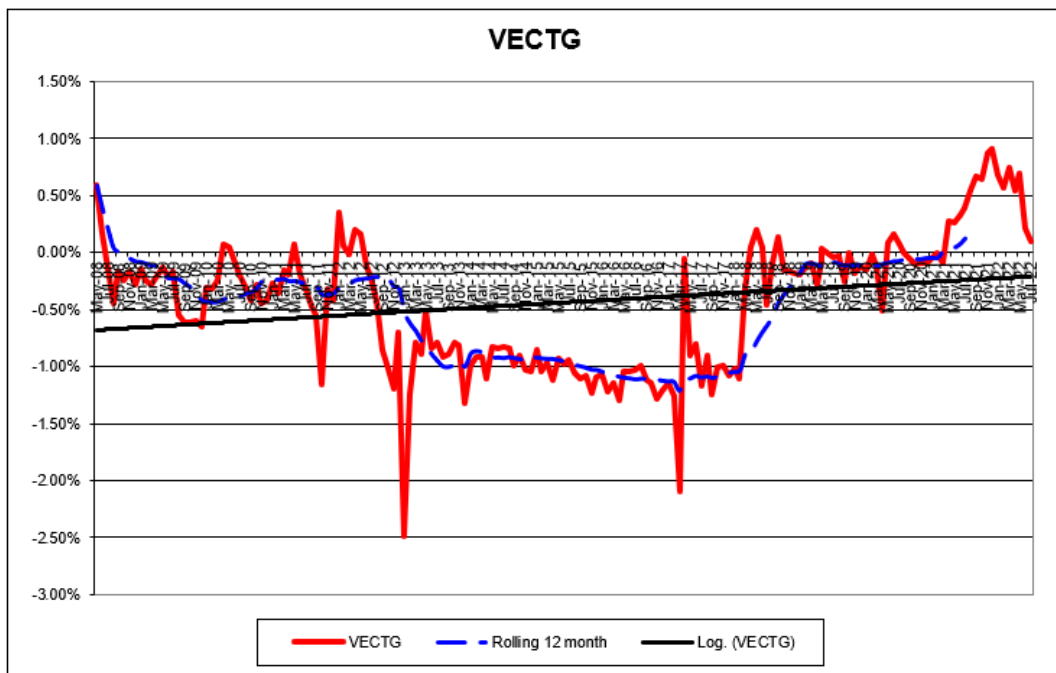
Vector commented that loss factors for the Vector networks increased due to a change of distribution of the load caused by Covid. More people work from homes, which are connected to the LV network, connections are further from transformers therefore losses are higher. Additionally, there has been significant increase of domestic connection on the Northern network due to establishing new suburbs.

The Authority provided the following UFE graphs for the VECT and UNET networks, which showed both were within the  $\pm 1\%$  threshold.

Compliant
