ELECTRICITY INDUSTRY PARTICIPATION CODE  
DISTRIBUTED UNMETERED LOAD AUDIT REPORT

WELLINGTON CITY COUNCIL AND  
MERIDIAN ENERGY

Prepared by: Bernie Cross

Date audit commenced: 21 February 2023

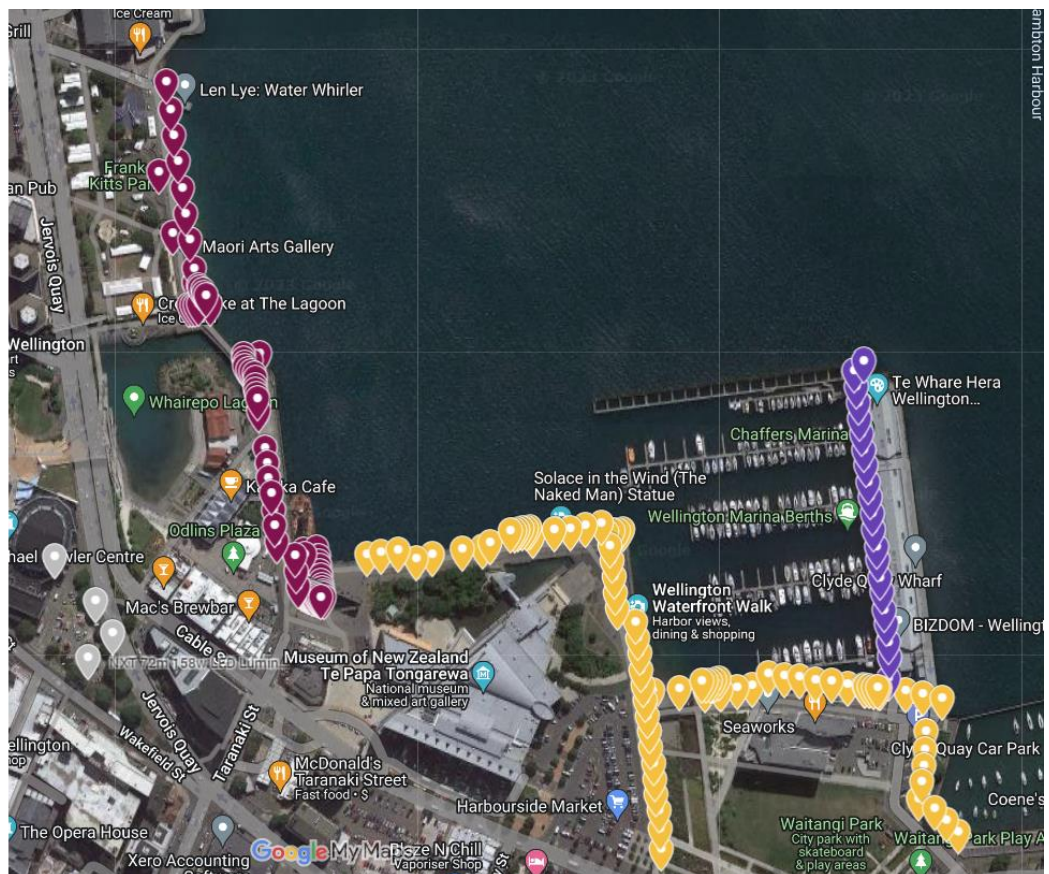
The previous audit identified that WCC also manages 20 hectares of waterfront land extending from Waterloo Apartments to Clyde Quay wharf and there are a number illuminated paths and walkways within this area. The responsibility for these lights is currently unknown as they do not appear in the DUML database and also there does not appear to be DUML or metered ICPs created for these. Three of these walkways (Great Harbour Way/Te Aranui o Poneke, Commonwealth Walkway and Clyde Quay walkway from Clyde Quay at the southern end of these walkways to Frank Kitts Park) were mapped as part of this field audit. This exercise identified 173 lights with an assessed annual load of 77,206 kWh that appear to not be accounted for as shown in the below map.

No progress has been made between Wellington City Council and Meridian in determining how these lights are being accounted for. Non-compliance is recorded below and in sections 2.1, 3.1 and 3.2 for these missing lights.
