ELECTRICITY INDUSTRY PARTICIPATION CODE
DISTRIBUTED UNMETERED LOAD AUDIT REPORT

PORIRUA CITY COUNCIL
AND MERIDIAN ENERGY LIMITED

Prepared by: Bernie Cross

Date audit commenced: 6 June 2023

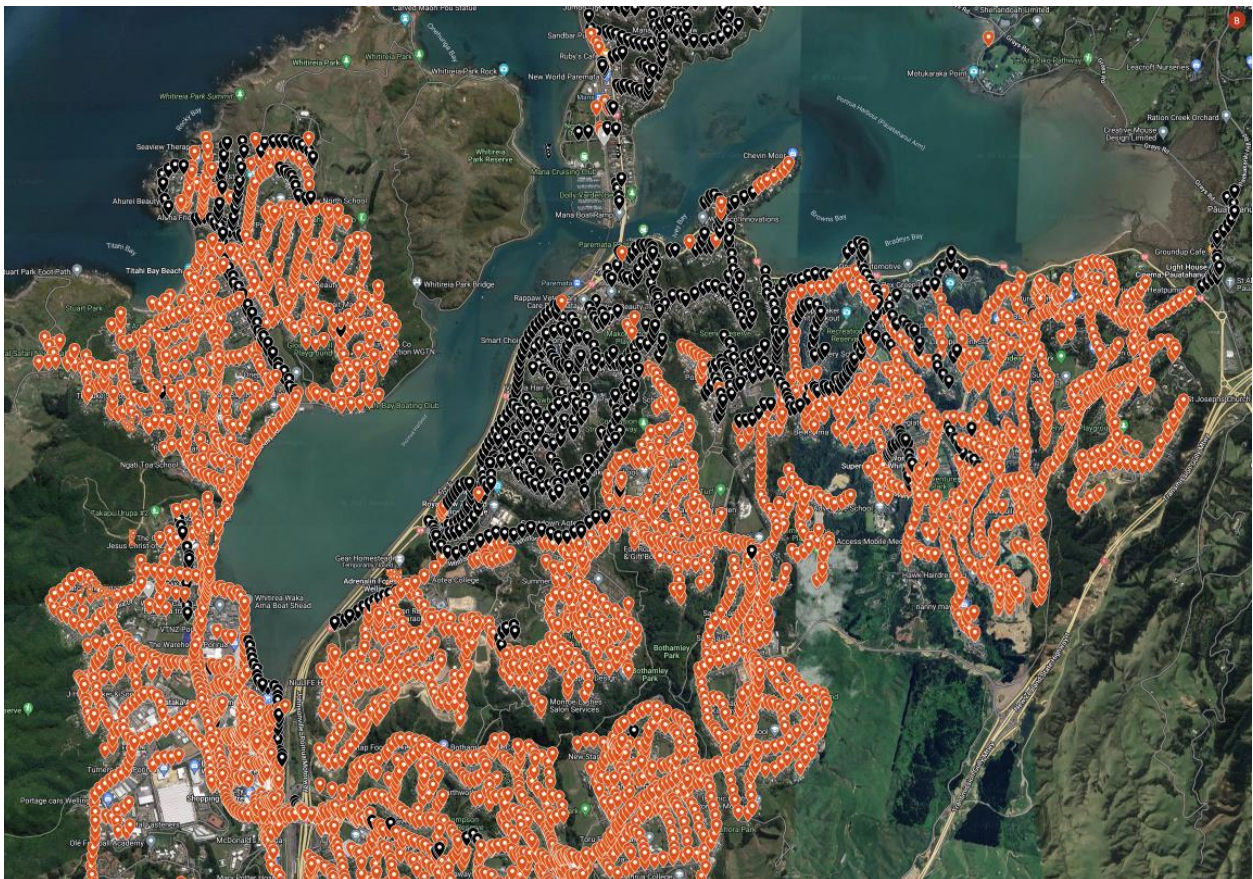
All items of load were plotted to ensure the correct network supply point (NSP) was allocated through the ICP assignment. In the map below the red plots are for NSP TKR0331 and the black plots are for PNI0331.

The map shows that the ICP/NSP assignment to the lights is not consistently applied resulting in some load being incorrectly assigned to ICPs and the associated NSP for reconciliation purposes. I repeat the previous audits recommendation that Meridian works with Wellington Electricity to clearly define the boundaries between lights supplied by TKR0331 and PNI0331 NSPs.

Recommendation	Description	Audited party comment	Remedial action
Improve accuracy of ICP assignment to each item of load.	Meridian to work with Wellington Electricity to clearly define the boundaries between lights supplied by TKR0331 and PNI0331 NSPs and ensure the database then correctly reflects these boundaries.	Meridian is currently working with WE to assign the items of load to the correct NSP's	Identified
