ELECTRICITY INDUSTRY PARTICIPATION CODE
DISTRIBUTED UNMETERED LOAD AUDIT REPORT

UPPER HUTT CITY COUNCIL
AND
GENESIS ENERGY LIMITED

Date audit commenced: 23 July 2023

Date audit report completed: 8 August 2023

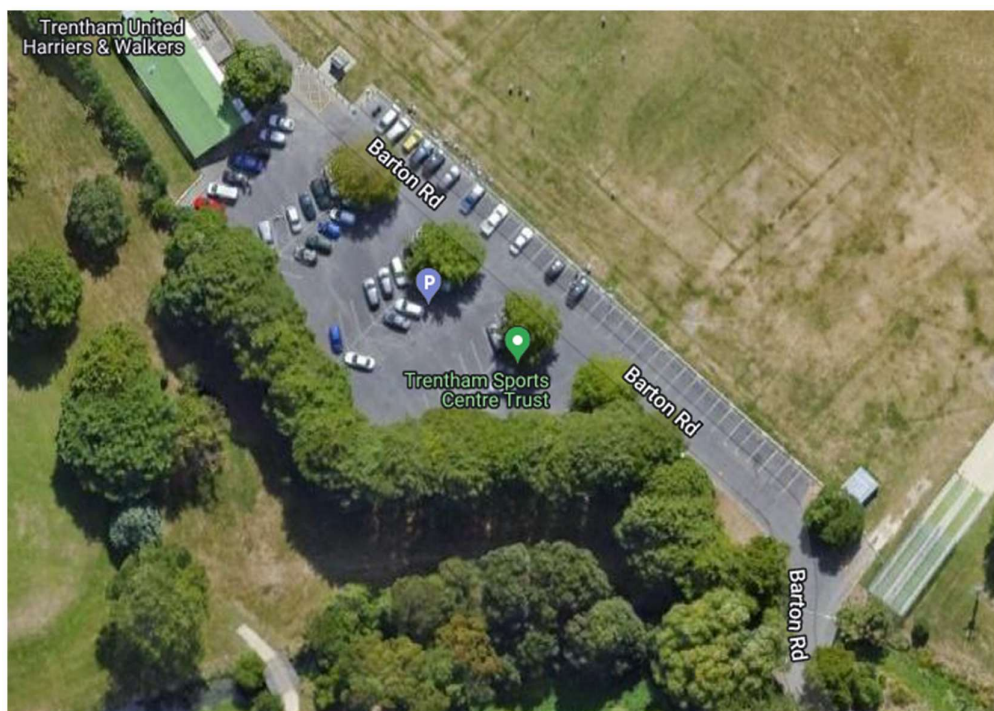
Trentham Memorial Park still has no lights with GPS locations in its carpark off Barton Road. The previous audit recorded that there were two floodlights aimed at the carpark.

The previous audit recommended that Genesis works with UHCC to confirm the ownership and operation of these carpark lights to ensure this load is accounted for, and I have repeated this recommendation.

Recommendation	Description	Audited party comment	Remedial action
Confirm the ownership and operation of carpark lights to ensure this load is accounted for	Confirm the ownership and operation of the carpark lights at Trentham Memorial Park and Maidstone Park to ensure this load is accounted for.	These assets have been investigated. There are some lights in the database from these locations and also some that are not connected to the streetlight circuit which are metered lights, also owned by the Upper Hutt CC.	Investigating

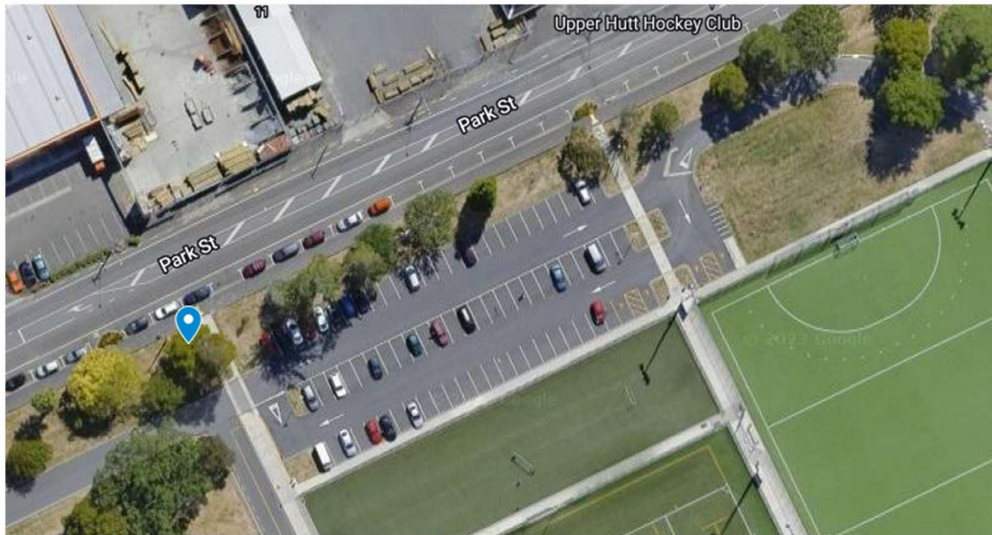
Maidstone Park still has no lights with GPS coordinates within its carpark off Park Road. The previous audit recorded that there were seven Phillips HPS lights positioned around the carpark.
