Consultation Paper – 30 July 2022 and 7 October 2022 under-frequency events

Independent Review
HVDC Power Reduction Event
7 October 2022

Issued To: Transpower New Zealand Ltd
Written By: Ranil de Silva – Technical Director, PBA Consulting
Approved By: Tony Armstrong – Director, PBA Consulting
Report Number: JC-001-105 Final Report 16 November 2022

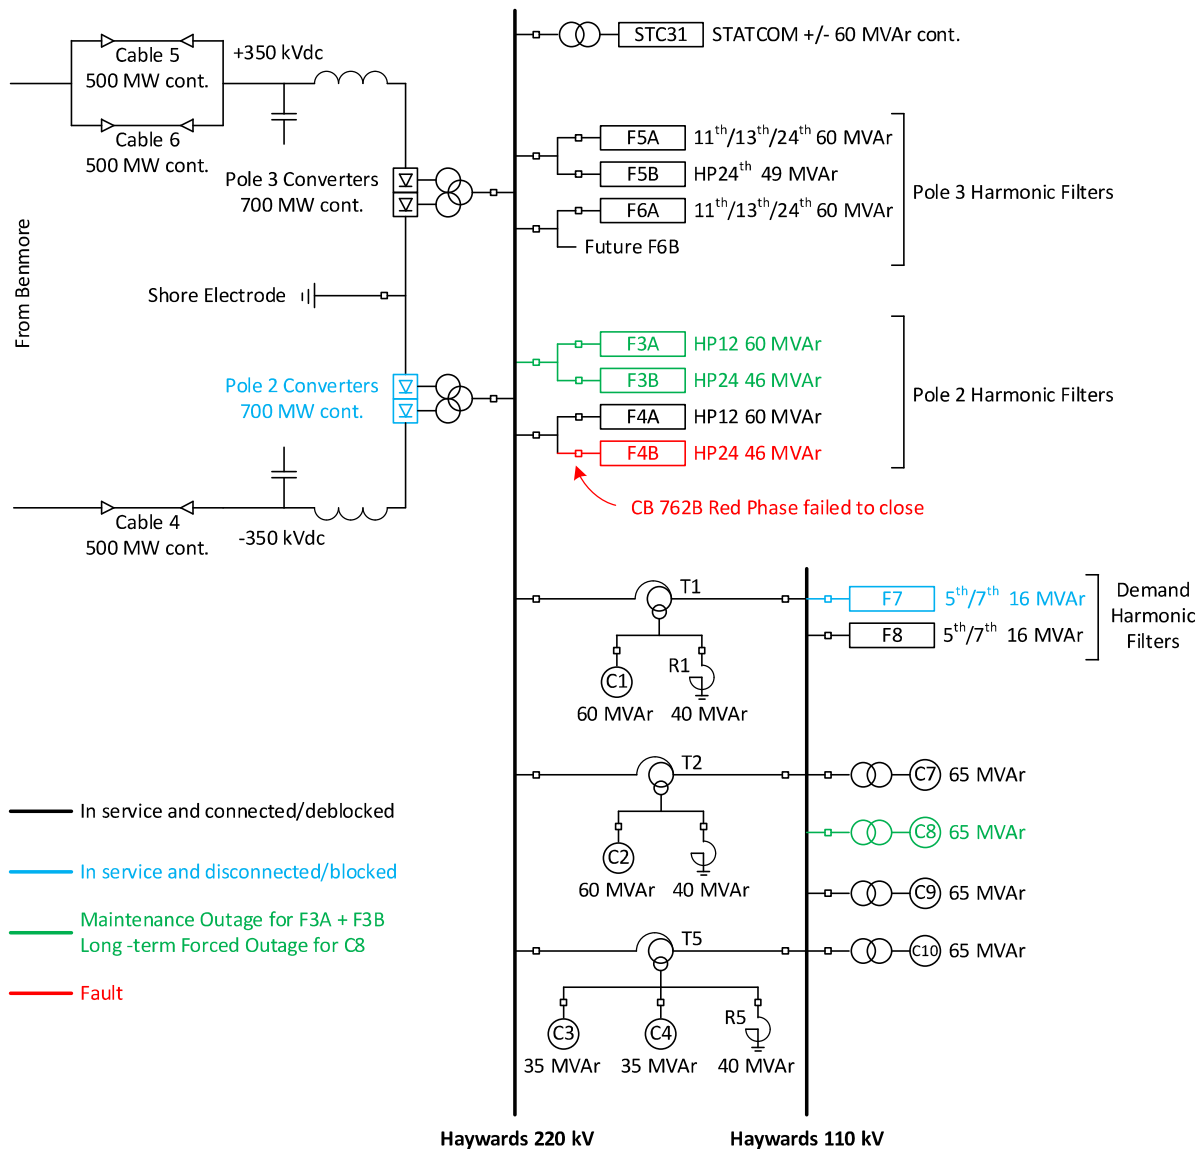
Figure 1. Simplified Single Line Diagram for Haywards Substation at 0536 Before Pole 2 Deblocks and HVDC Controls Attempt to Connect Filter F4B

Figure 1 shows a simplified single line diagram of the present Haywards HVDC converters for Pole 2 and Pole 3, and ancillary equipment including harmonic filters, synchronous condensers, and STATCOM. With all equipment in service, the HVDC Link is rated for 1200 MW Northward and 850 MW Southward.

The diagram shows the status of equipment just before Pole 2 deblocks and the HVDC controls attempt to connect Filter F4B, prior to F4B tripping and the HVDC power reduction.

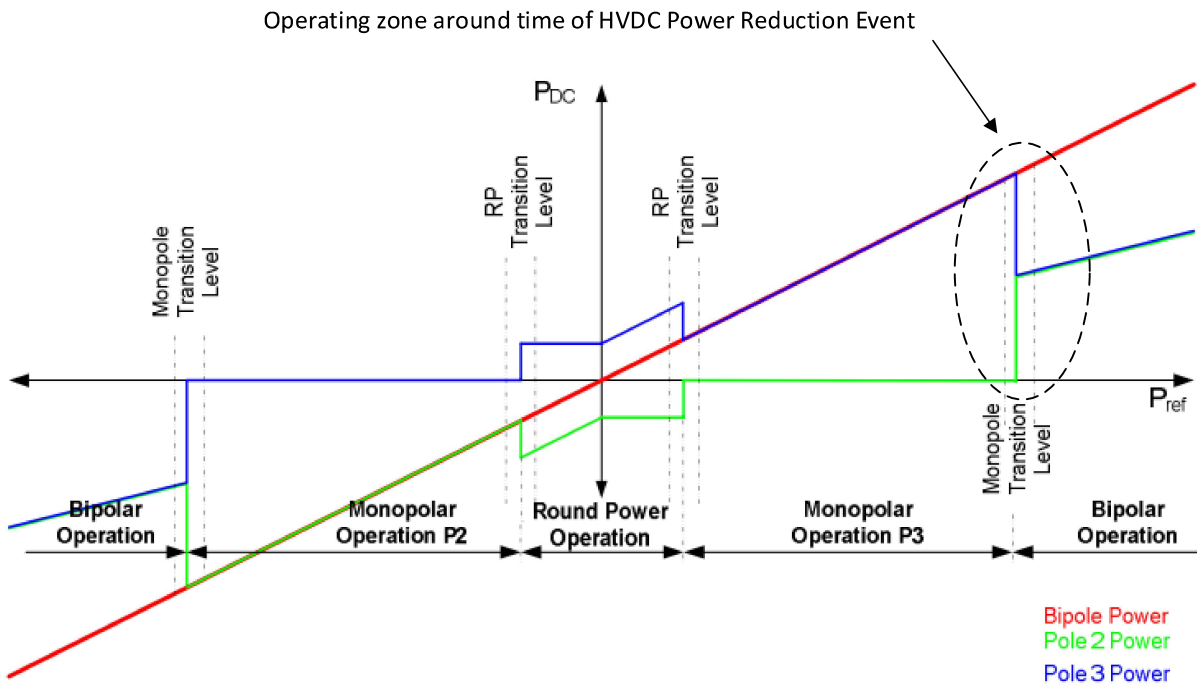
Figure 2. Roundpower Mode ¹

In respect of this report, Figure 2 also shows where the HVDC was being operated in Roundpower mode around the time of the power reduction event, changing back and forth between Pole 3 monopole operation and bipole operation.

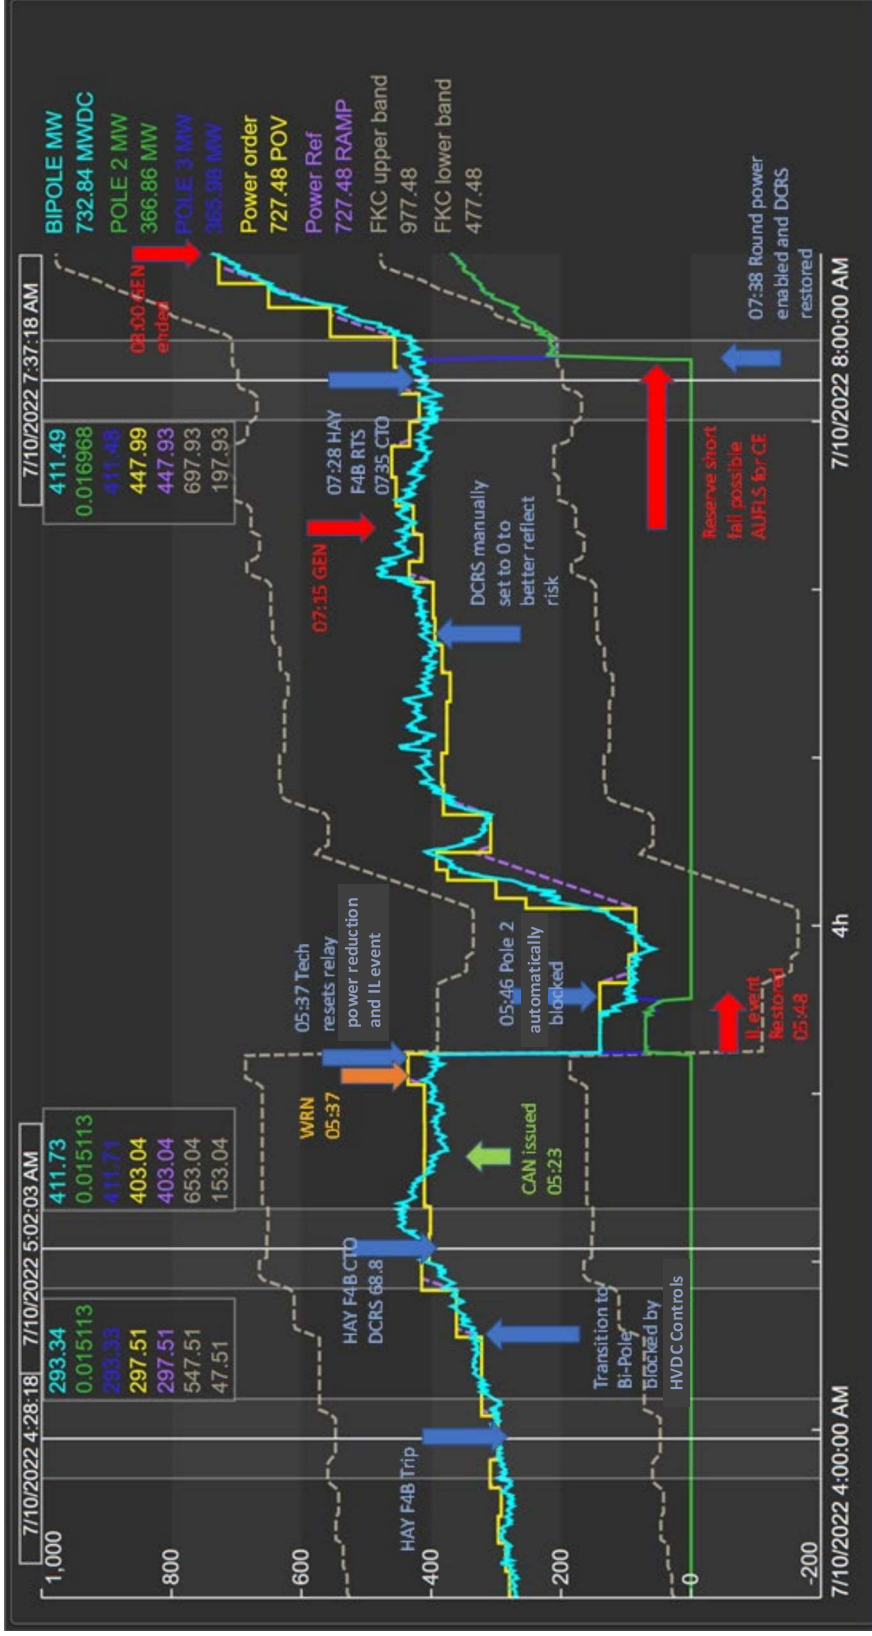
Figure 3. Overview of HVDC Power Transfer ³

Table 2 shows a timeline for the HVDC Power Reduction Event of 7 October 2022, beginning with the first HVDC upgrade in 1992 and ending with Transpower’s ongoing investigation into Filter F4B switching failures at Haywards substation. Figure 3 shows plots of the HVDC transfer over the whole event, and Figure 4 shows plots covering the few seconds around the HVDC power reduction.

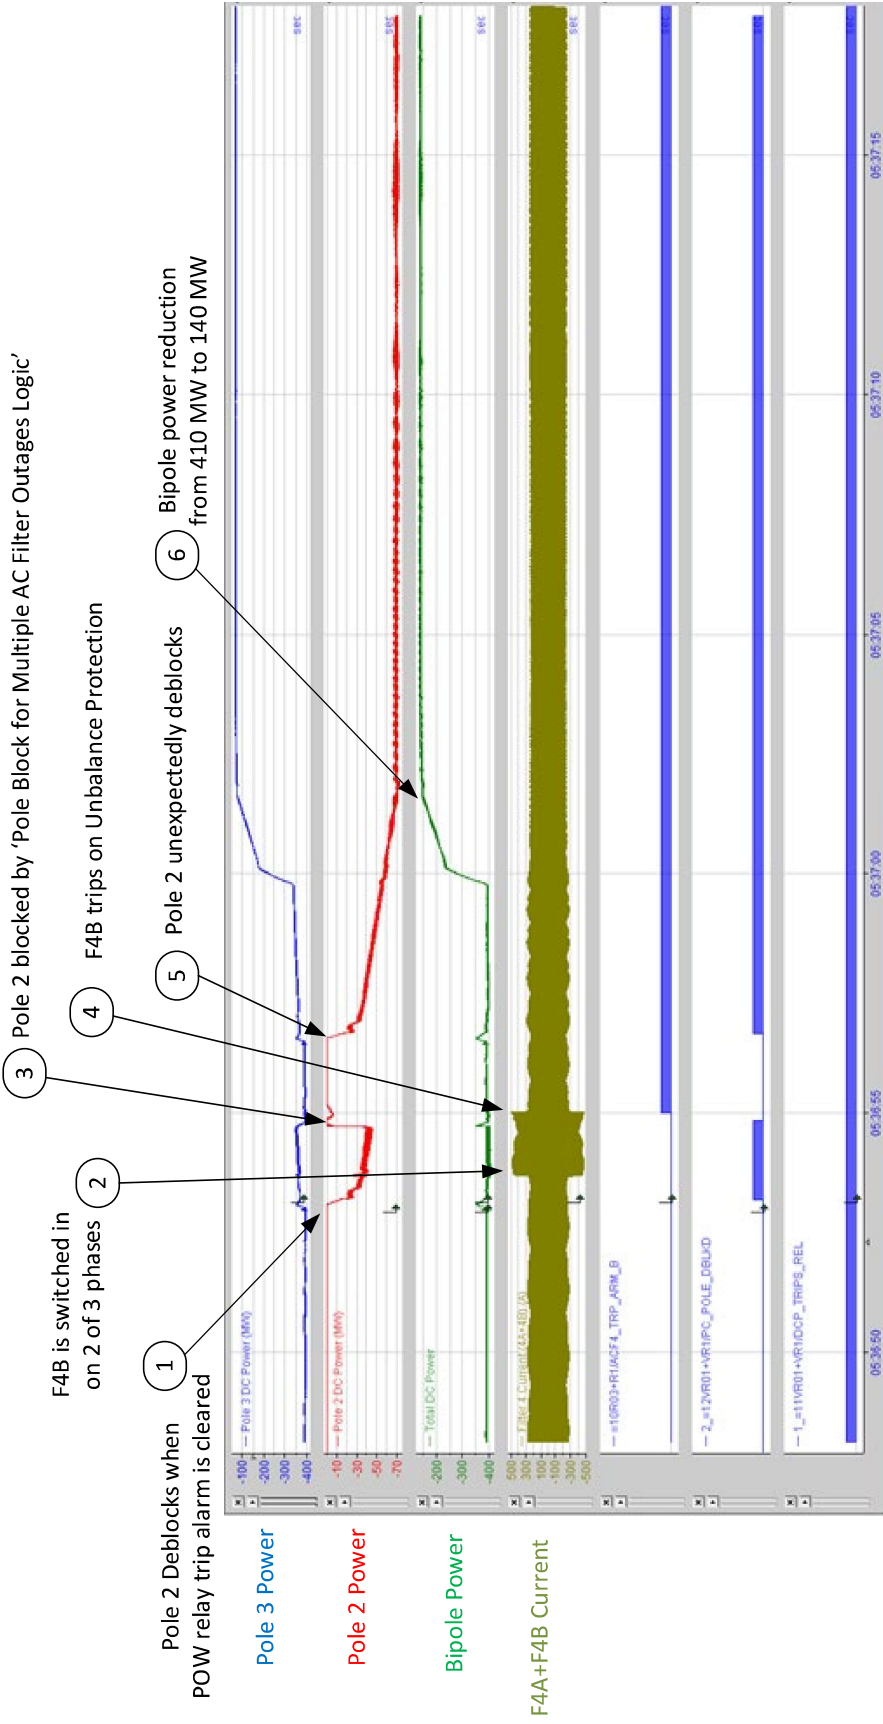
Figure 4. HVDC Power Transfer During Power Reduction ⁴

2 seconds after deblocking Pole 2 the RPC attempted to connect Filter F4B (Point 2 on Figure 4), however red phase failed to close a second time, and the 'Pole Block for Multiple AC Filter Outages Logic' blocked Pole 2 (Point 3 on Figure 4) followed by unbalance protection tripping Filter F4B after 1.4 seconds (Point 4 on Figure 4). HVDC transfer was maintained at 410 MW by Pole 3 in monopole operation.

With three HAY AC filters now on outage (F3A, F3B for maintenance and F4B tripped) and the HVDC in bipole operation, an HVDC power limit was set by the control system which limited the total transfer capacity to 140MW. This caused a 270 MW power reduction in HVDC transfer from around 410 MW to 140MW within 2 seconds (Point 6 on Figure 4).
