ELECTRICITY INDUSTRY PARTICIPATION CODE
DISTRIBUTED UNMETERED LOAD AUDIT REPORT

SOUTH WAIRARAPA DISTRICT COUNCIL
AND MERCURY ENERGY LIMITED

Prepared by: Tara Gannon

Date audit commenced: 2 September 2023

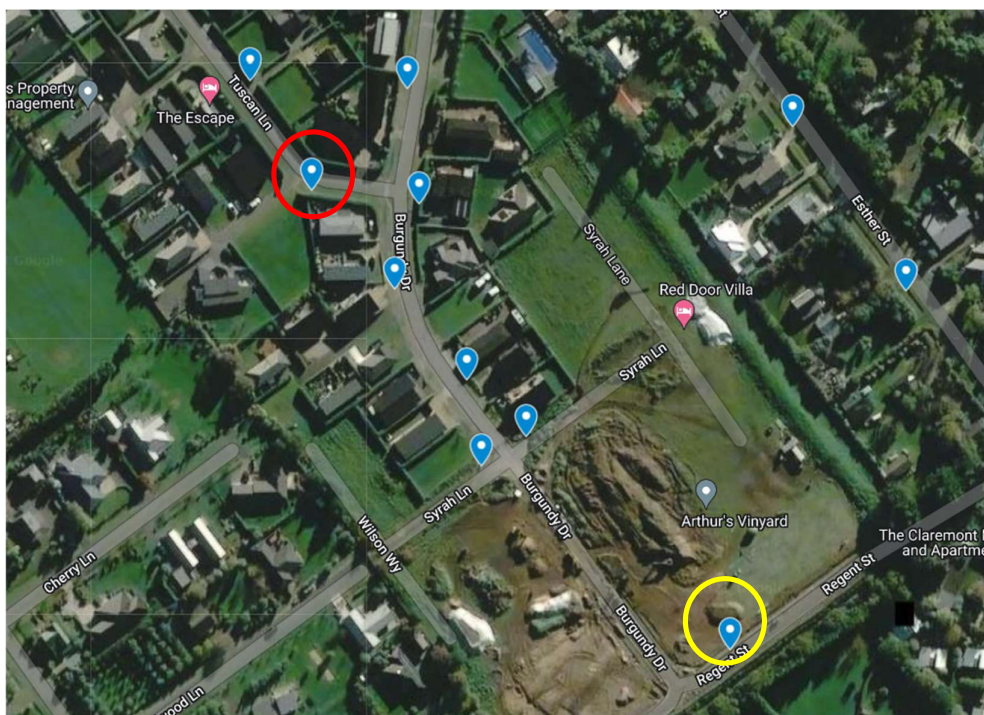
The previous audit recorded that six items of load had the correct GPS coordinates, but incorrectly recorded street address. Four of the exceptions relating to Vinters Lane have been resolved, because the section of Dublin St they were on has been renamed to Vinters Lane. The other two exceptions are to be checked by SWDC and updated if necessary.

Road	Location	Pole ID	Expected road name
ESTHER ST	16	1911 (circled in yellow)	Burgundy Dr
ESTHER ST	264	1988 (circled in red)	Tuscan Lane

The three lights at the northern end of Tuscan Lane are recorded with a road name of Jellicoe St.

I repeat the previous audit recommendation to resolve these issues:

Recommendation	Description	Audited party comment	Remedial action
Database address accuracy	<p>Correct the 33 items of load that have transposed GPS coordinates, with the northing value recorded in the easting field and vice versa.</p> <p>Check and update the street addresses for lights recorded on Tuscan Lane, Martinborough.</p>	We have recommended to South Wairarapa DC that they make the necessary corrections.	Identified
