ELECTRICITY INDUSTRY PARTICIPATION CODE
DISTRIBUTED UNMETERED LOAD AUDIT REPORT

CENTRAL OTAGO DISTRICT COUNCIL
RAMM DATABASE
AND CONTACT ENERGY
NZBN: 9429038549977

Prepared by: Steve Woods

Date audit commenced: 5 January 2024

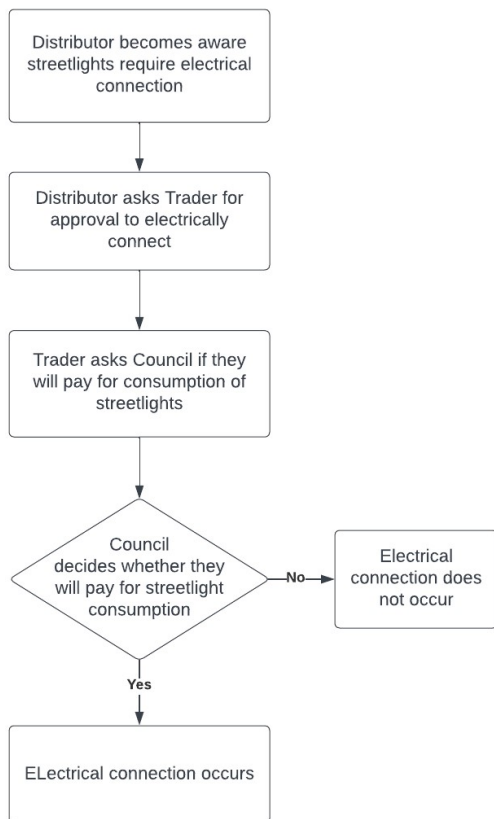
15 of the 33 field audit discrepancies related to newly installed streetlights.

I recommend Contact reviews and strengthens the electrical connection process for new streetlights, in conjunction with CODC and the distributor, to include the following steps:
