INDEX TO APPENDICES	
Document	Page
Appendix A - List of persons interviewed	001
Appendix B - List of documents reviewed	002
Appendix C - Terms of references	006
Appendix D - Contracting arrangements between Transpower and Omexom	009
Appendix E - Drawing TE37252	013
Appendix F - Beca report	019
Appendix G.1 - Press releases	040
Appendix H - Example Quality Assurance (QA) form	064
Appendix I - System operator report	068
Appendix J - Omexom procedure ELP-T414, Issue 5, dated 18 August 2022	112

Figure 1 - HEN-MDN A Tower 130 site layout and approximate location of tower post Incident

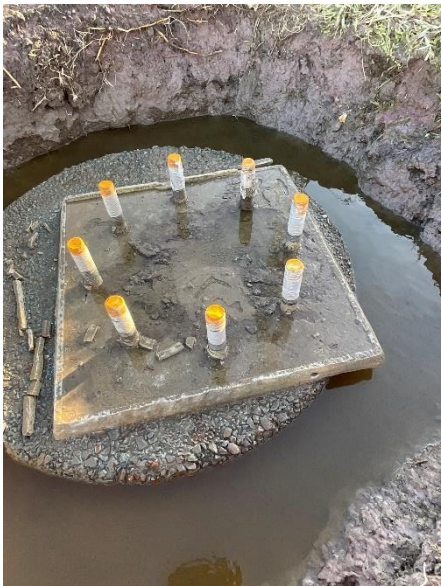
Photo A.2: Leg A foundation underwater upon arriving to site, prior to being drained.

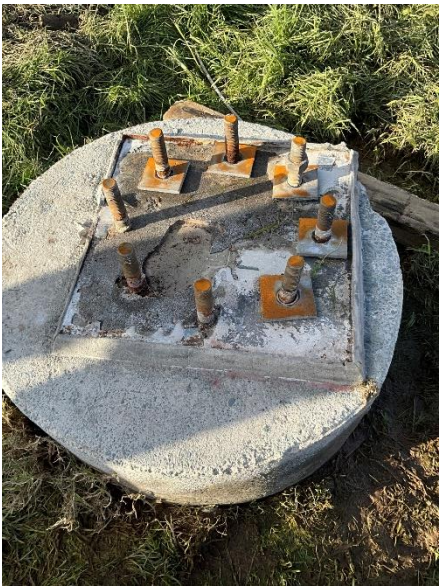
Photo A.3: Leg A foundation after being drained. No holding down bolts with nuts installed. No damage to bolt threads observed.

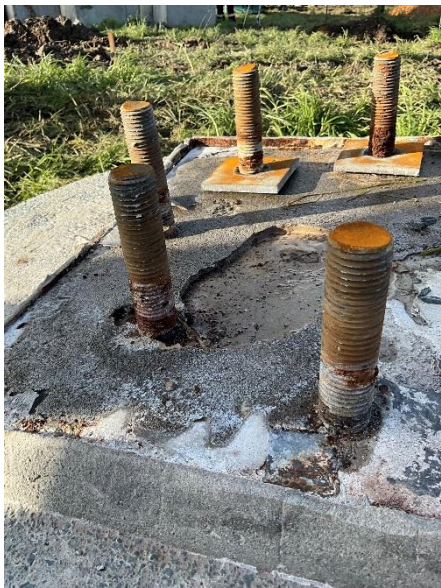
Photo A.4: Leg B foundation holding down bolts. Square washers and nut suspected to be placed back on bolts after tower fall. No damage to bolt threads observed.

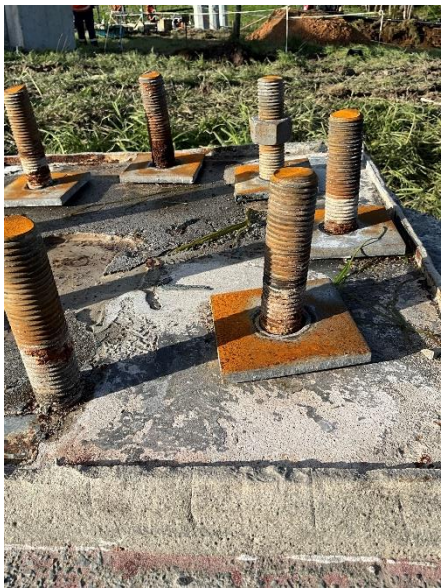
Photo A.5: Leg B foundation holding down bolts. No damage to bolt threads observed.

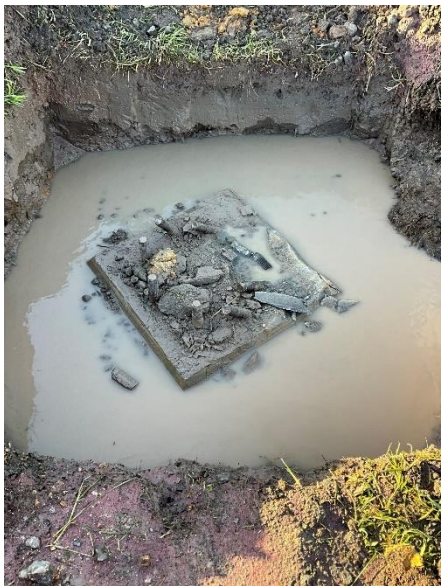
Photo A.7: Leg C foundation underwater upon arriving to site, prior to being drained.

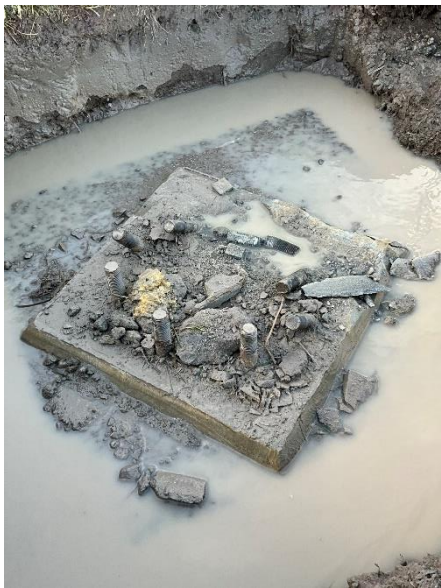
Photo A.8: Leg C foundation after being drained. No holding down bolts with nuts installed. Five holding down bolts on the eastern side bent towards the west, with the bolt furthest to the east broken in two places. No obvious evidence to suggest that the nuts had been stripped from any of the holding down bolts.

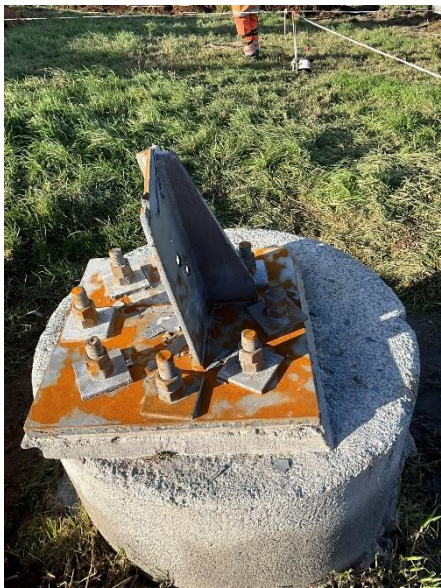
- There were signs of sand blasting to base plates, bolts and nuts on leg D, as shown by the presence of surface rust. Refer to photos A.12 to A.15 in Attachment A.
- There were signs of sand blasting to the base plates on legs A and C, as shown by the presence of surface rust. Refer photos A.17 and A.21 in Attachment A. As surface rust was not present where the square washers would have been located, it indicates sand blasting was undertaken prior to the removal of the square washers and nuts.
- Sand blasting may have been undertaken to leg B, however the presence of surface rust was less visible in the site photos captured compared to other legs. Refer to photo A.24 in Attachment A.
- There were no indications that corrosion or sabotage might have played a role in the fall of the tower.

Photo A.12: Leg D ruptured. No nuts removed. Sign of sand blasting to base plate, bolts and nuts.

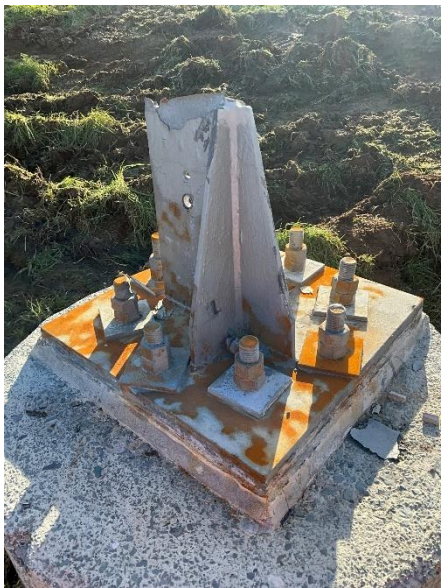
Photo A.13: Leg D ruptured. No nuts removed.

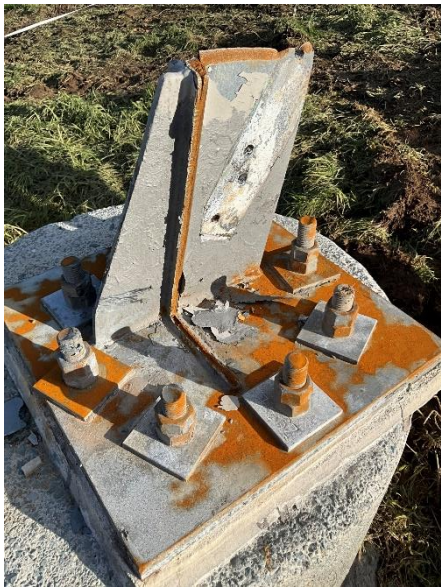
Photo A.14: Leg D ruptured. No nuts removed.

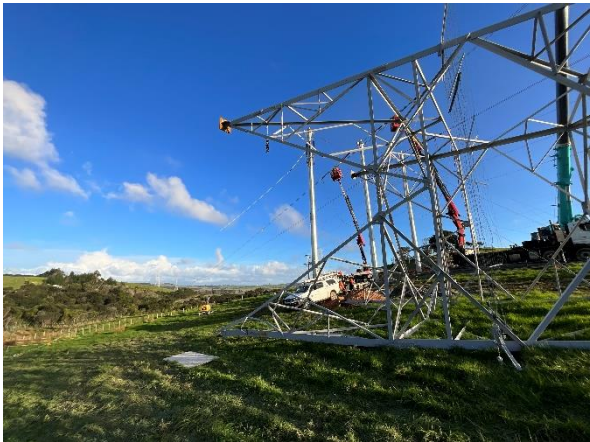
Photo A.16: Legs A and B of fallen tower (top of image). No obvious damage observed from ground level. Approx. 8 nuts and square washers tied via rope to leg A.

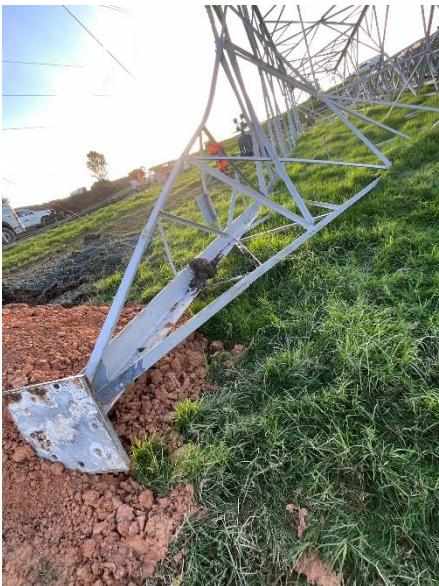
Photo A.17: Leg A (top, left). Sign of sand blasting on leg A prior to removal of square washers, as shown by presence of surface rust on the top of the base plate and paint removed on the leg members.

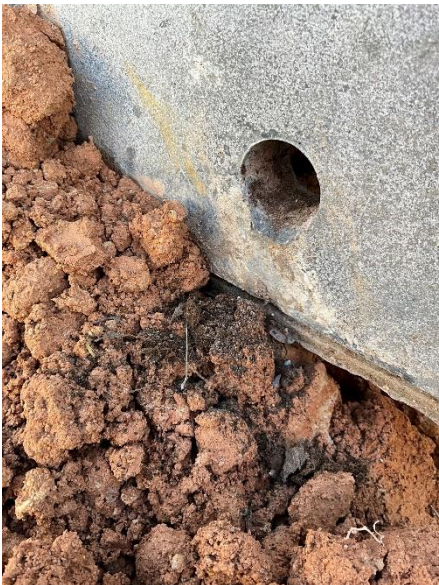
Photo A.19: Underside of baseplate of leg C. Some damage to the bolt hole closest to the ground (eastern side of base plate), which aligns with broken bolt.

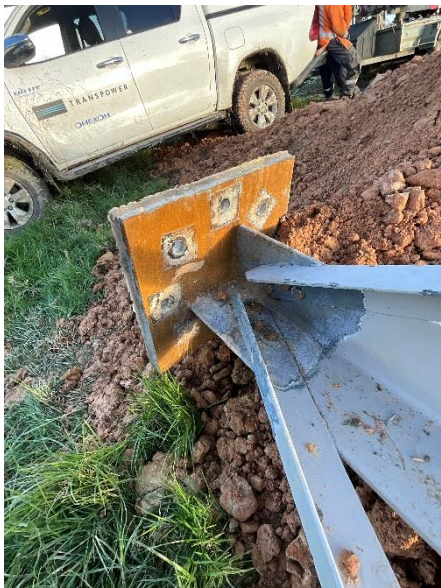
Photo A.20: Underside of baseplate of leg C. Some damage to the bolt hole closest to the ground (eastern side of base plate), which aligns with broken bolt.

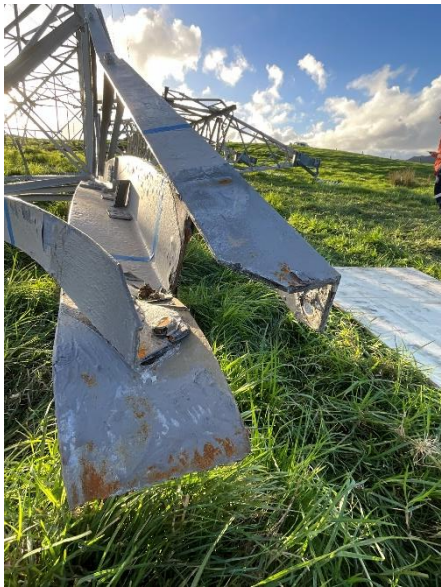
Photo A.22: Leg D of fallen tower. Ruptured from stub leg attached to foundation.
