# **Draft determination of causer: 26 July 2024 under-frequency event**

Consultation paper

System Operator Event 4477

December 2024

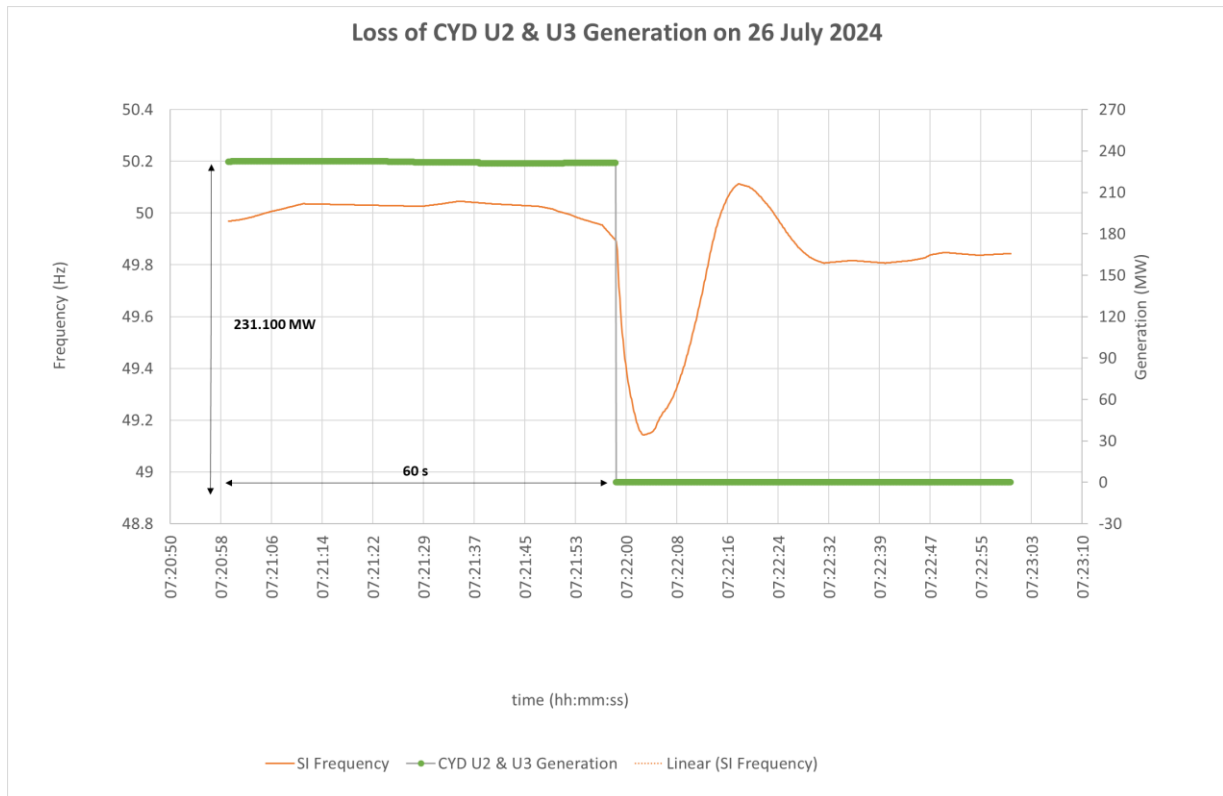
**South Island Frequency**

Please note the system operator’s graph below does not precisely time the tripping of Clyde Units. This is because there is a time delay in the system operator’s SCADA data (which resulted in the delayed recording of Clyde Unit 2 and Clyde Unit 3 tripping).

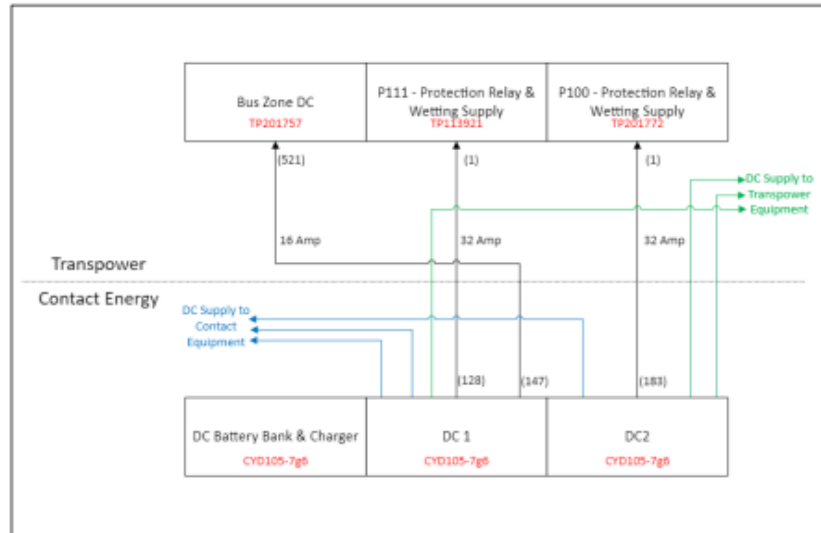
Figure 1- CYD generating station DC System diagram

4.1. CYD has a shared secondary DC system which is used to supply DC to the Transpower (Grid Owner) protection system as well as CYD station equipment. Figure 1.

4.2. CYD generator disconnectors (DIS413, 415, 433, 435, 453, 455, 473 & 475) are owned by the Grid Owner and operated by Contact Energy. See the Figure 1 for information.

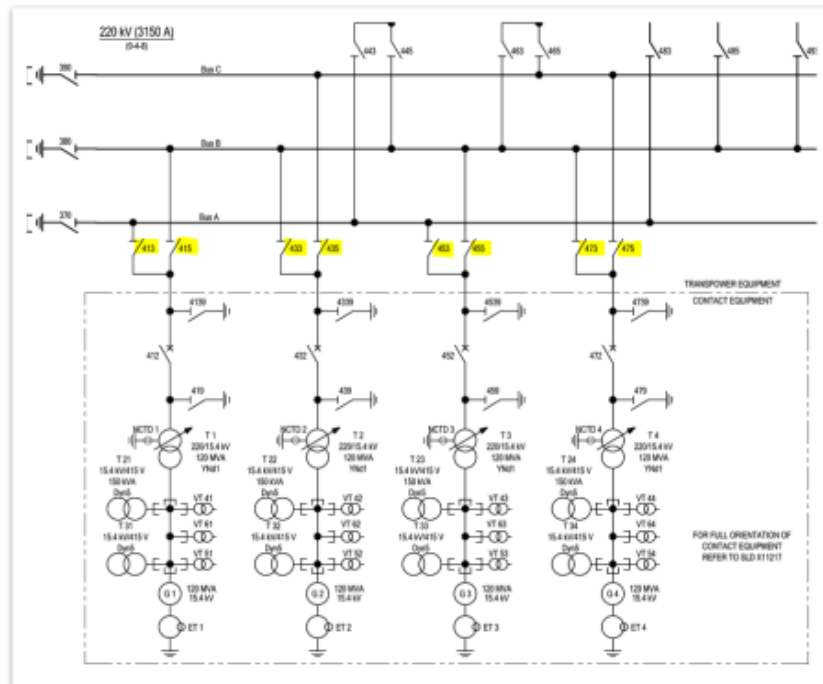
Figure 2- CYD generating station single line diagram

4.7. Contact Energy’s CYD generating units (G2 and 3), which were online during this event, tripped due to a “TRANSPower BZ/CBFail TRIP”.

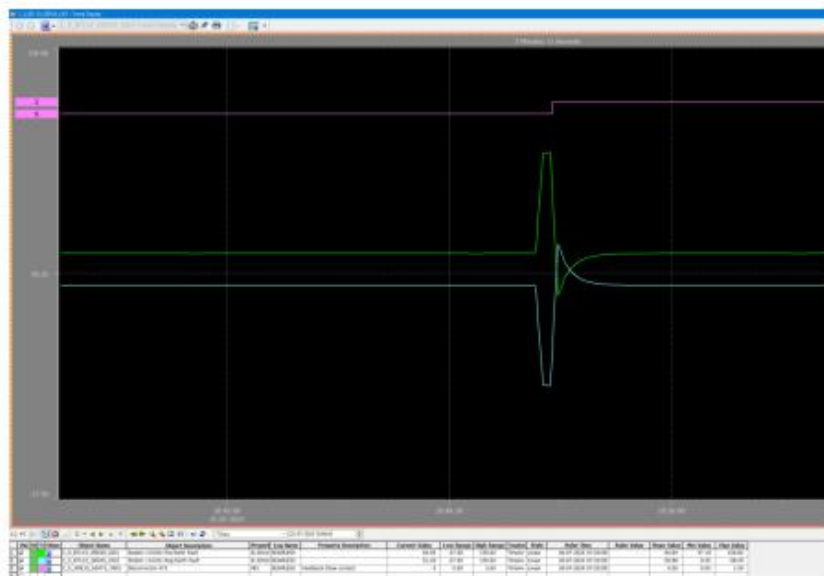
Figure 3 - CYD generating station DC traces during the earth fault

- 5.1. When CYD DIS473 was operated during a planned operation, an earth fault occurred. The earth fault was caused by a wire (uninsulated flexible connection to motor brush terminal) that contacted a manual crank pole and shorted to the ground.
- 5.2. The earth fault changed the DC system reference voltages. It created a spike in the positive voltage reference (green curve) and a dip in negative voltage reference (light blue) as shown in the Figure 3.

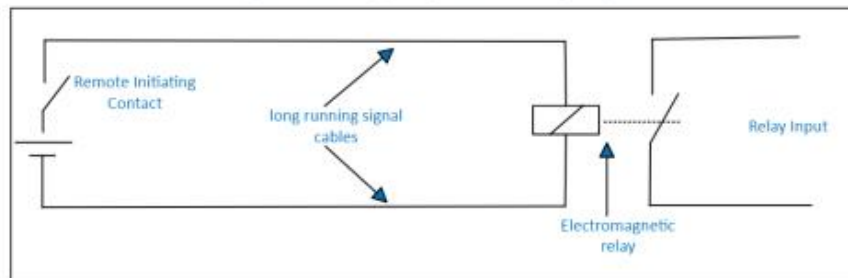
Figure 4 - Basic Diagram of Remote Initiating Relay

5.3. Contact Energy’s SEL 2440 relay inputs are connected to the Grid Owner’s initiating relay via a set of lengthy signal cable (200-300 m) owned by the Grid Owner. The earth fault caused a discharge of capacitive current into Contact Energy’s SEL 2440 relay and caused primary protection to trip CYD generating units (G2 and G3). See Figure 4 below.

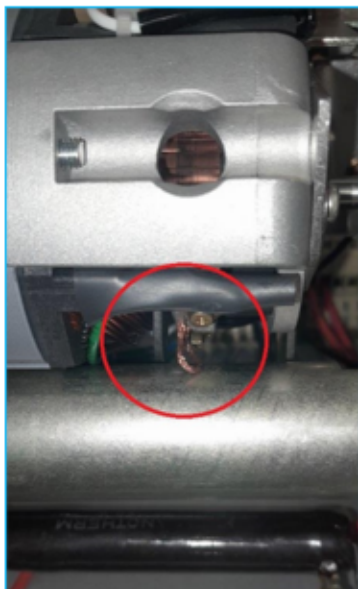
1. On operation of the CYD DIS473, the motor experienced a DC earth fault. Transpower own this disconnect, Contact have operational control. The cause of the motor DC fault was determined to be an exposed DC supply that was in contact with the manual crank pole. This appears to be a flaw in the build quality of the motors by the manufacturer which have recently been refurbished.

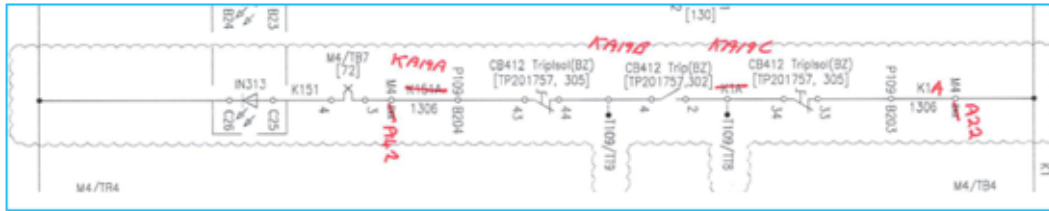
2. Contact generator protection tripped G2 & G3 at the same time this earth fault developed. We suspect that this is an issue with their protection not being secure during secondary DC earth faults. From our initial discussion with the Service Provider on site, there appears to be some best practice not followed in their secondary protection design. The trip input of the generator protection from out BZ trip does not appear to have a hold down resistor and may have picked up during the DC earth fault.
