# **Draft determination of causer: 21 December 2024 under-frequency event**

Consultation paper

System Operator event 4523

May 2025

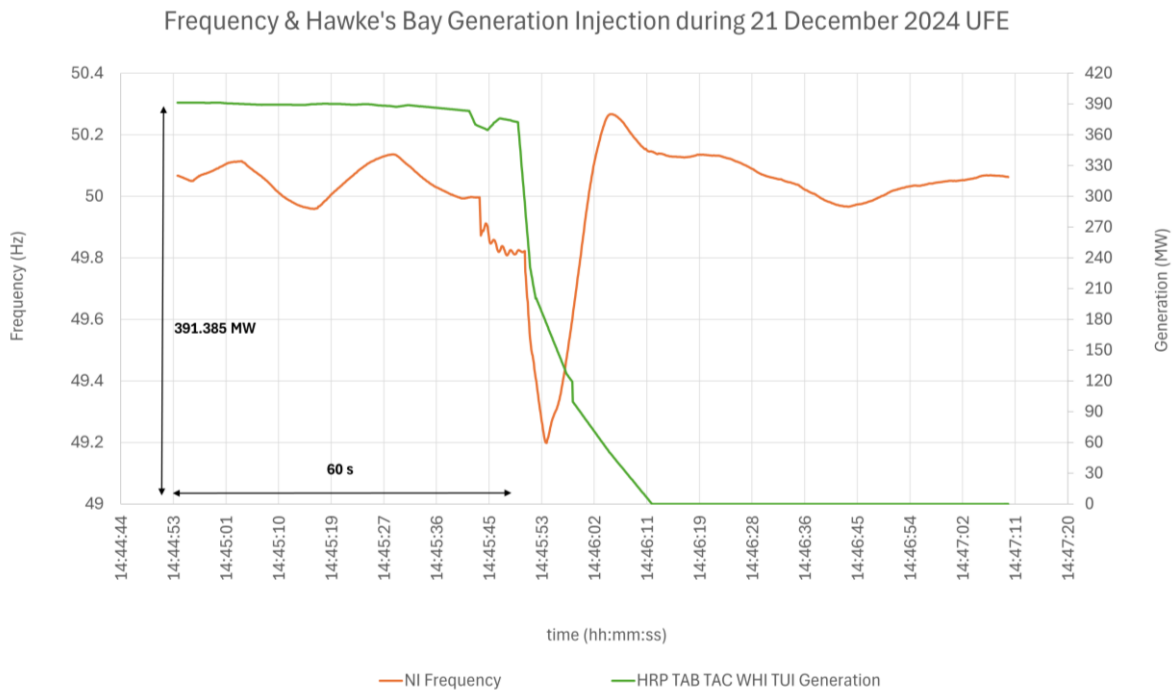
Figure 1: Graph of Frequency and Generation in Hawke's Bay during the 21/12/2024 UFE

The disconnection of Tauhara B and Te Huka C removed approximately 212.38 MW, while 163.9 MW was removed due to the loss of Harapaki Wind Farm. The disconnection of Tuai and Piripaua stations removed another 15.1 MW of generation injection into the power system. A total of 391.4 MW generation was disconnected. The reduction in net export from the region was 224 MW. The loss of this net generation export caused the North Island frequency to fall to 49.2. At 14:46:10, the grid frequency returned to normal band. Figure 1 below shows the frequency over the event timeframe and the reduction in total generation.

Please note *the System Operator's graph above may not map precisely to tripping of the Hawke's Bay generation. This is because there is a time delay in the System Operator's SCADA data.*

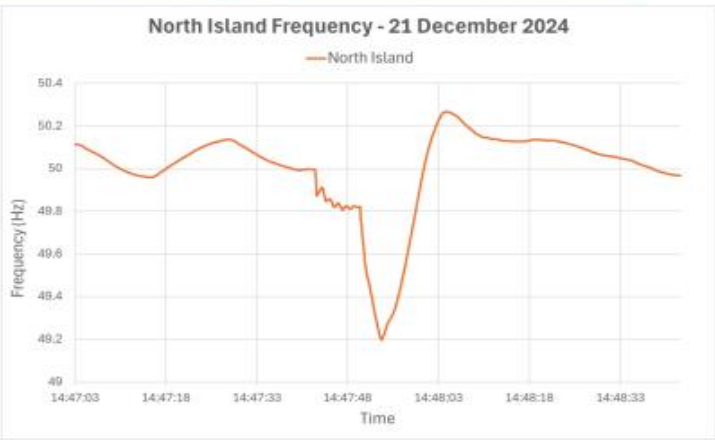
**North Island Frequency - 21 December 2024**

<b>Event ID</b>	4523
<b>Affected Islands:</b>	North Island
<b>North Island Minimum Frequency:</b>	49.20 Hz
<b>Time (start of UFE):</b>	14:45:53
<b>Time (of min. frequency):</b>	14:45:54

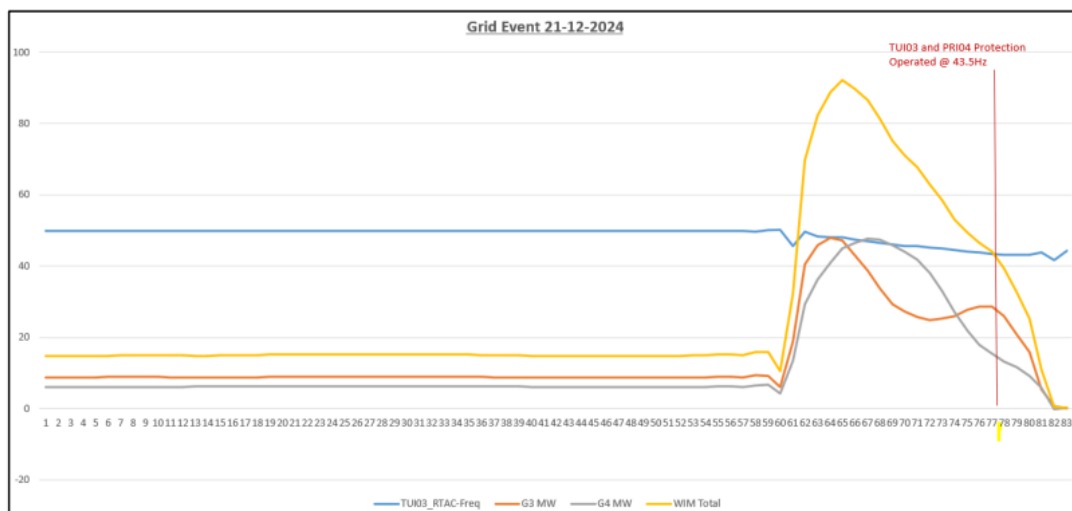
TUI03 and PRI04 were running at Waikaremoana. Post the Transpower 220kV circuit trippings into Hawkes Bay the two running units attempted to pick up load. But in an islanded/constrained grid situation, they could not match the load demand. The frequency and voltage collapsed at Tuai, and both units tripped at 14:45:51 on under frequency stage 4 protection when the local frequency went below 43.5Hz. The trend below shows the Hz, and the MW of both units.

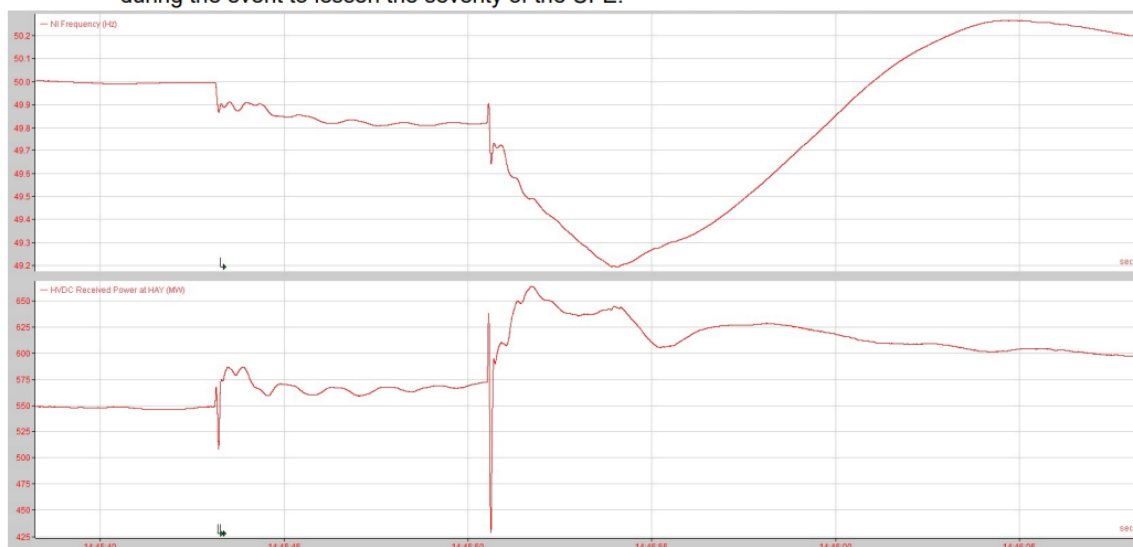
- There were no HVDC events that contributed to the UFE. On the contrary the HVDC system responded to lessen the severity of the UFE. Prior to the event, the HVDC was transferring 549MW north (received power). The transfer was modulated up to 663MW north (received power) during the event to lessen the severity of the UFE.
