Causation Report

21 December 2024

Under-Frequency Event

System Operator event 4523

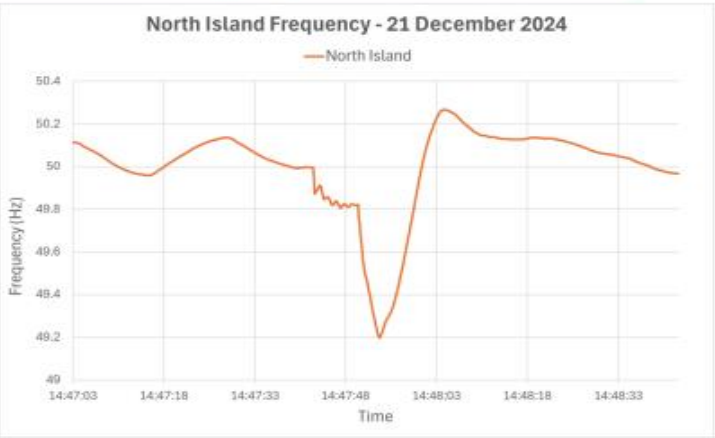
North Island Frequency - 21 December 2024

Event ID	4523
Affected Islands:	North Island
North Island Minimum Frequency:	49.20 Hz
Time (start of UFE):	14:45:53
Time (of min. frequency):	14:45:54

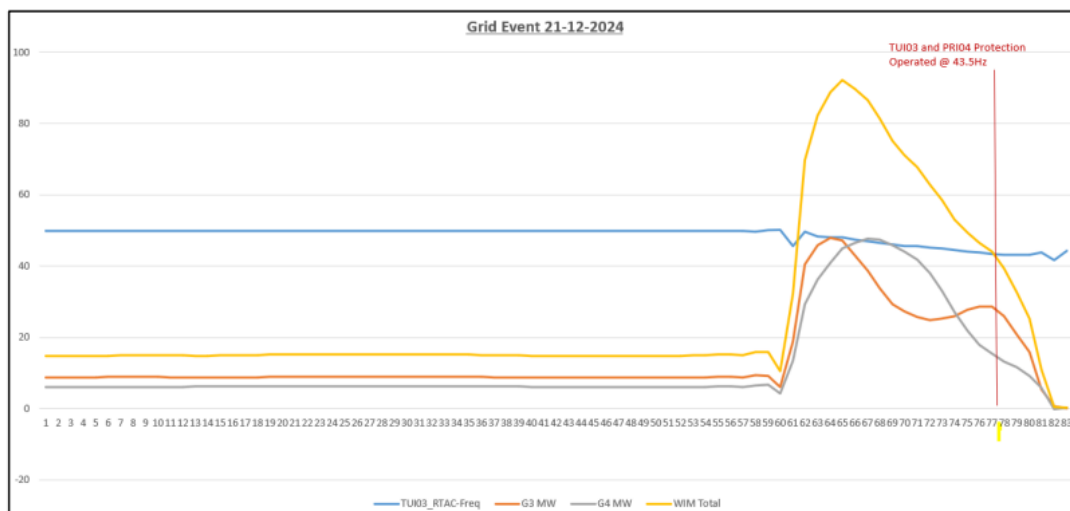
Explain What Initiated the Breakers at Waikaremoana to Trip

TUI03 and PRI04 were running at Waikaremoana. Post the Transpower 220kV circuit trippings into Hawkes Bay the two running units attempted to pick up load. But in an islanded/constrained grid situation, they could not match the load demand. The frequency and voltage collapsed at Tuai, and both units tripped at 14:45:51 on under frequency stage 4 protection when the local frequency went below 43.5Hz. The trend below shows the Hz, and the MW of both units.
