# **Draft determination of causer: 11 July 2025 under- frequency event**

**Consultation paper**

System Operator event 4586 & 4587

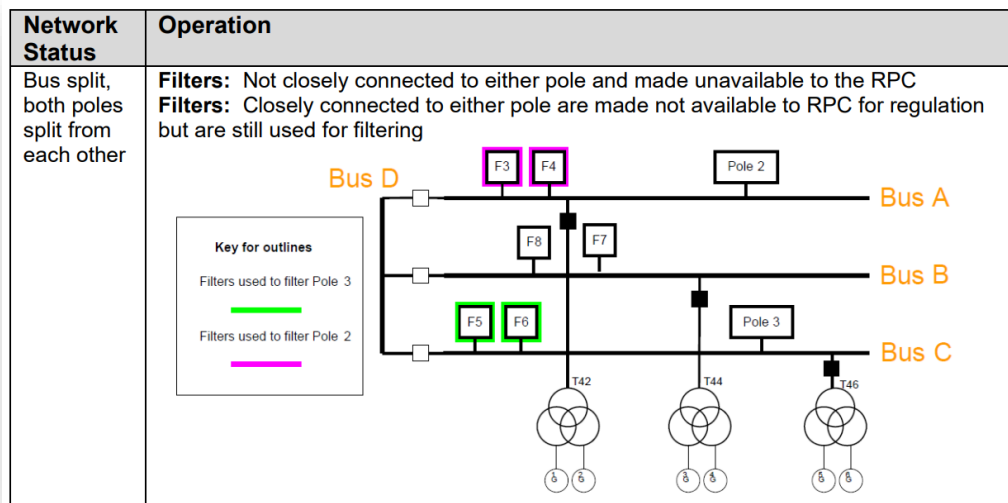
Figure 1: Bus D removed, splits the 220 kV bus

The root cause for the power limit being applied was a failure to select key control settings for the HPC – **not** selecting HPC Round power to Monopole at HAY and **not** selecting HPC Switch Level to “Increased” at HAY.

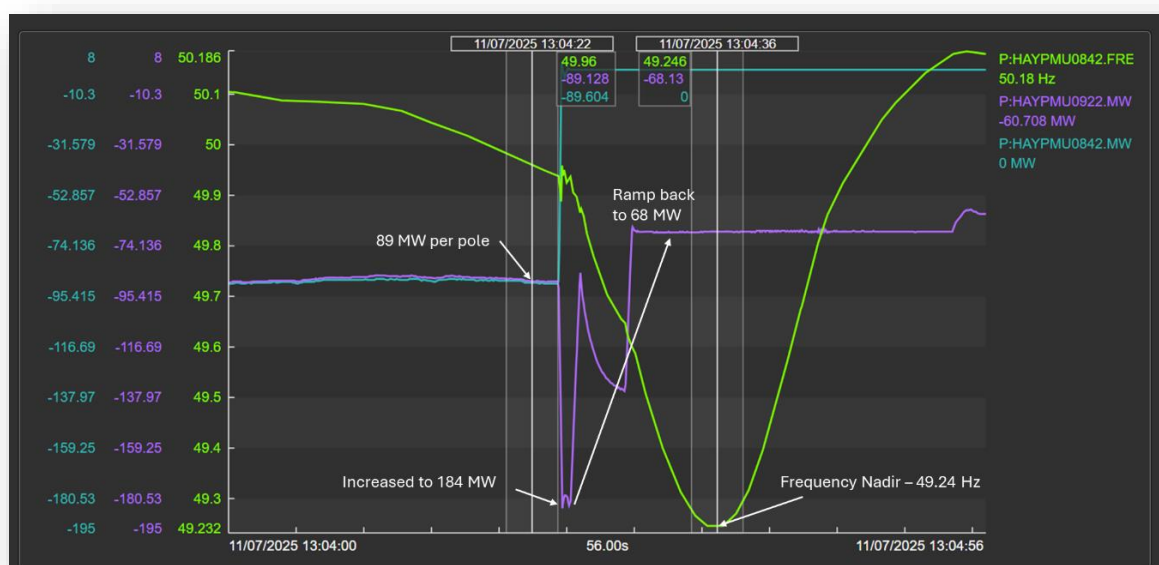
During the outage of Bus D at Haywards, at 13:04, the HVDC ramped down to 68 MW from a pre-event transfer of 178 MW<sup>2</sup>. As the HVDC was transferring power north, the sudden ramp down to 68 MW caused the frequency to drop to 49.24 Hz at 13:04:36, triggering the UFE. The MW lost during the HVDC runback was 119.84 MW which was lower than the highest risk in the North Island at the time of the event. The following diagram shows the PMU data for HVDC MWAC and frequency in the North Island<sup>3</sup>.

Figure 2: Frequency and HVDC injection at Haywards.

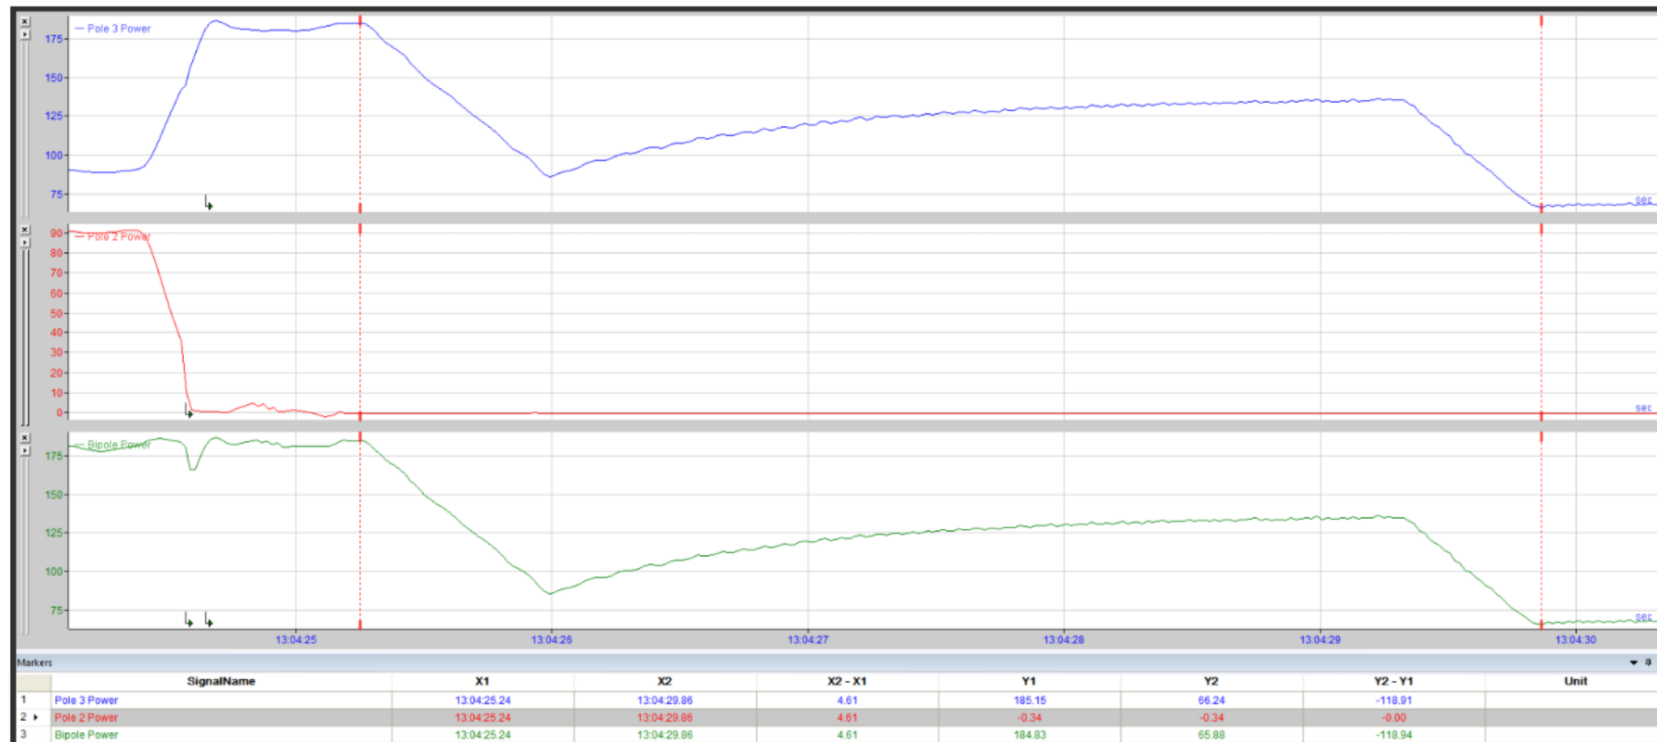
## Appendix B – HVDC Fault Recorder Graph: MW Loss at HAY 220kV Bus (11 July 2025)

Could you provide any other information regarding the event and what you believe may have caused the under-frequency to occur on 11 July 2025.	
	We have assessed the MW lost during the event as 119.84 MW at Haywards. Can you please confirm this assessment or provide data that indicates a different value of MW lost.	The Haywards transient fault recorder embedded in the HVDC controls recorded a loss of 118.94 MW at the HAY 220kV bus. This value is based on the under-frequency event starting at 13:04:25.24 and ending at 13:04:29.86.
