Final determination of causer: 11 July 2025 under-frequency event

Decision paper

System Operator event 4586 & 4587

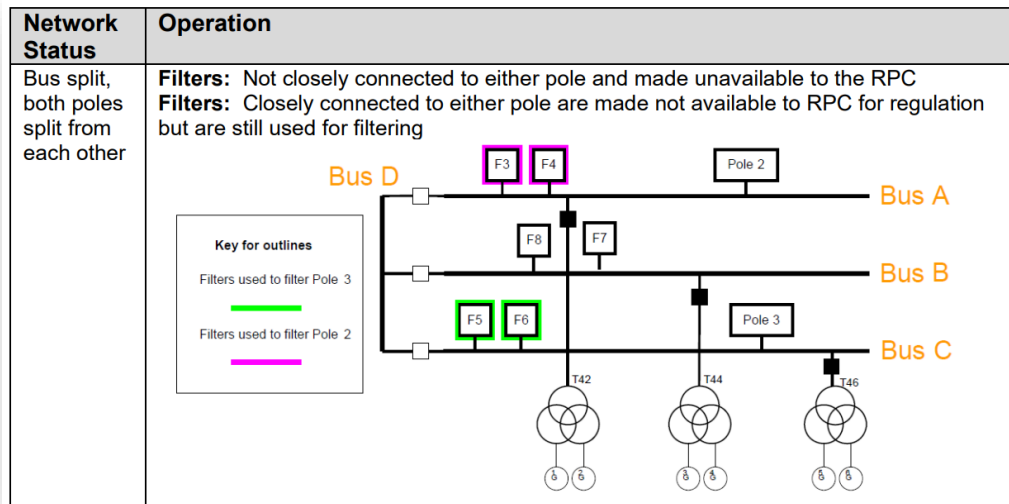
Figure 1: Bus D removed, splits the 220 kV bus

The UFE occurred during a planned outage of Bus D at Haywards (HAY). The removal of Bus D splits the 220 kV bus. Figure 1 below shows the bus layout, indicating buses A, B and C are separated electrically (split) when Bus D is removed from service (i.e. is on outage).

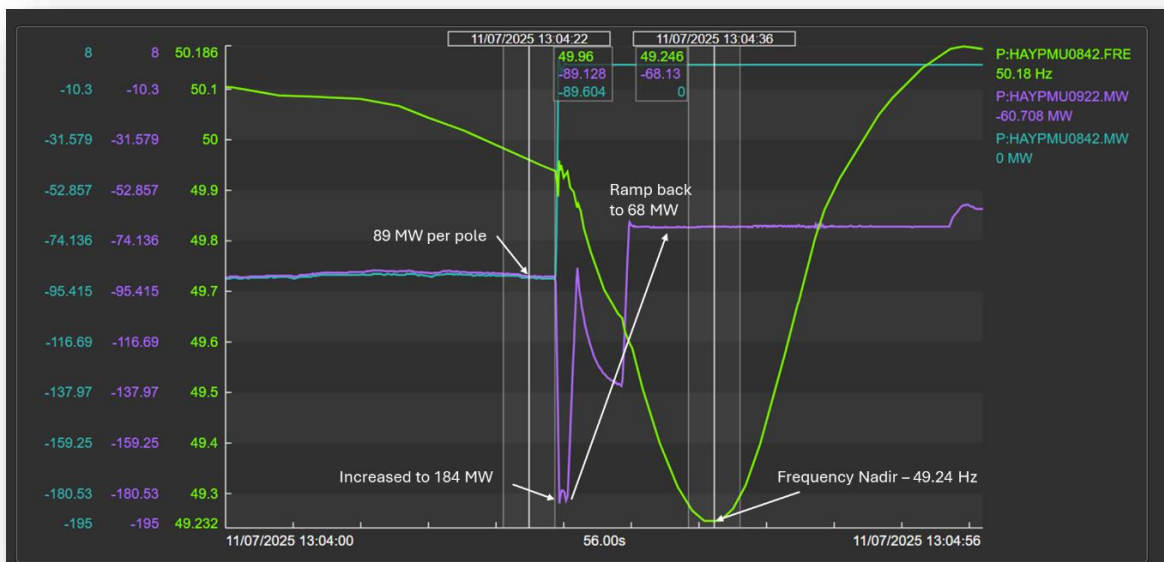
Figure 2: Frequency and HVDC injection at Haywards.

During the outage of Bus D at Haywards, at 13:04, the HVDC ramped down to 68 MW from a pre-event transfer of 178 MW². As the HVDC was transferring power north, the sudden ramp down to 68 MW caused the frequency to drop to 49.24 Hz at 13:04:36, triggering the UFE. The MW lost during the HVDC runback was 119.84 MW which was lower than the highest risk in the North Island at the time of the event. The following diagram shows the PMU data for HVDC MWAC and frequency in the North Island³.

The investigation found that the trigger for the UFE was the ramp down of the HVDC transfer north when a power limit was applied by the HVDC control system.

The root cause for the power limit being applied was a failure to select key control settings for the HPC – **not** selecting HPC Round power to Monopole at HAY and **not** selecting HPC Switch Level to “Increased” at HAY.

In response, temporary HVDC constraints were applied at 13:12 to limit dispatch while the cause of the run back was being identified. Once identified, NGOC requested an instruction from NCC to select HPC Round power to Monopole at 13:13 — 9 minutes after the event. By 13:40, all constraints were removed, and normal dispatch resumed.

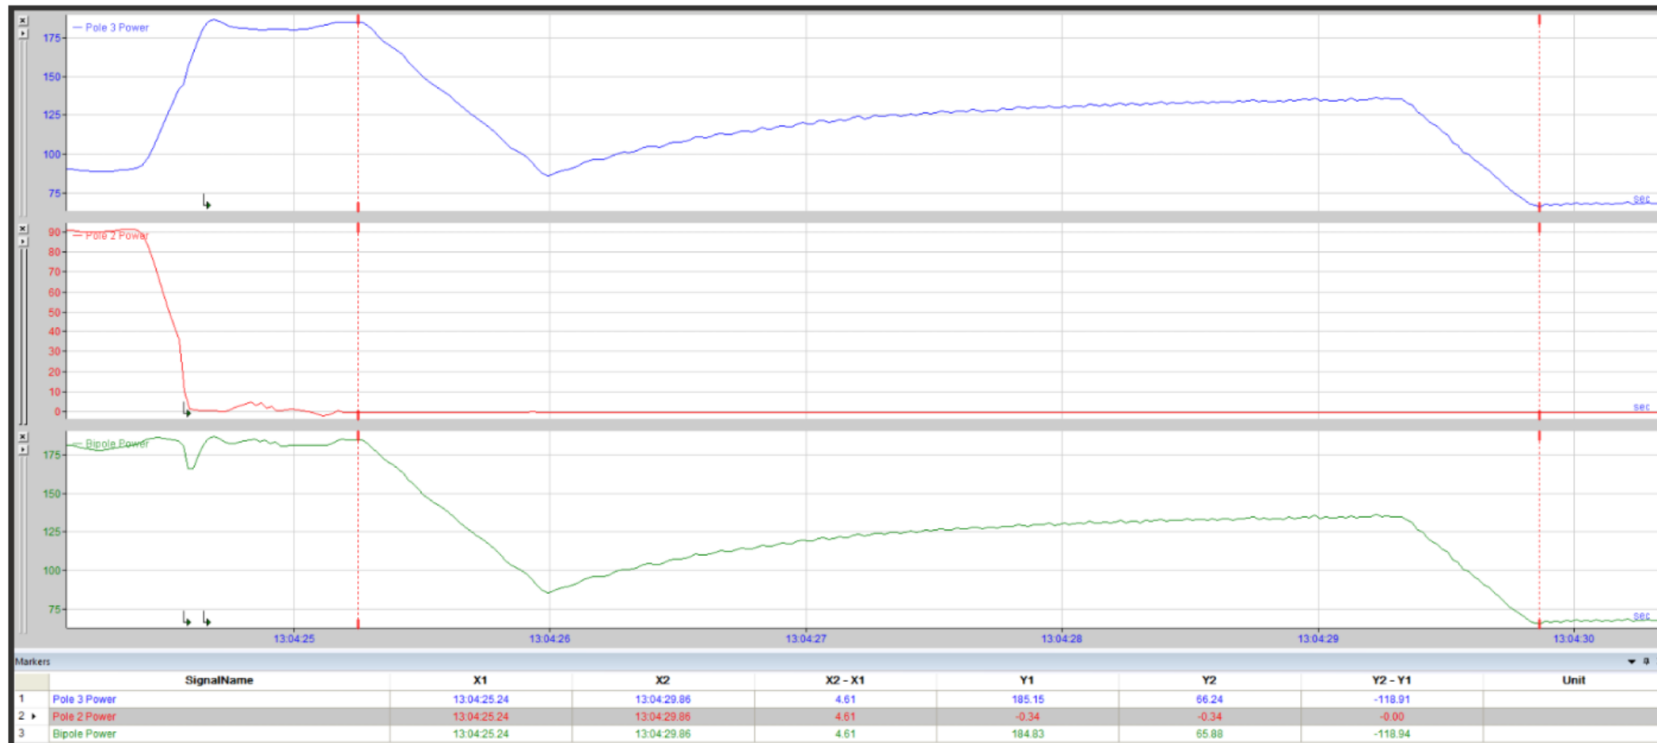
Reference	Question	Grid Owner's Reply
		Please refer to Appendix B – HVDC Fault Recorder Graph: MW Loss at HAY 220kV Bus (11 July 2025) for the visual representation of this data.
	Could you also confirm whether or not you could have been the causer of the under-frequency event as per the Code.	<p>We consider that the System Operator is the causer.</p> <p>The definition of “causer” is set out in Part 1 of the Code. Paragraph (a) provides that the participant whose asset or assets cause the interruption/reduction of supply, or increase in demand, is the causer <i>unless</i> another participant’s act or omission causes the interruption/reduction/increase, in which case the other participant is the causer.</p> <p>The System Operator is a participant. As set out above in response to earlier questions, the System Operator failure to instruct the grid asset controller to change the ‘HPC Round Power’ setting to ‘Monopole’, in a situation when the instruction should have been given (i.e. an omission by the System Operator) caused the reduction. As such, we consider the System Operator is the causer.</p>
