Transpower New Zealand Limited Report of Investigation into 20 June 2024 Tower 130 Henderson to Marsden A Line Incident

26 July 2024

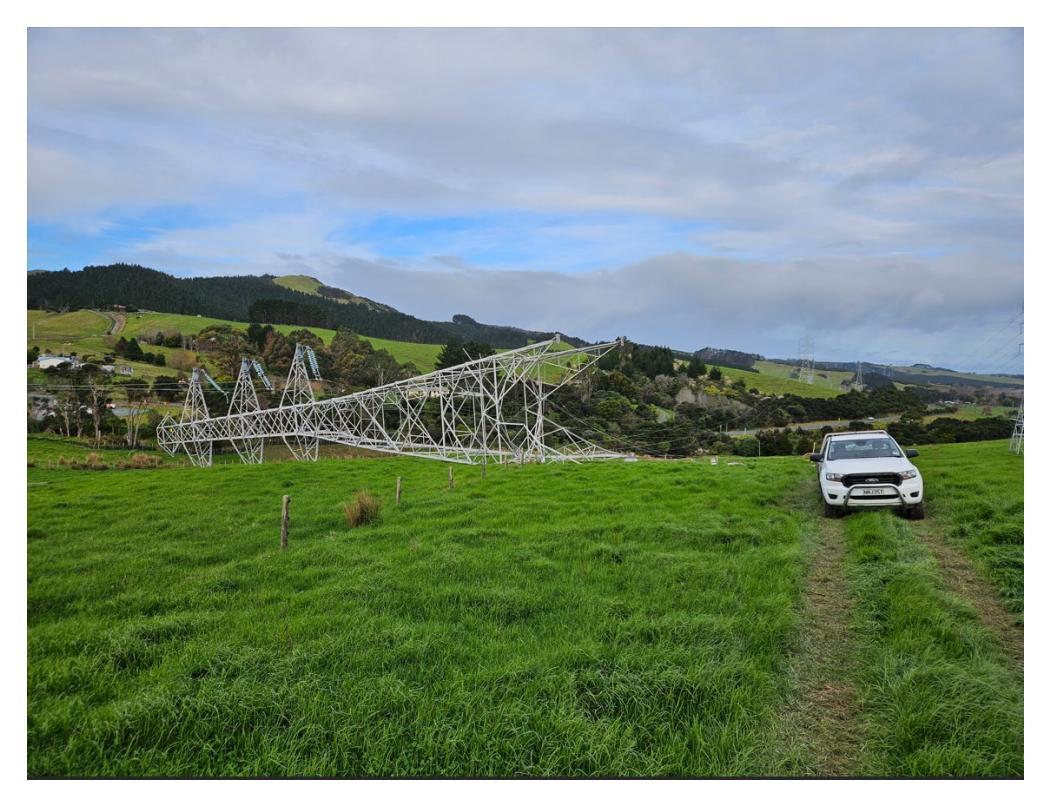
1.16 Beca Limited (Beca), an engineering consultancy firm, concluded from an investigation commissioned by Transpower that the cause of the failure of Tower 130 was the removal of the nuts from Legs A and B by the Omexom field crew. Its analysis indicated removal of the nuts from legs A and B by the Omexom field crew, which were intended to resist tension forces on the tower, compromised the stability of the tower, causing it to rupture and ultimately caused the tower to fall.

3.8 At approximately 11:03 am on 20 June 2024, Tower 130 fell. This immediately caused the remaining Bream Bay to Marsden, BRB_MDN_1 220 kV circuit to Northland to trip, causing a loss of approximately 159 MW of supply to the region.

Photograph of Tower 130 after the Incident

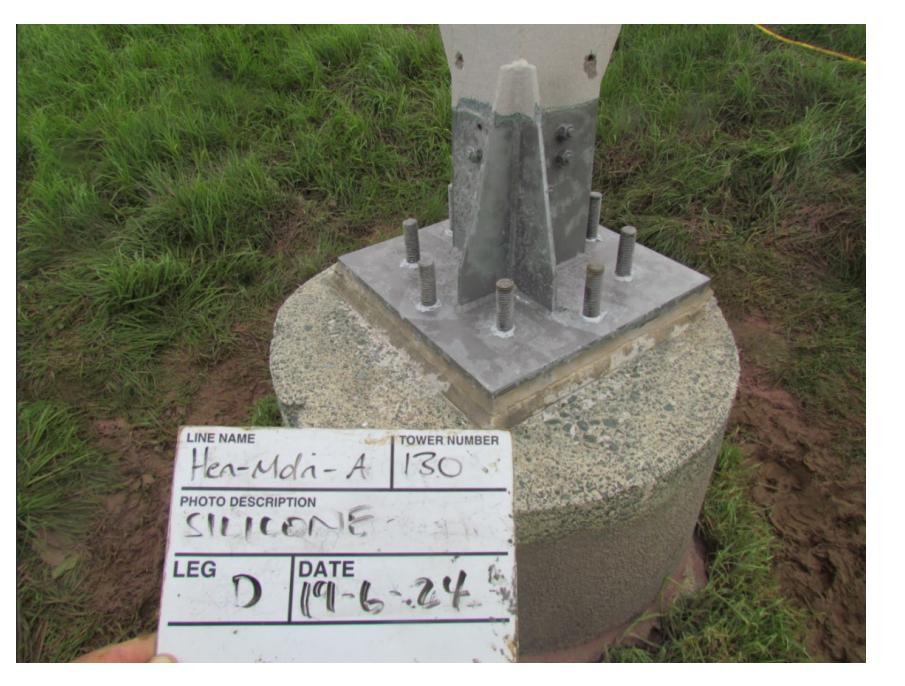
Tower 130 Leg D

reattached overnight. The following photograph⁴⁴ is of Leg D, with what appears to be all nuts removed, evidently before the end of work for the day.

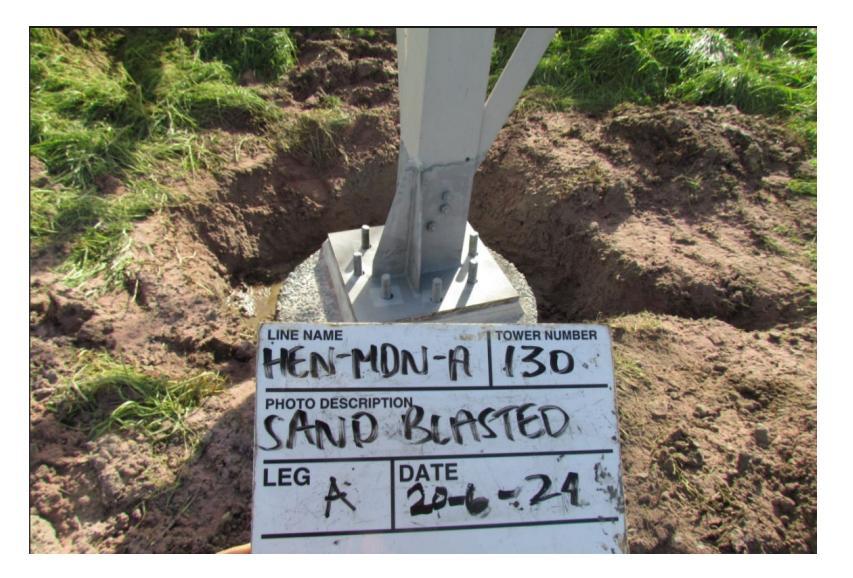
be separately sandblasted); all nuts were removed from each bolt - 16 nuts for each leg. The team's photograph recording the Leg A work (below), shows six bolts with nuts removed (it was reported that all nuts were removed).

Leg A showing six bolts with nuts removed

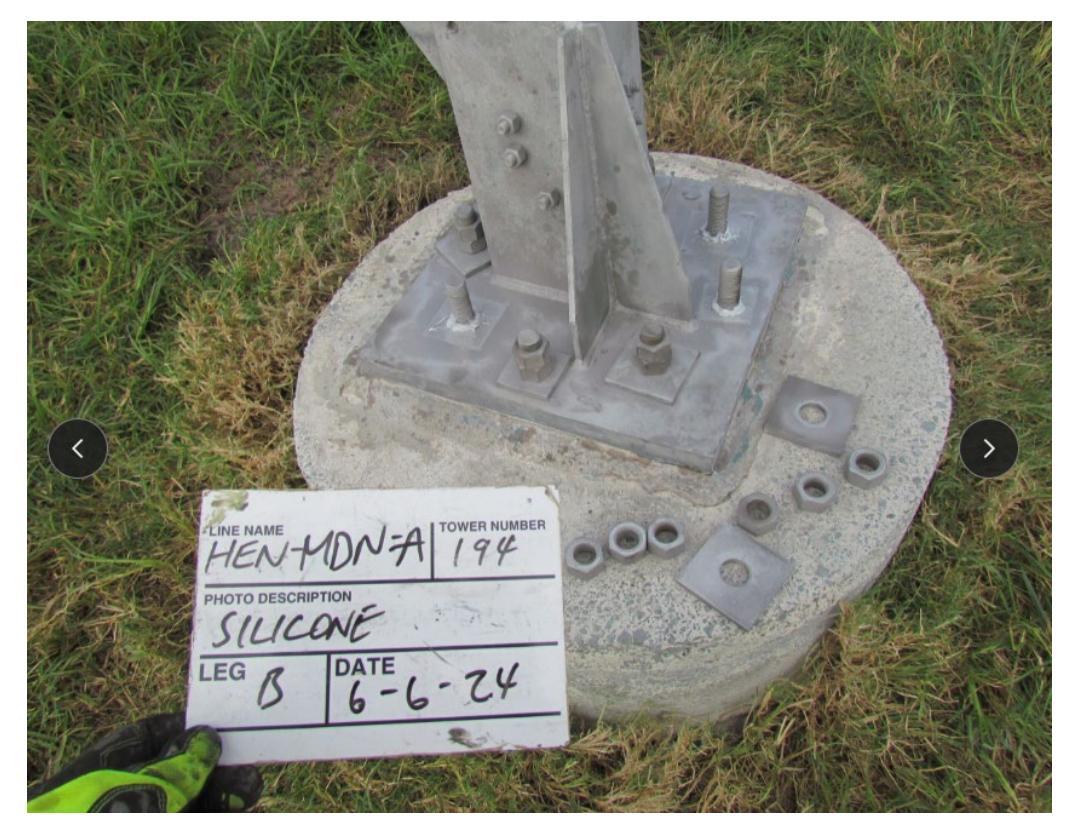
some of the bolts for some of the legs. For example, the photograph below of Leg B after the application of silicone shows several nuts still in place.

Leg B after application of silicone shows several nuts still in place

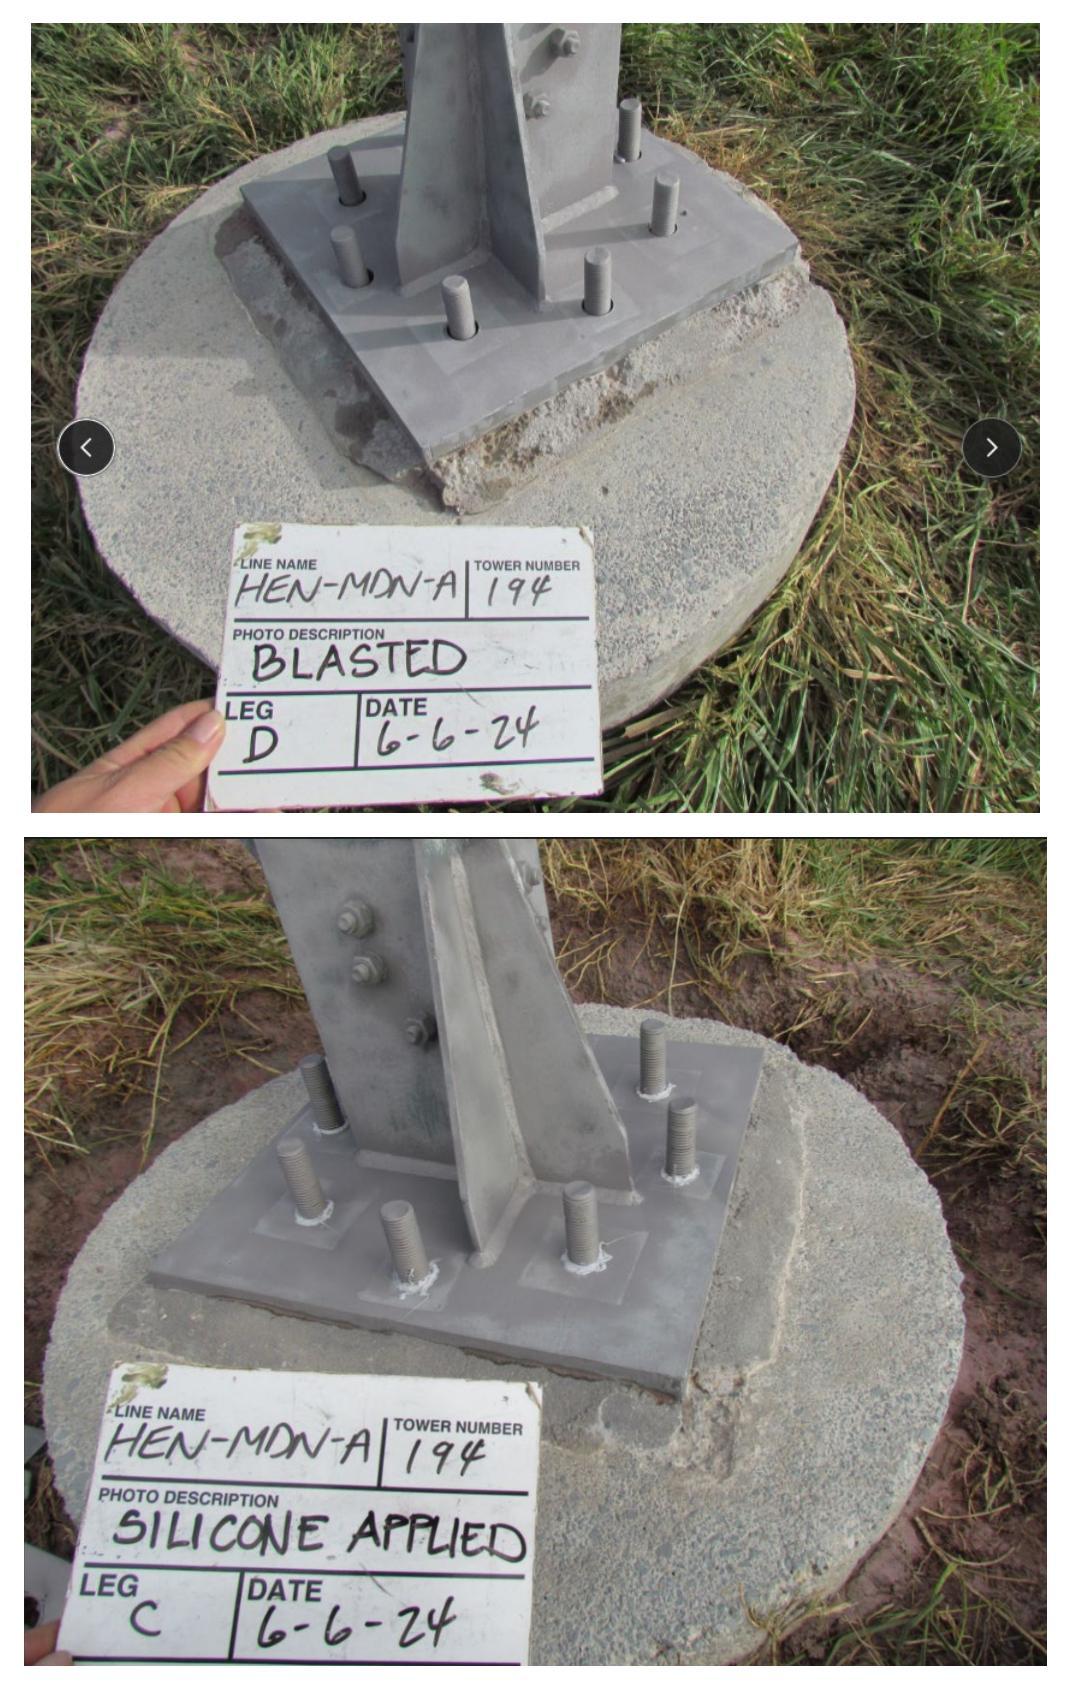
6.45 The metadata for the photographs (below) of Legs D and C indicates the photographs were taken within two minutes of each other. For Leg D, the photograph appears to be taken after sandblasting and appears to show all nuts removed (one bolt is obscured). The Leg C photograph appears to be taken after silicone was applied and shows a similar number of nuts removed to Leg D. The photographs, assuming accurate timings, suggest Legs C and D had all or most of the nuts removed at the same time.

Photographs of Legs D and C taken within two minutes of each other
