# Report: Review of Generator Protection Performance

**13003045 Under-Frequency Event of 23 October 2025  
Tauhara (TAB) and Te Huka (TAC) Geothermal Generation**

Transpower New Zealand Limited

28 August 2026

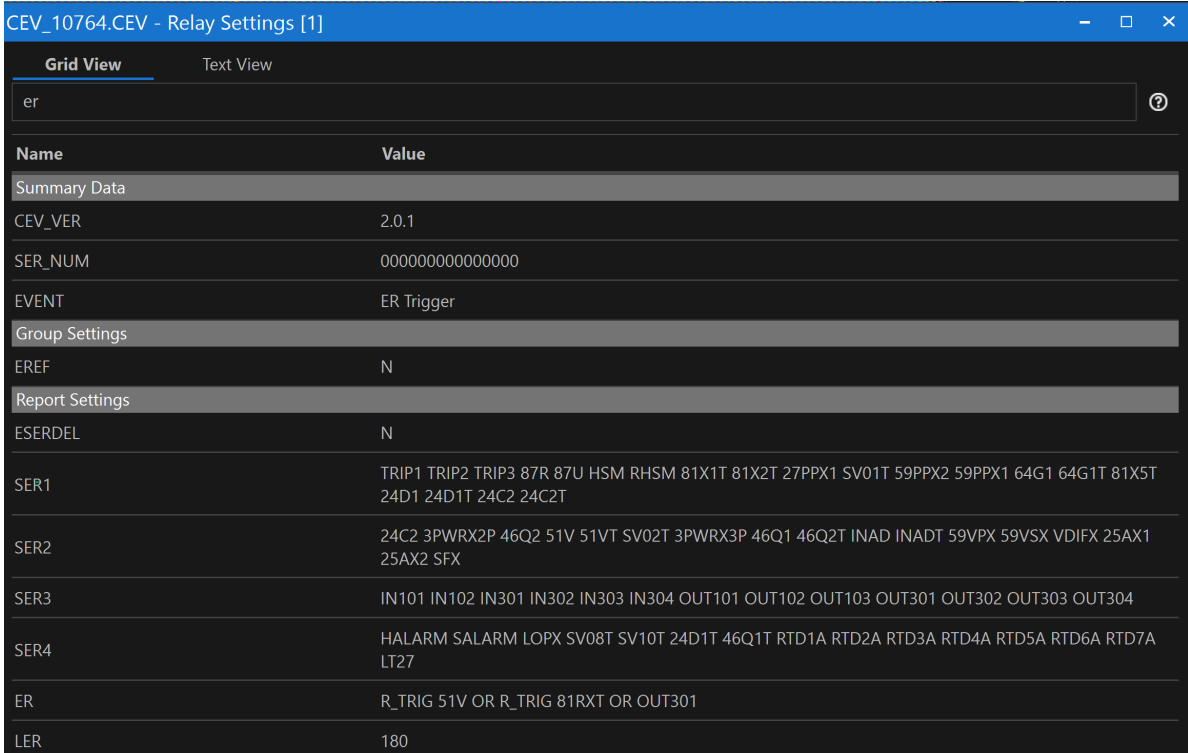
**ER = R\_TRIG 51V or R\_TRIG 81RXT or OUT301**

Because the ER flag is common to the 51V (voltage-restrained overcurrent), 81RXT (rate-of-change-of-frequency) and OUT301 sources, the presence of ER alone does not identify which element picked up. TAC is provided with duplicate protection: a SEL-400G relay and a SEL-700G relay and both were reviewed. As set out below, the relay record contains **two separate ER events**: a first event associated with the 51V element, and a second, later event associated with the 81RXT (RoCoF) element.
