# **Draft determination of causer: 26 July 2024 under-frequency event**

Consultation paper

System Operator Event 4477

December 2024

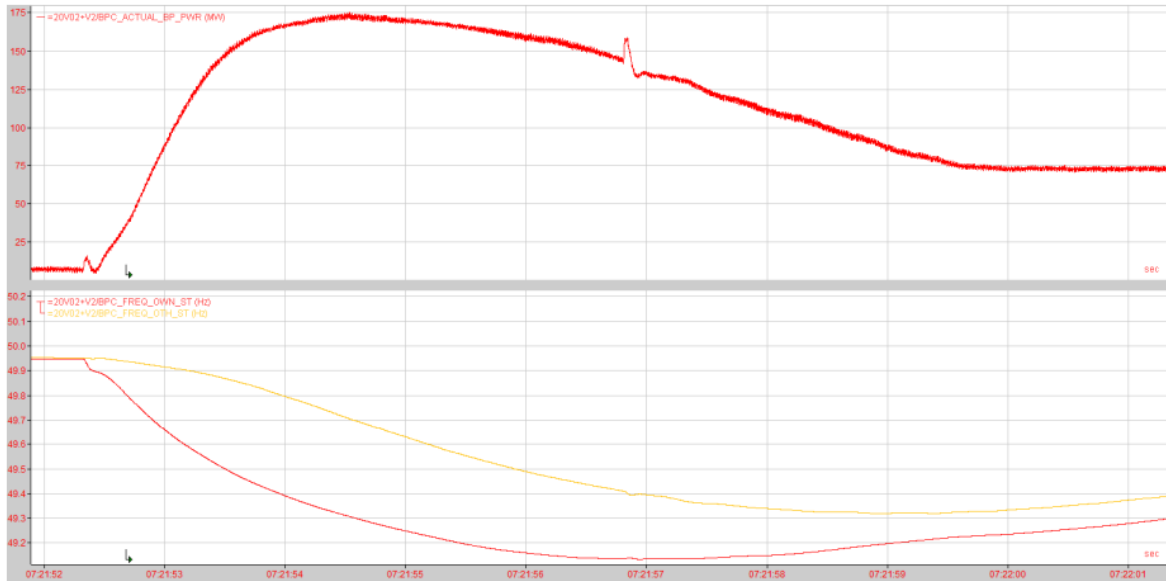
Below graph shows the response of the HVDC during the event.

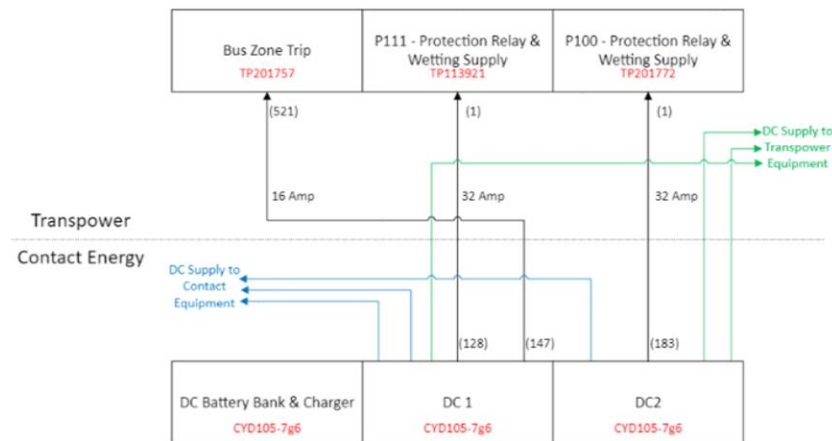
As I informed to you over the phone while ago, I'm working on this event and would like get further information around this and appreciate if you can provide me some clarification for the below queries. Please refer to the below DC distribution sketch to find drawing numbers and equipment I'm referring to.

- Contact DC1 & DC2 provide DC supply to the all station and Bus Zone equipment (all secondary supply to Transpower equipment at CYD and Transpower protection – Bus Zone trip + P111 +P100). Transpower provides BZ cross trip input back to Contact.
  - Does the supply cables from DC1 & DC2 to Transpower equipment separated from the BZ cross trip input cables?
  - If yes, how you think this protection relay assertions happened?
- Is DC supply for the DIS473 provided through DC1 & DC2 panel by Contact or other connection point at BZ?
- If possible please confirm the ownership/responsibility of below items (Contact or Transpower)
  - DC supply cables between DC1 & DC2 panels and Transpower equipment & relay supply panels
  - BZ cross trip input signal cables
