# **Draft determination of causer: 21 December 2024 under-frequency event**

Consultation paper

System Operator event 4523

May 2025

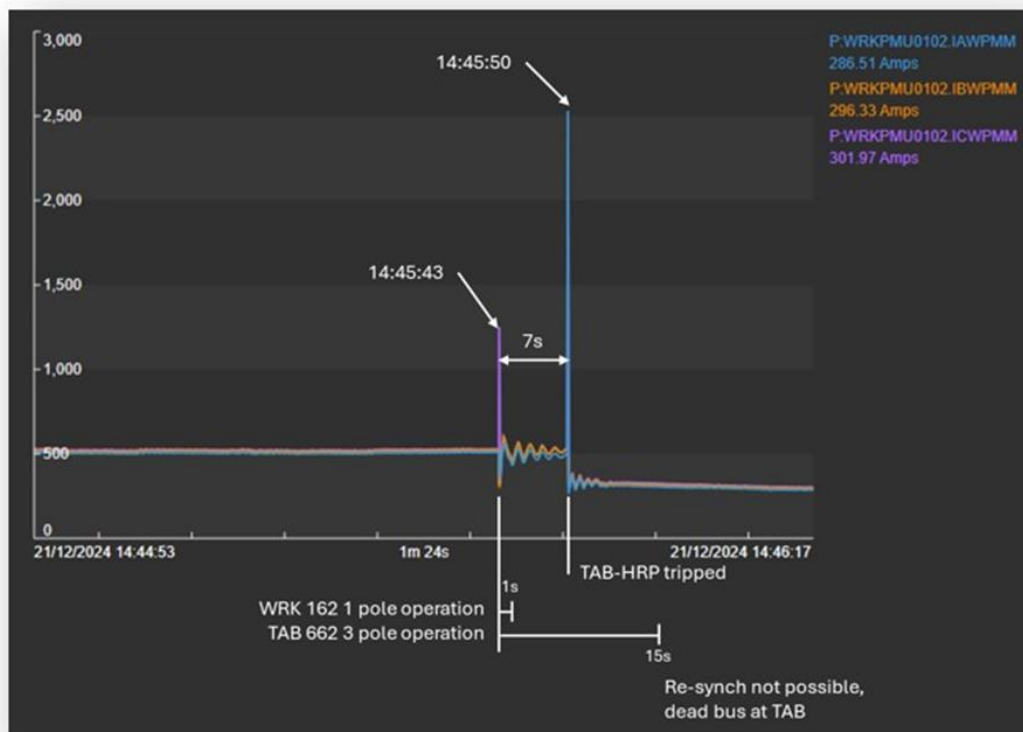
Figure 2: Translation of information

- ii. In the information provided, you stated that WRK CB 162 successfully reclosed for the same fault at 14:45:43. There was no clarification on why two relays sensing the same fault responded differently. I have a figure 2 below that translates the information provided by the Grid Owner. Kindly clarify this. [GO] Due to the highly meshed nature of a transmission power system, it is common for the same fault to appear differently to relays at either end of the protected circuit. The location of the fault, the source impedance behind each relay, and the impedance of the fault all impact the currents and voltages measured by the relays during a fault. In this specific case, the fault was electrically closer to WRK, and with WRK having a lower source impedance than TAB, this resulted in higher current and more voltage depression measured at the WRK end of the circuit.
