ELECTRICITY INDUSTRY PARTICIPATION CODE
RECONCILIATION PARTICIPANT AUDIT REPORT

TRUSTPOWER LIMITED

Prepared by: Rebecca Elliot and Tara Gannon

Date audit commenced: 25 March 2020

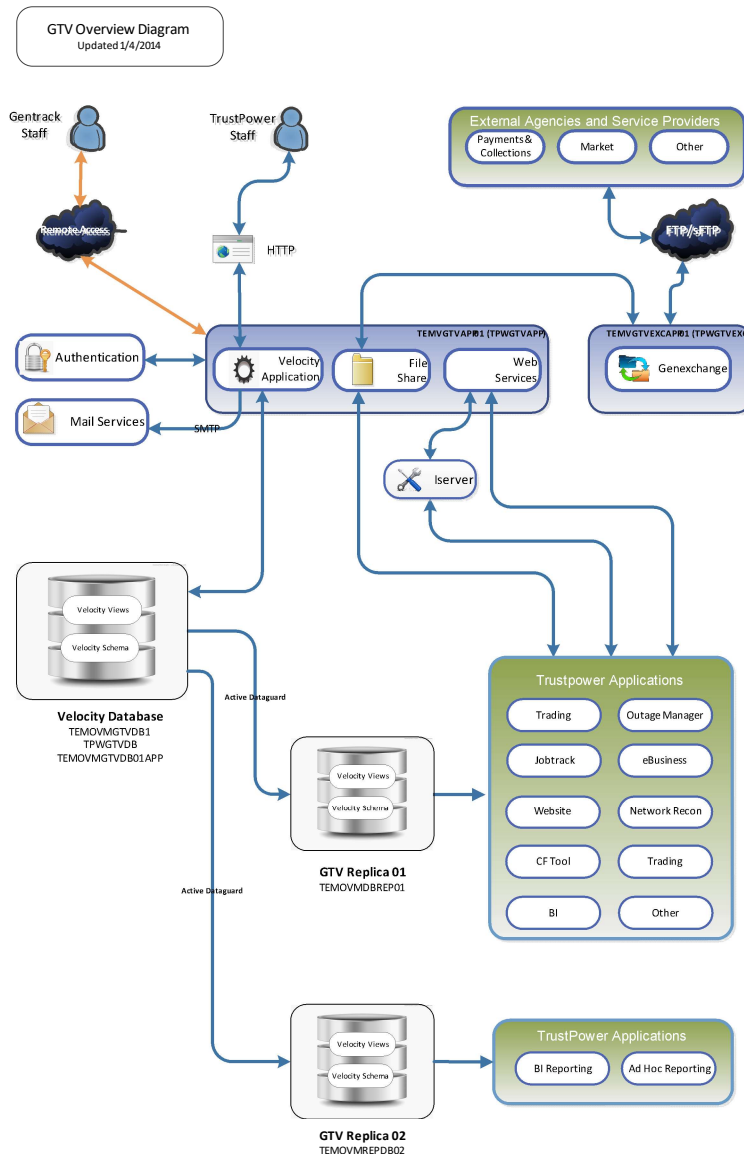
A diagram of Trustpower's system configuration is shown below.

Access to systems is restricted using logins and passwords. There are comprehensive back up processes in place. Trustpower provided a detailed breakdown of these.

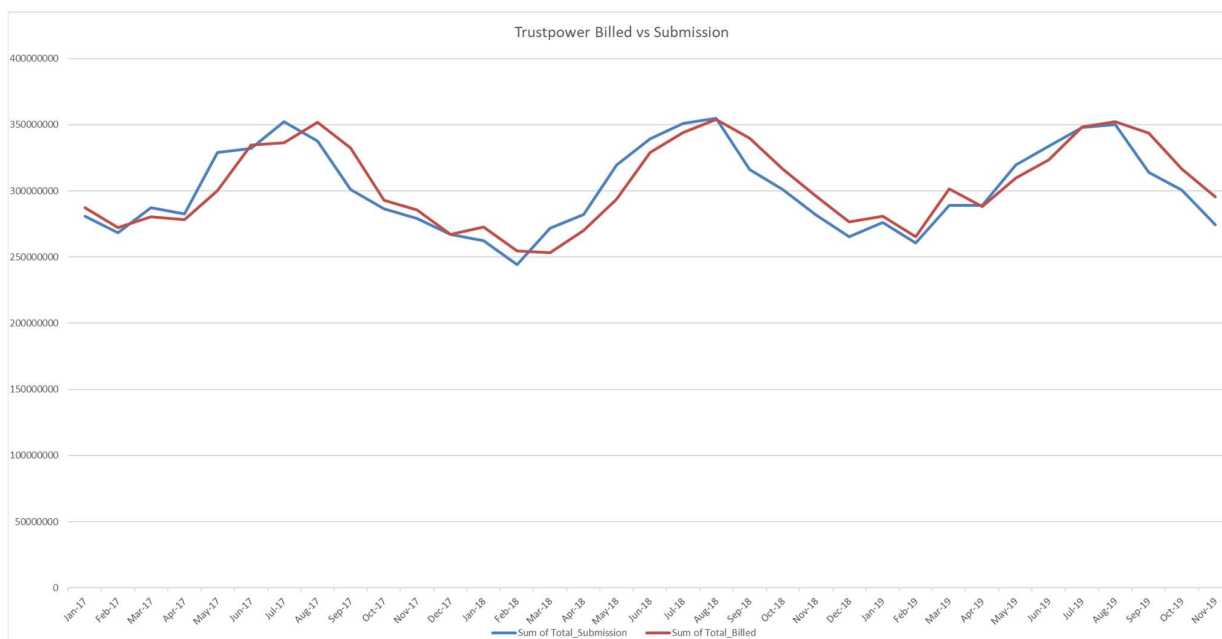
I also checked the difference between submission and electricity supplied information for a 24 month period, and the results are shown in the chart below. The total difference is 2.2% for the year ended November 2019 (billed higher than submission), and 1.1% for the two years ended November 2019 (billed higher than submission). This is an increase from the last audit when the variance between billed vs submitted as 0.27%. This is due to a number of factors:

- In October 2018, Trustpower altered the way they applied their pre-scaled profile shapes for the initial submission. This took a couple of months to be bedded in but the variances between the initial submission and R1 submission is now much closer.
- The move of all manual meter reading to MRS from Trustpower caused a drop in the meter reading attainment level as is discussed in **section 6.9**. This has had a flow on effect to billed vs submitted volumes as a larger number of ICPs were estimated resulting in lower billed vs submitted volumes then reversed to be higher billed vs submitted volumes when actual reads were gained.

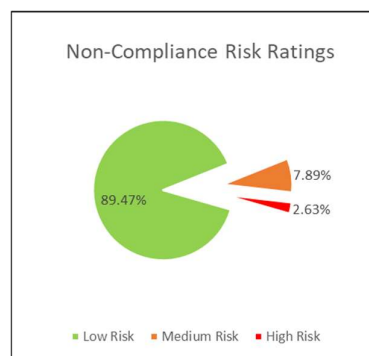
38 non-compliances identified in this report, most (89.47% or 34 of the 38) are **LOW risk** and would have a **MINOR impact** if not addressed within 12-24 months.

7.89% (3 of the 38) are rated medium risk indicating that the impact, if not addressed within the next 6-12 months would have a moderate impact, and **only 1** of the non-compliances (2.63%) relates to a High-risk impact. This high-risk impact is in relation to DUMML. Additional controls were introduced in late 2019 including the formation of a new governance group to oversee progress on DUMML issues.
