**ELECTRICITY INDUSTRY PARTICIPATION CODE
DISTRIBUTOR AUDIT REPORT**

For

Aurora Energy Limited

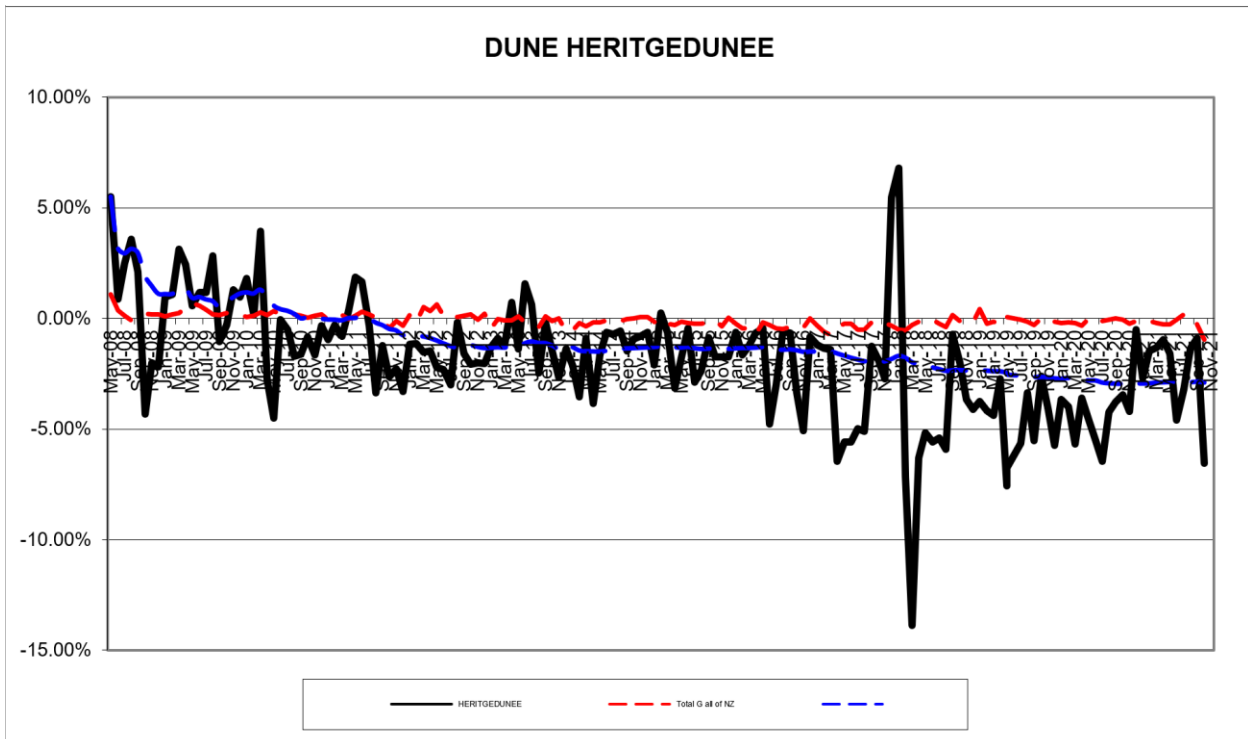
Heritage Estate Embedded Network

I reviewed Auroras calculations for the Loss Factor for Heritage Estate. Aurora take the total metered quantity for Heritage Estate, they sum all of the ICP kWh's from the EIEP1 files and calculate the difference between the two. The calculation is over a rolling 5 year period. This process is robust, and the methodology is compliant.
