ELECTRICITY INDUSTRY PARTICIPATION CODE
DISTRIBUTED UNMETERED LOAD AUDIT REPORT

BULLER DISTRICT COUNCIL
RAMM DATABASE
AND MERIDIAN ENERGY
NZBN: 9429037696863

Prepared by: Steve Woods

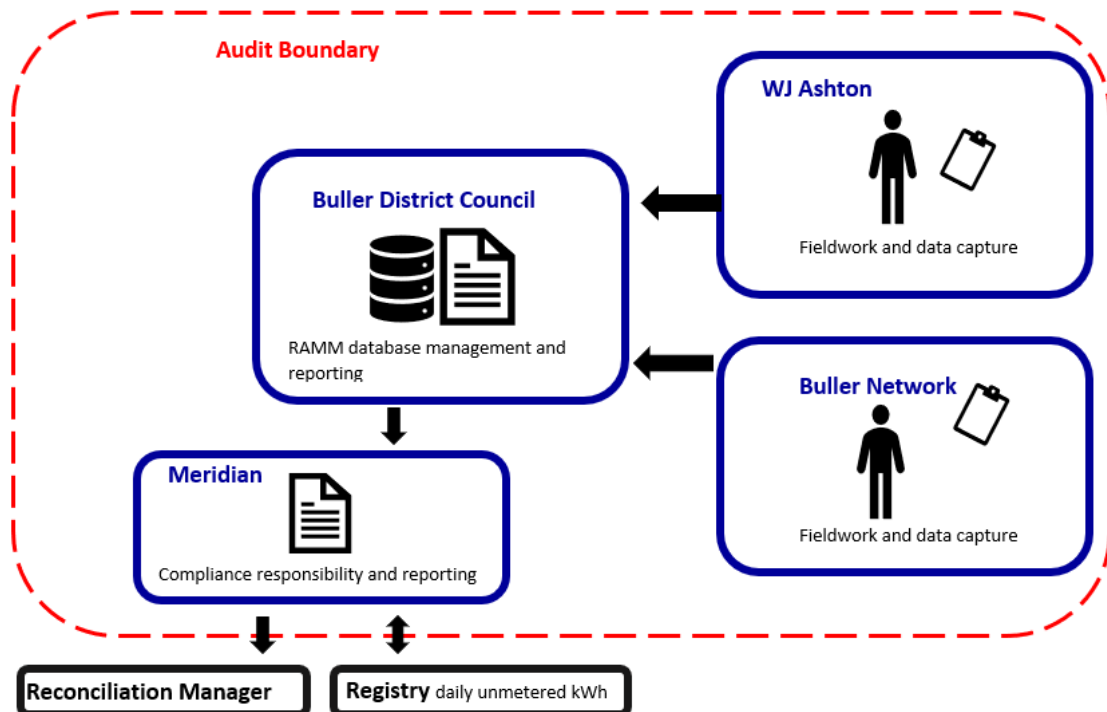
The scope of the audit encompasses the collection, security, and accuracy of the data, including the preparation of submission information based on the database reporting. The diagram below shows the audit boundary for clarity: audit was conducted in accordance with the audit guidelines for DUML audits version 1.1.

The diagram below shows the audit boundary for clarity.
