ELECTRICITY INDUSTRY PARTICIPATION CODE
DISTRIBUTED UNMETERED LOAD AUDIT REPORT

HOROWHENUA DISTRICT COUNCIL AND
CONTACT ENERGY LIMITED
NZBN: 9429038549977

Prepared by: Tara Gannon

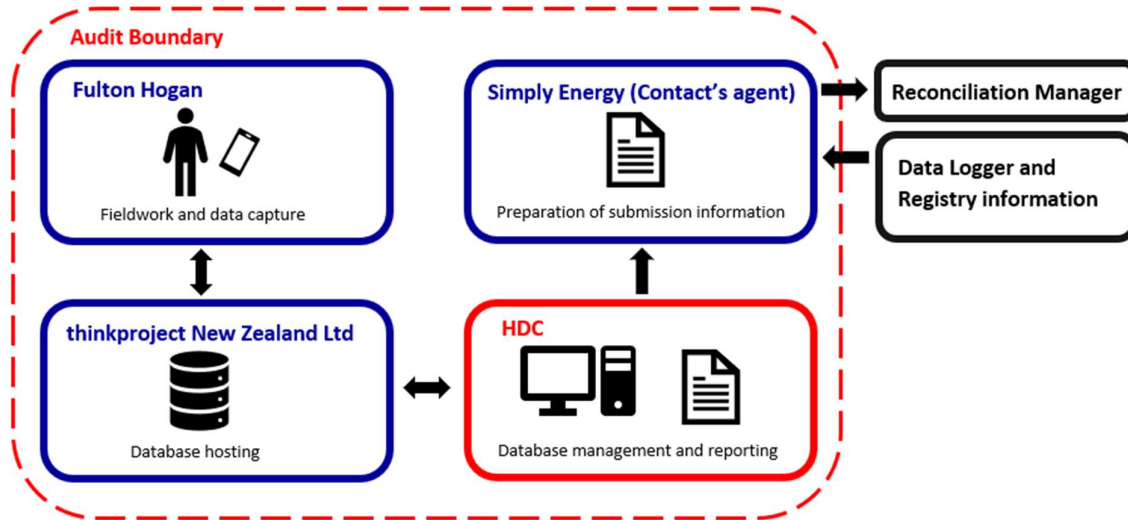
The scope of the audit encompasses the collection, security, and accuracy of the data, including the preparation of submission information based on the database reporting. The diagram below shows the audit boundary for clarity.
