ELECTRICITY INDUSTRY PARTICIPATION CODE  
DISTRIBUTOR AUDIT REPORT

THE LINES COMPANY  
NZBN: 9429038879517

Prepared by: Tara Gannon

Date audit commenced: 1 February 2023

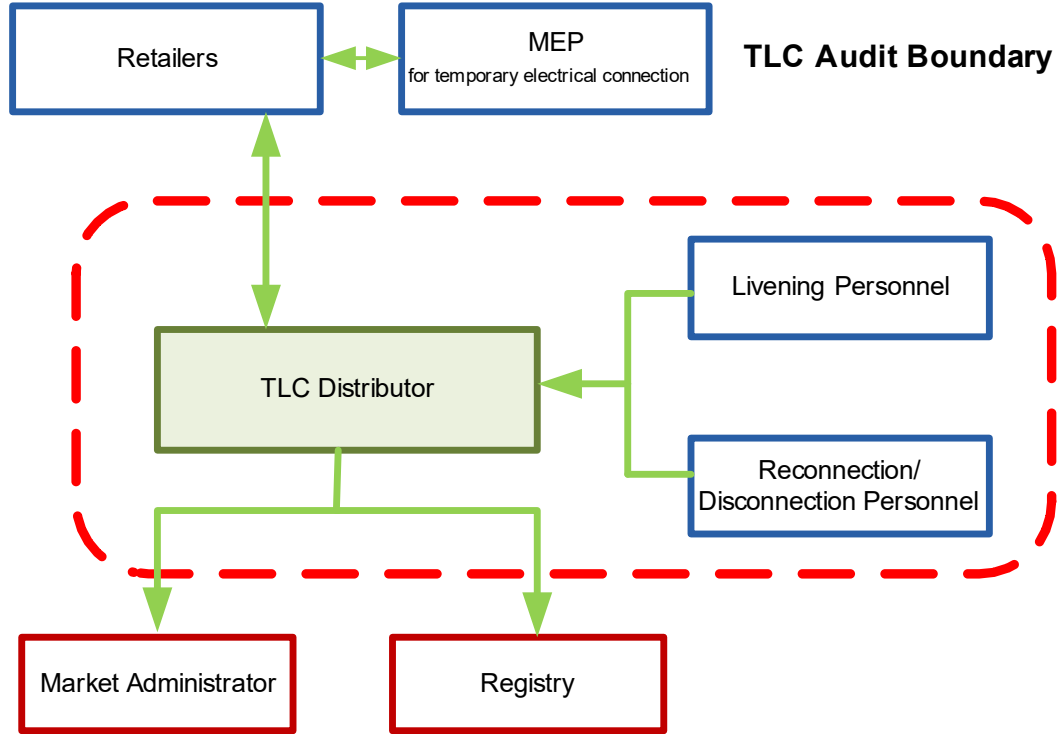
The audit analysis was based on registry list, event detail and audit compliance reports for 1 January 2022 to 21 October 2022, and registry list snapshot and meter installation details reports for 21 October 2022.

The scope of the audit is shown in the diagram below, with the TLC audit boundary shown for clarity.

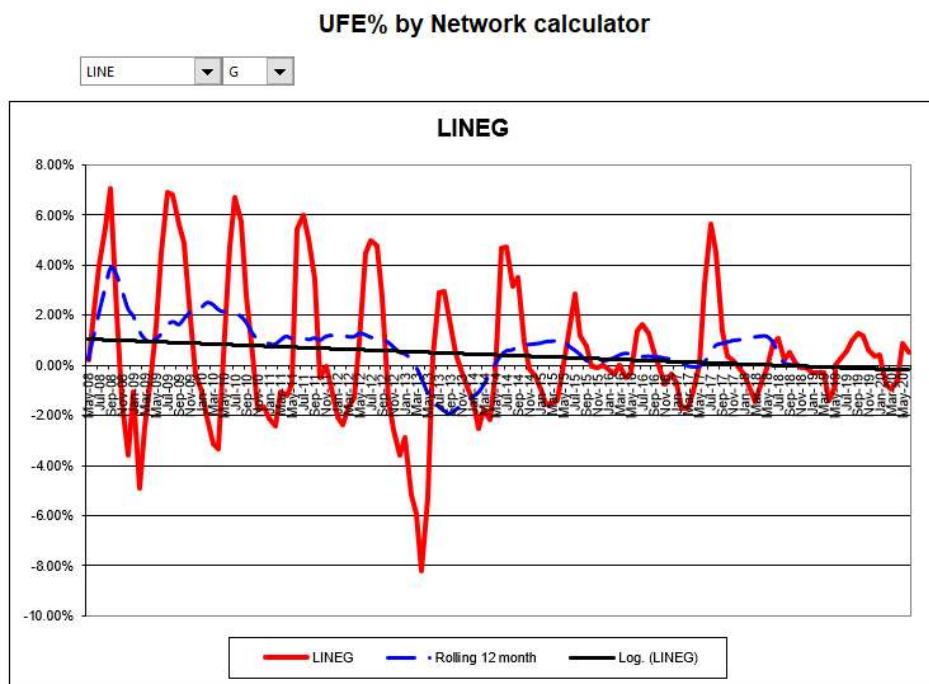
Loss factor reviews were historically conducted every ten years, or if a major change to the network occurs which is likely to have a material impact on loss factors. TLC’s loss factors were last updated in April 2008. A review of loss factors has not been completed in recent years, in part due to staffing changes. TLC provided their last internal correspondence from October 2022 which was investigating who could complete the review.

I was provided by the Electricity Authority the reconciliation losses by for the Lines Company network. The chart below indicates losses for the network are tracking within the +/- 1% threshold.
