ELECTRICITY INDUSTRY PARTICIPATION CODE
DISTRIBUTED UNMETERED LOAD AUDIT REPORT

TARARUA DISTRICT COUNCIL
AND MERCURY ENERGY LIMITED
NZBN: 9429037706609

Prepared by: Bernie Cross

Date audit commenced: 1 February 2023

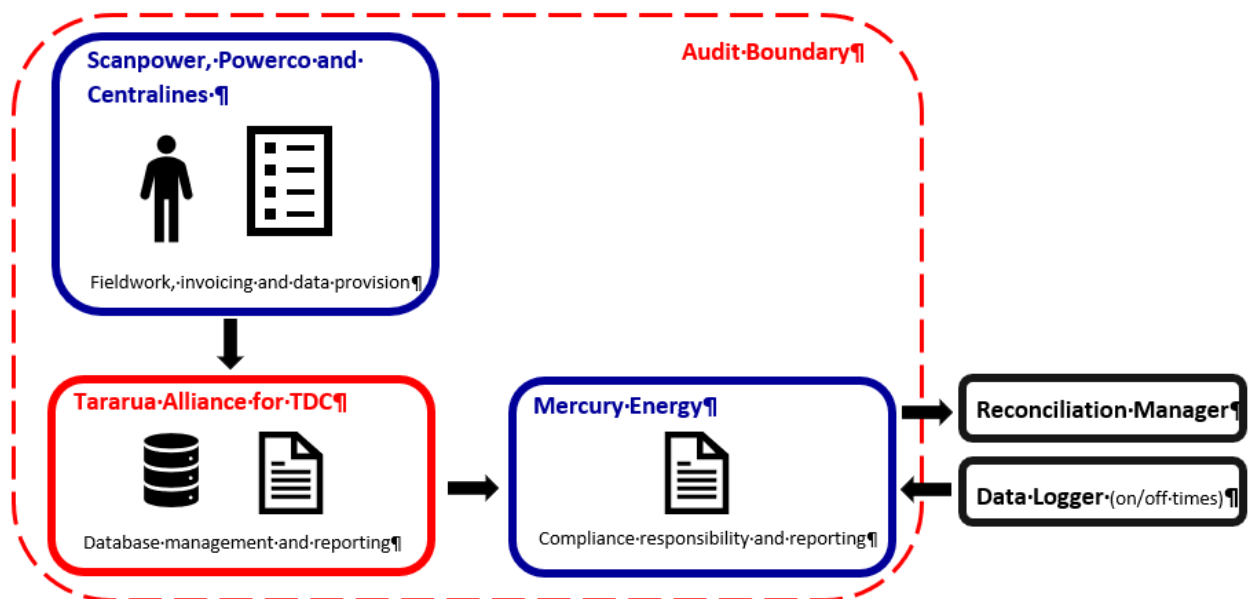
The scope of the audit encompasses the collection, security, and accuracy of the data, including the preparation of submission information based on the monthly reporting. The diagram below shows the flow of information and the audit boundary for clarity.
