ELECTRICITY INDUSTRY PARTICIPATION CODE
DISTRIBUTOR AUDIT REPORT

POWERCO LIMITED
NZBN: 9429037332174

Prepared by: Tara Gannon

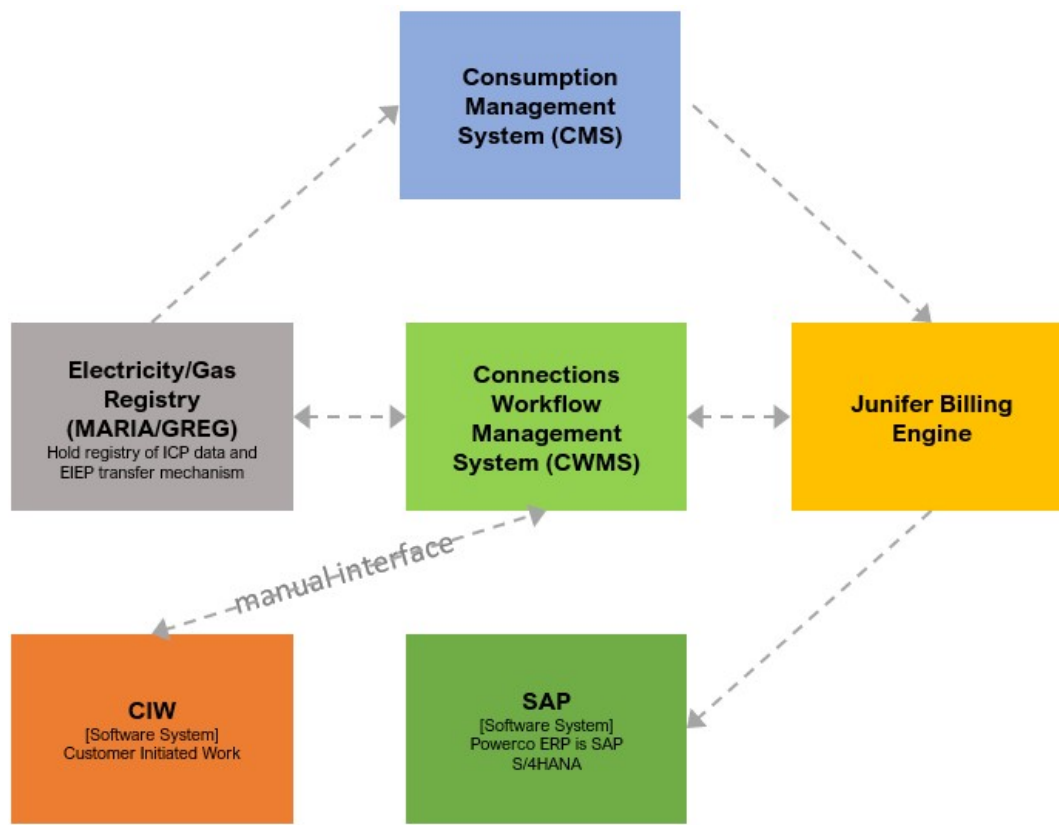
- **Customer Initiated Works (CIW)** which is an online submission portal which retailers and contractors can access directly.
- **Customer Workflow Management System (CWMS)** is used to manage ICP information; and send and receive registry data.

This is set out in the diagram below:

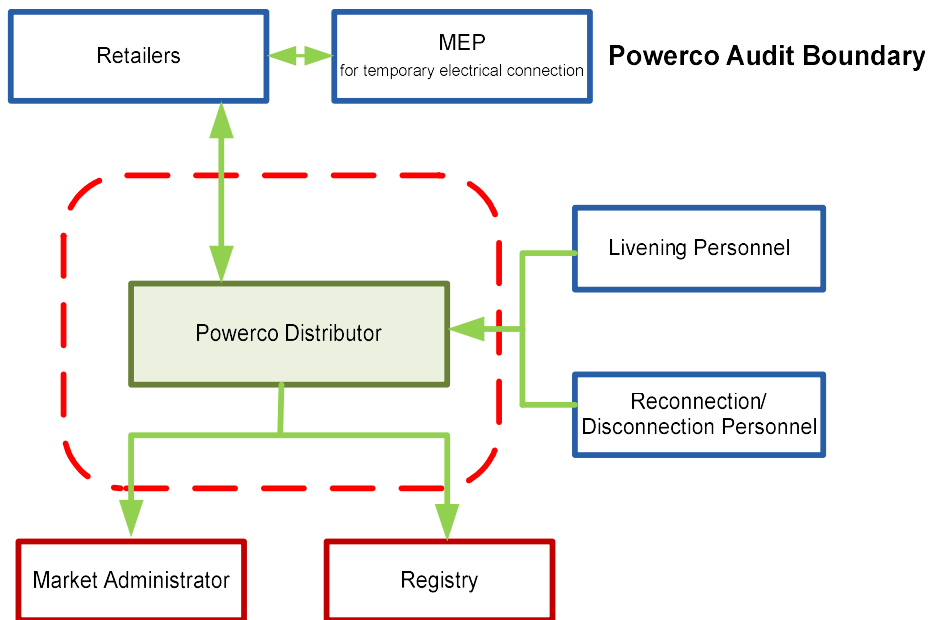
The scope of the audit is shown in the diagram below, with the Powerco audit boundary shown for clarity.

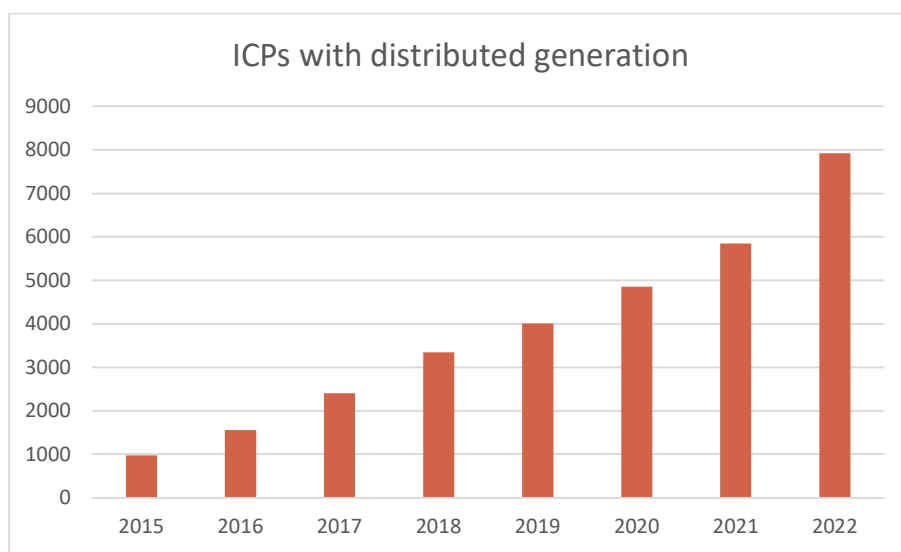
The list file recorded 7,925 active ICPs with distributed generation. The table below tracks the number of ICPs with distributed generation by year:

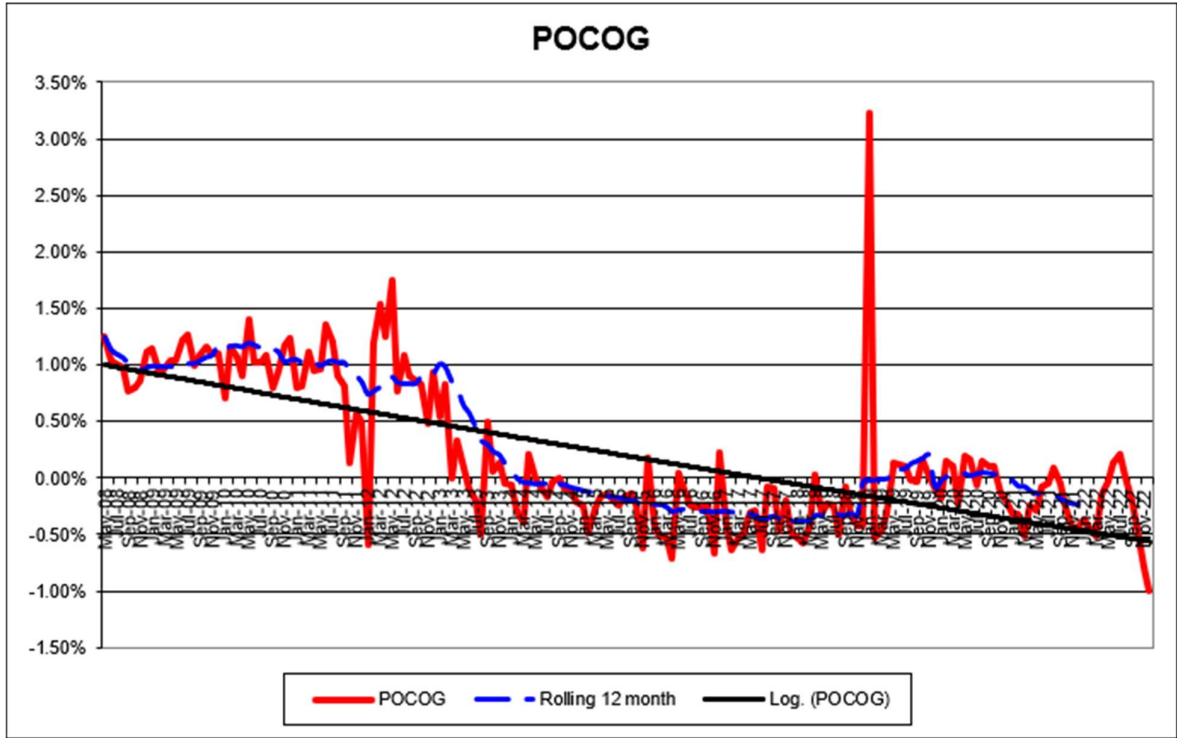
I was provided by the Electricity Authority the reconciliation losses which indicate losses are tracking within the +/- 1% threshold indicated in the guideline when all balancing areas are considered as a group:
