ELECTRICITY INDUSTRY PARTICIPATION CODE DISTRIBUTED UNMETERED LOAD AUDIT REPORT

RUAPEHU DISTRICT COUNCIL AND MERIDIAN ENERGY LIMITED NZBN: 9429037696863

Prepared by: Rebecca Elliot

Date audit report completed: 10 February 2023

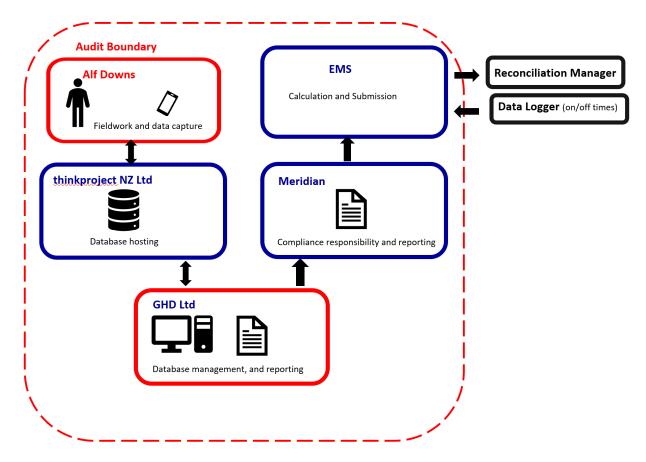
The scope of the audit encompasses the collection, security, and accuracy of the data, including the preparation of submission information based on the database reporting. The diagram below shows the audit boundary for clarity.

Meridian reconciles this DUML load using the DST profile. The on and off times are derived from a data logger read by EMS and are used to create a shape file. Meridian supplies EMS with the capacity information and EMS calculates the kWh figure for each ICP and includes this in the relevant AV080 file.
