ELECTRICITY INDUSTRY PARTICIPATION CODE  
DISTRIBUTED UNMETERED LOAD AUDIT REPORT

WAIMAKARIRI DISTRICT COUNCIL AND  
CONTACT ENERGY

Prepared by: Steve Woods

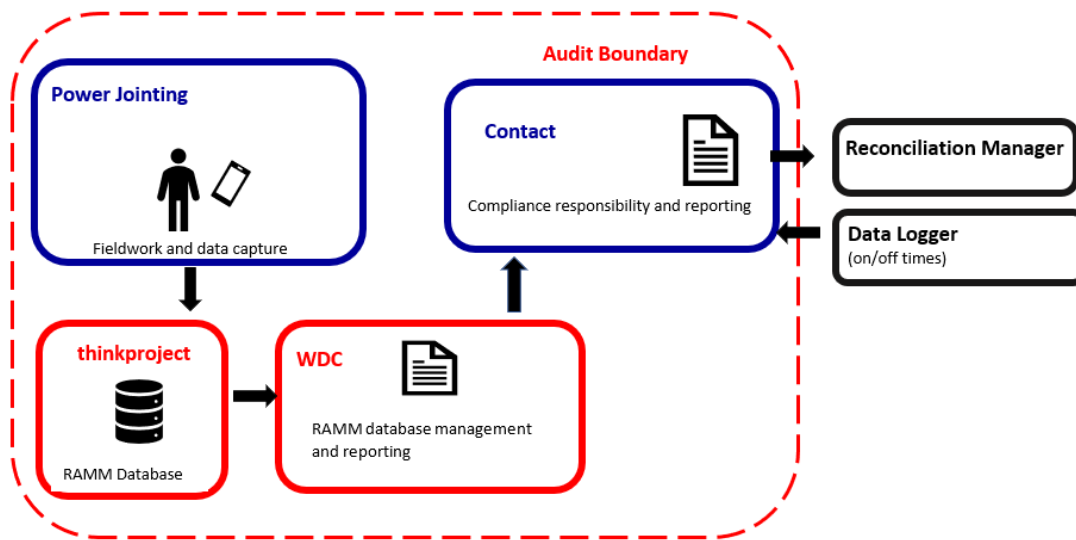
The diagram below shows the flow of information and the audit boundary for clarity.

The database is remotely hosted by thinkproject New Zealand Ltd and is managed by WDC, who is Contact's customer. Reporting is provided by WDC to Contact on a monthly basis. The fieldwork and asset data capture are conducted by Power Jointing Limited. The scope of the audit encompasses the collection, security and accuracy of the data, including the preparation of submission information based on the database reporting.
