ELECTRICITY INDUSTRY PARTICIPATION CODE
RECONCILIATION PARTICIPANT AUDIT REPORT

MERCURY NZ LIMITED
NZBN: 9429037705305

Date audit commenced: 16 November 2022

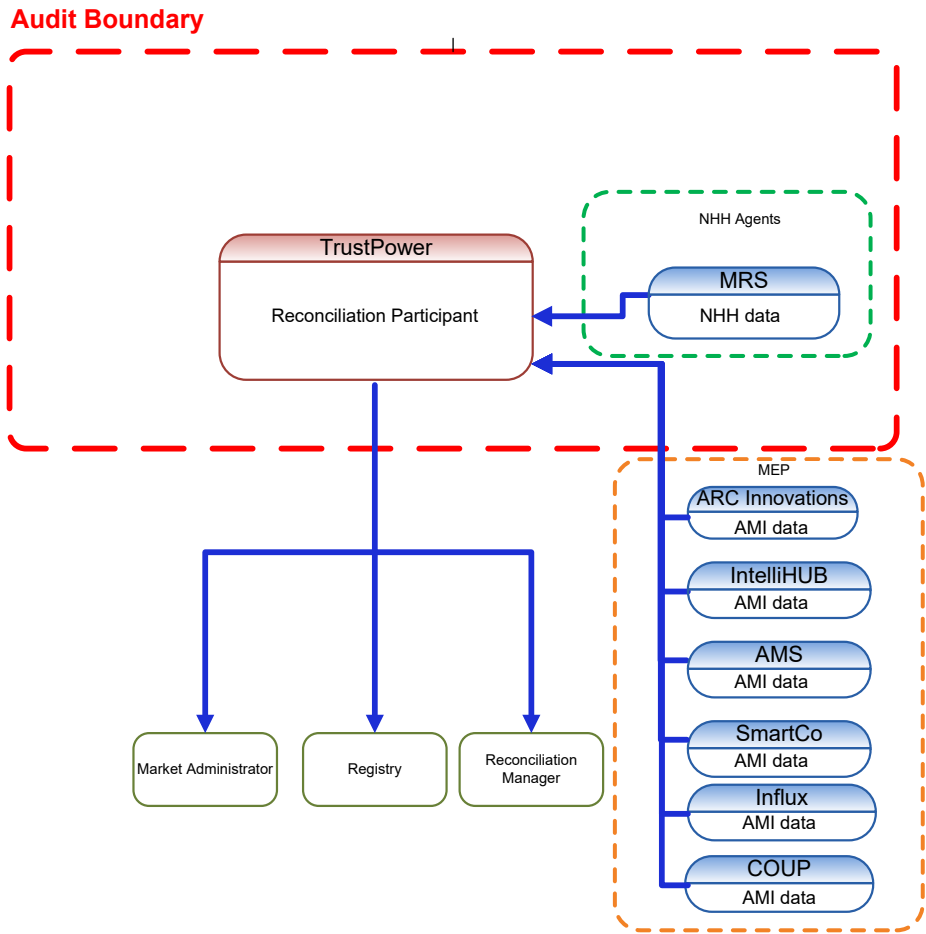
The scope of the audit for TRUS is shown in the diagram below, with the audit boundary shown for clarity.

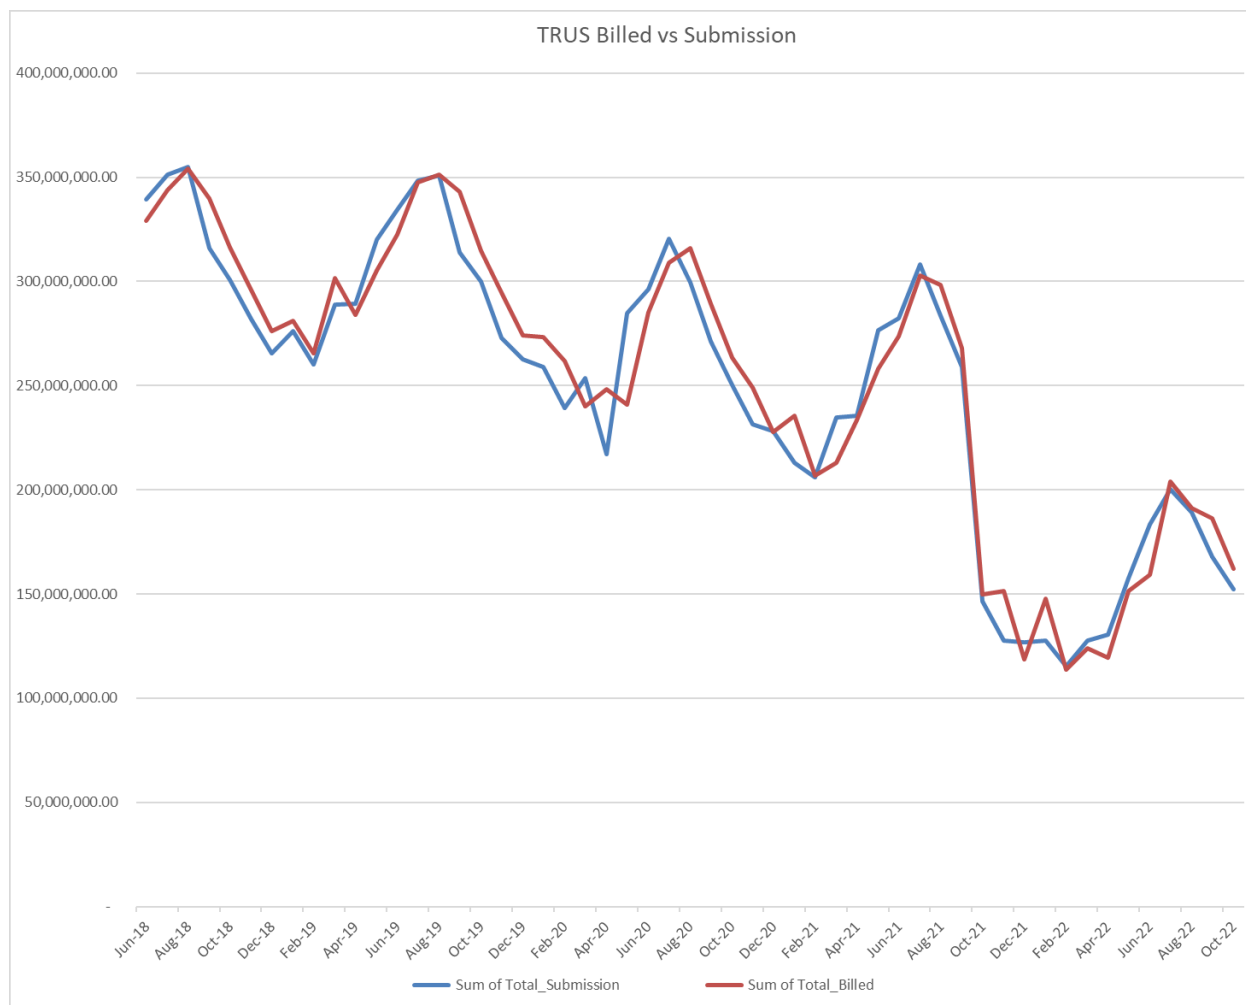
I checked the difference between submission and electricity supplied information for the period January 2020 to October 2022, and the results are shown in the chart below. The total difference is 1.6% (billed higher than submitted) for the year ended October 2022.
