ELECTRICITY INDUSTRY PARTICIPATION CODE
RECONCILIATION PARTICIPANT AUDIT REPORT

NOVA ENERGY LIMITED
NZBN: 9429030450660

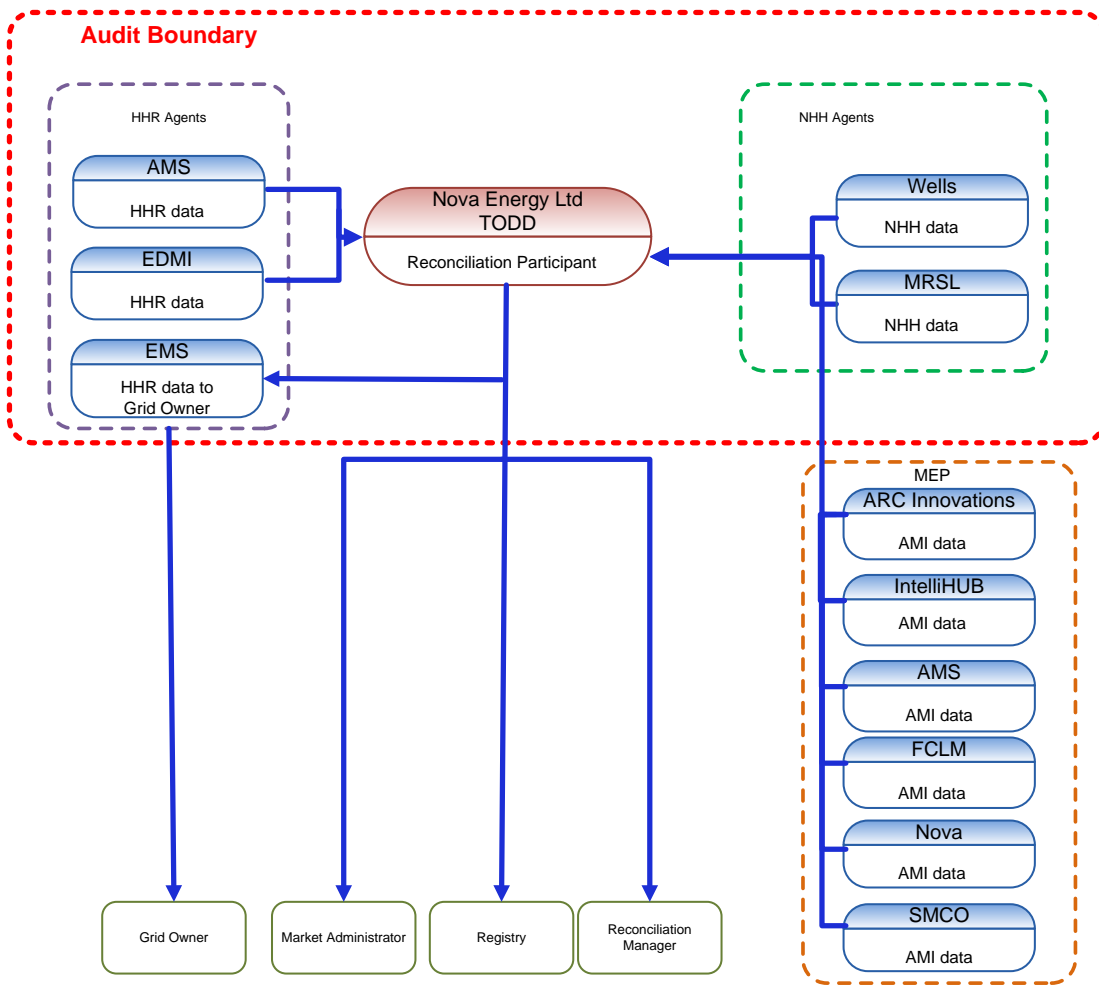
The scope of the audit is shown in the diagram below, with the audit boundary shown for clarity.

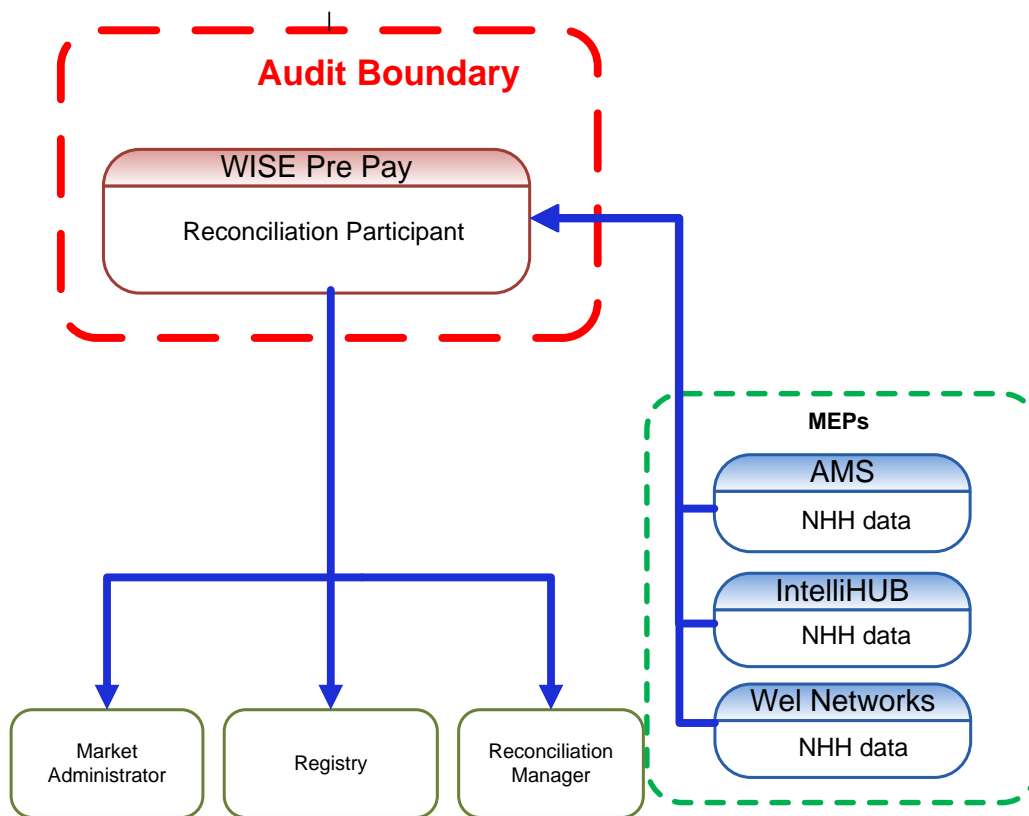
The scope of the audit is shown in the diagram below, with the audit boundary shown for clarity.

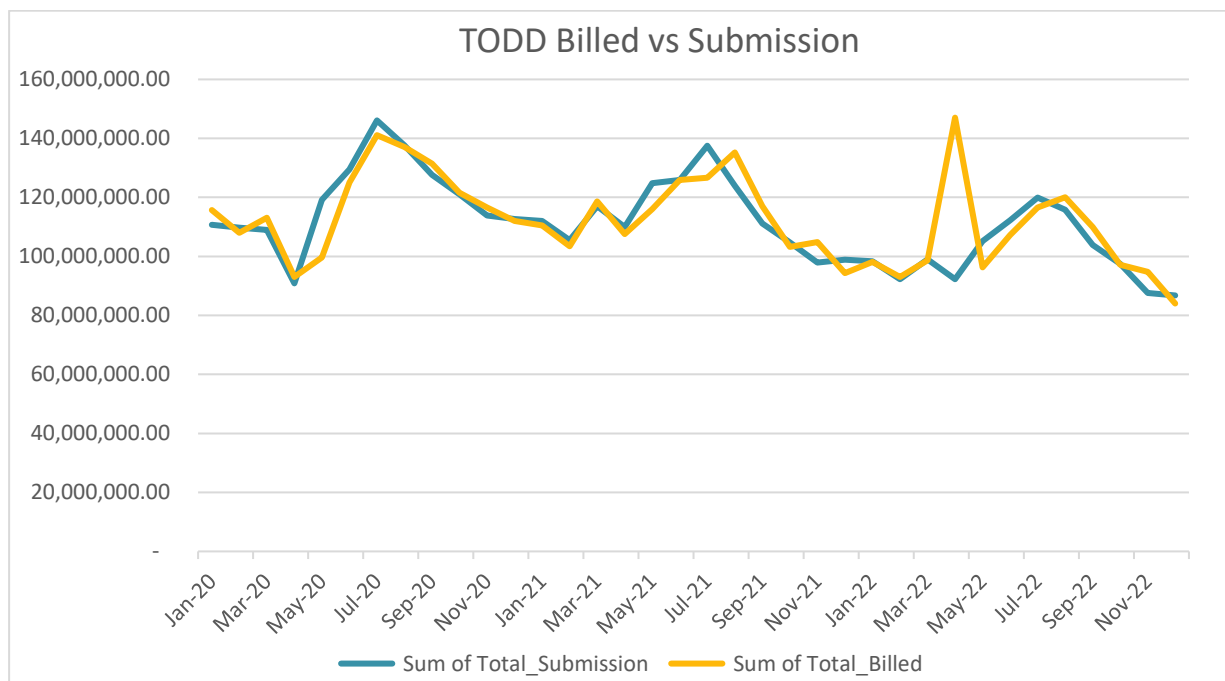
I checked the difference between submission and electricity supplied information for the period January 2020 to December 2022, and the results are shown chart below.

The difference between the billed and submitted data is largely caused by a spike in the billed data for April 2022. The issue was caused by a billing error for an ICP connected to TUI1101 in April 2023. The

following month the incorrect invoice was reversed. The reversal made the overall volume billed at TUI1101 negative for May 2022, so it was replaced with a zero so that the reconciliation manager portal would accept the file.

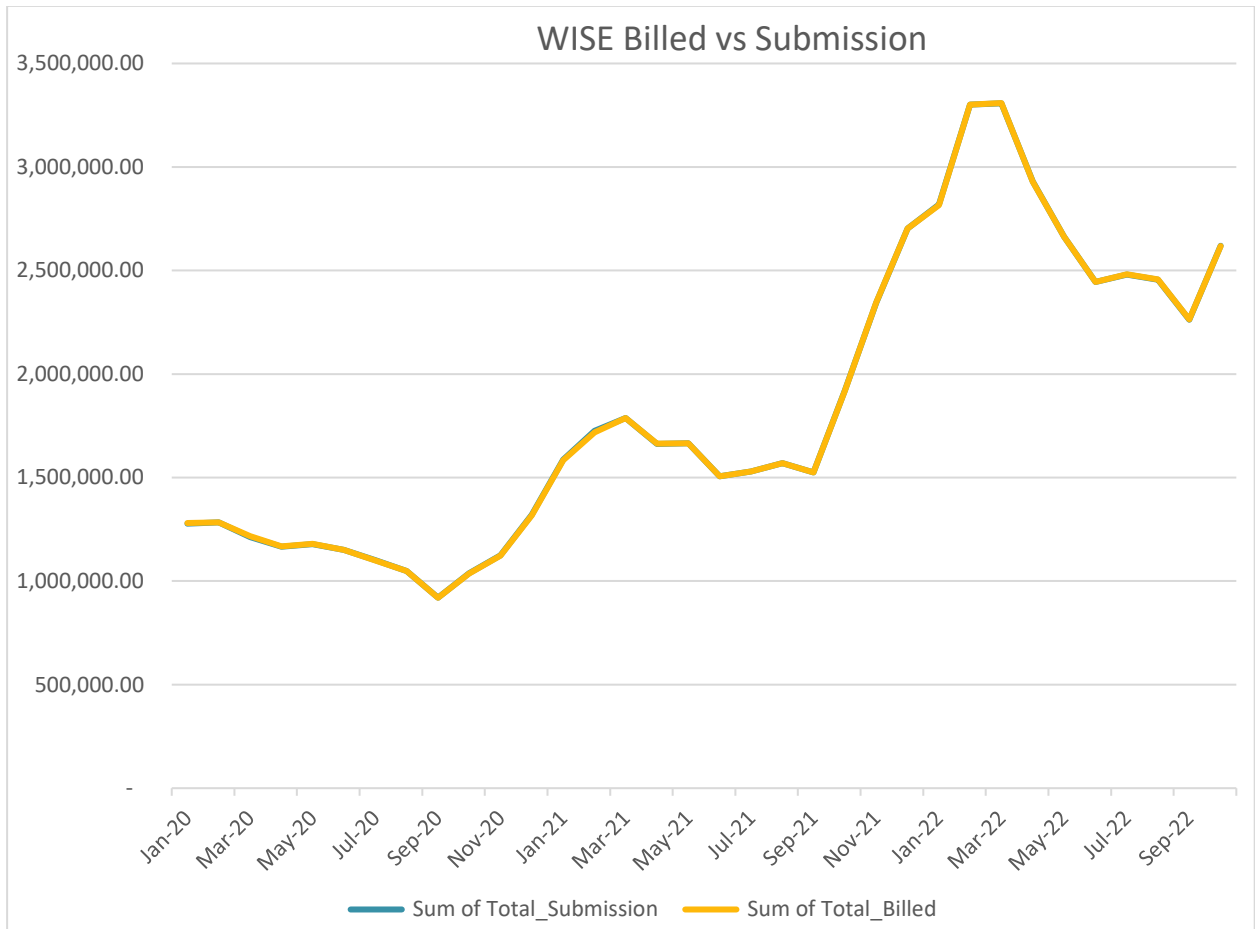
I also checked the difference between submission and electricity supplied information for the period January 2020 to October 2022, and the results are shown chart below. The total difference is -0.5% for the year ending October 2022 (billed higher than submission).
