ELECTRICITY INDUSTRY PARTICIPATION CODE DISTRIBUTED UNMETERED LOAD AUDIT REPORT

WAKA KOTAHI NZ TRANSPORT AGENCY NORTHLAND DISTRIBUTED UNMETERED LOAD GENESIS ENERGY NZBN:9429037706609

Supervising Auditor: Tara Gannon Supporting Auditor: Brett Piskulic Date audit commenced: 7 June 2023 Date audit report completed: 28 September 2023 Audit report due date: 1 June 2023

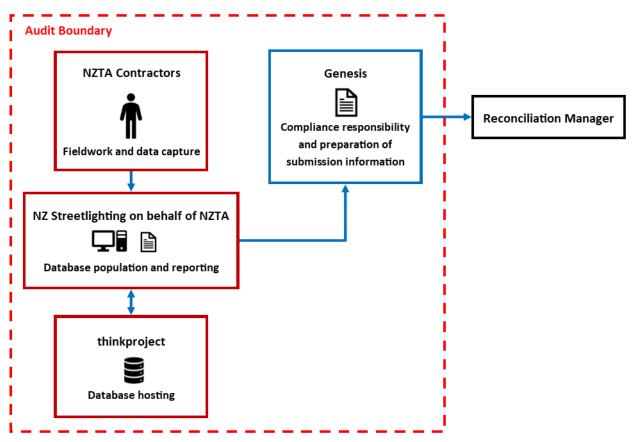
The scope of the audit encompasses the collection, security and accuracy of the data, including the preparation of submission information based on the database reporting. The diagram below shows the audit boundary for clarity.
