ELECTRICITY INDUSTRY PARTICIPATION CODE
DISTRIBUTED UNMETERED LOAD AUDIT REPORT

TASMAN DISTRICT COUNCIL
AND GENESIS ENERGY LIMITED
NZBN: 9429037706609

Prepared by: Tara Gannon

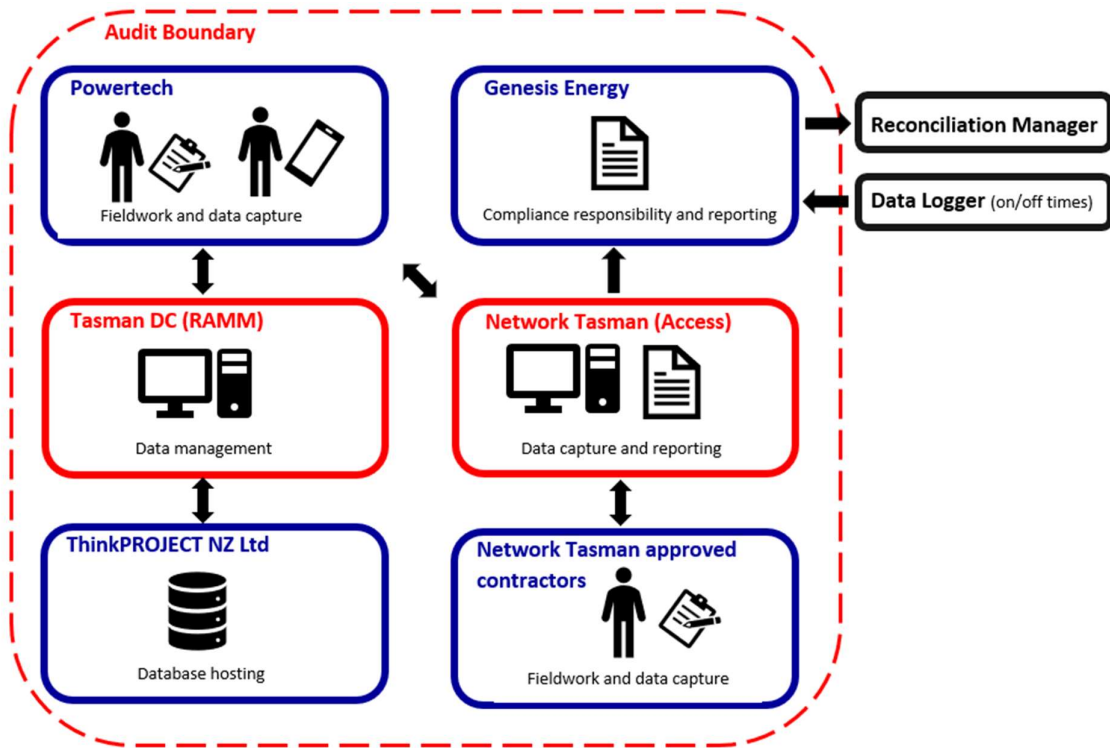
The scope of the audit encompasses the collection, security, and accuracy of the data, including the preparation of submission information based on the database reporting. The diagram below shows the audit boundary for clarity.
