ELECTRICITY INDUSTRY PARTICIPATION CODE  
DISTRIBUTOR AUDIT REPORT

UNISON NETWORKS LIMITED  
NZBN: 9429038928437

Prepared by: Rebecca Elliot, Veritek Limited

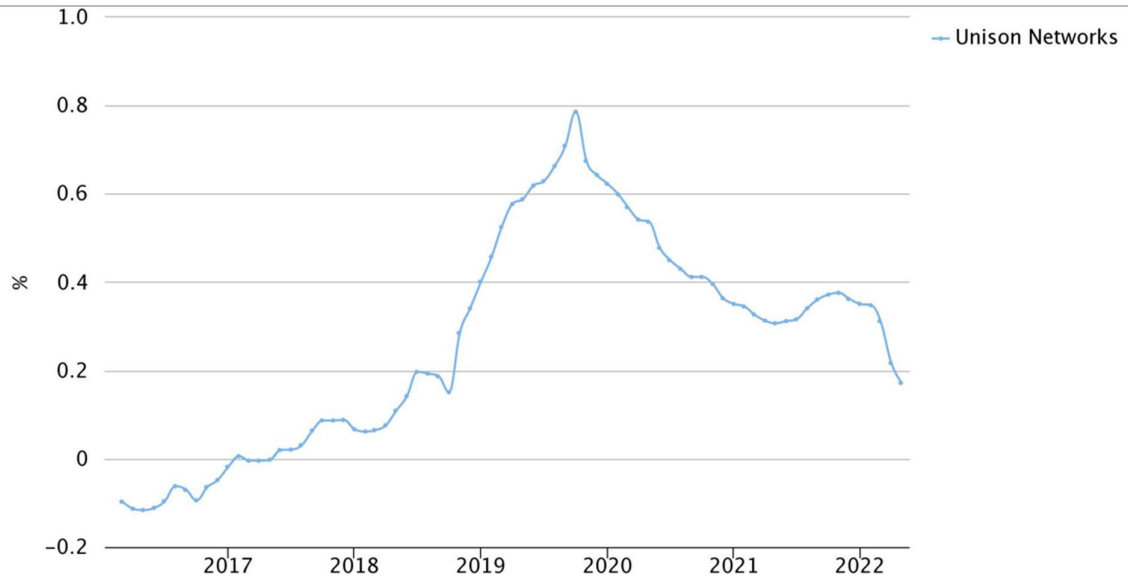
The UFE graph below indicates losses are tracking within the +/- 1% threshold indicated in the guideline.

The generation loss factors were updated for R3N and RKTPO.
