ELECTRICITY INDUSTRY PARTICIPATION CODE
DISTRIBUTOR AUDIT REPORT

THE LINES COMPANY LIMITED
NZBN: 9429038879517

Prepared by: Brett Piskulic

Date audit commenced: 24 October 2023

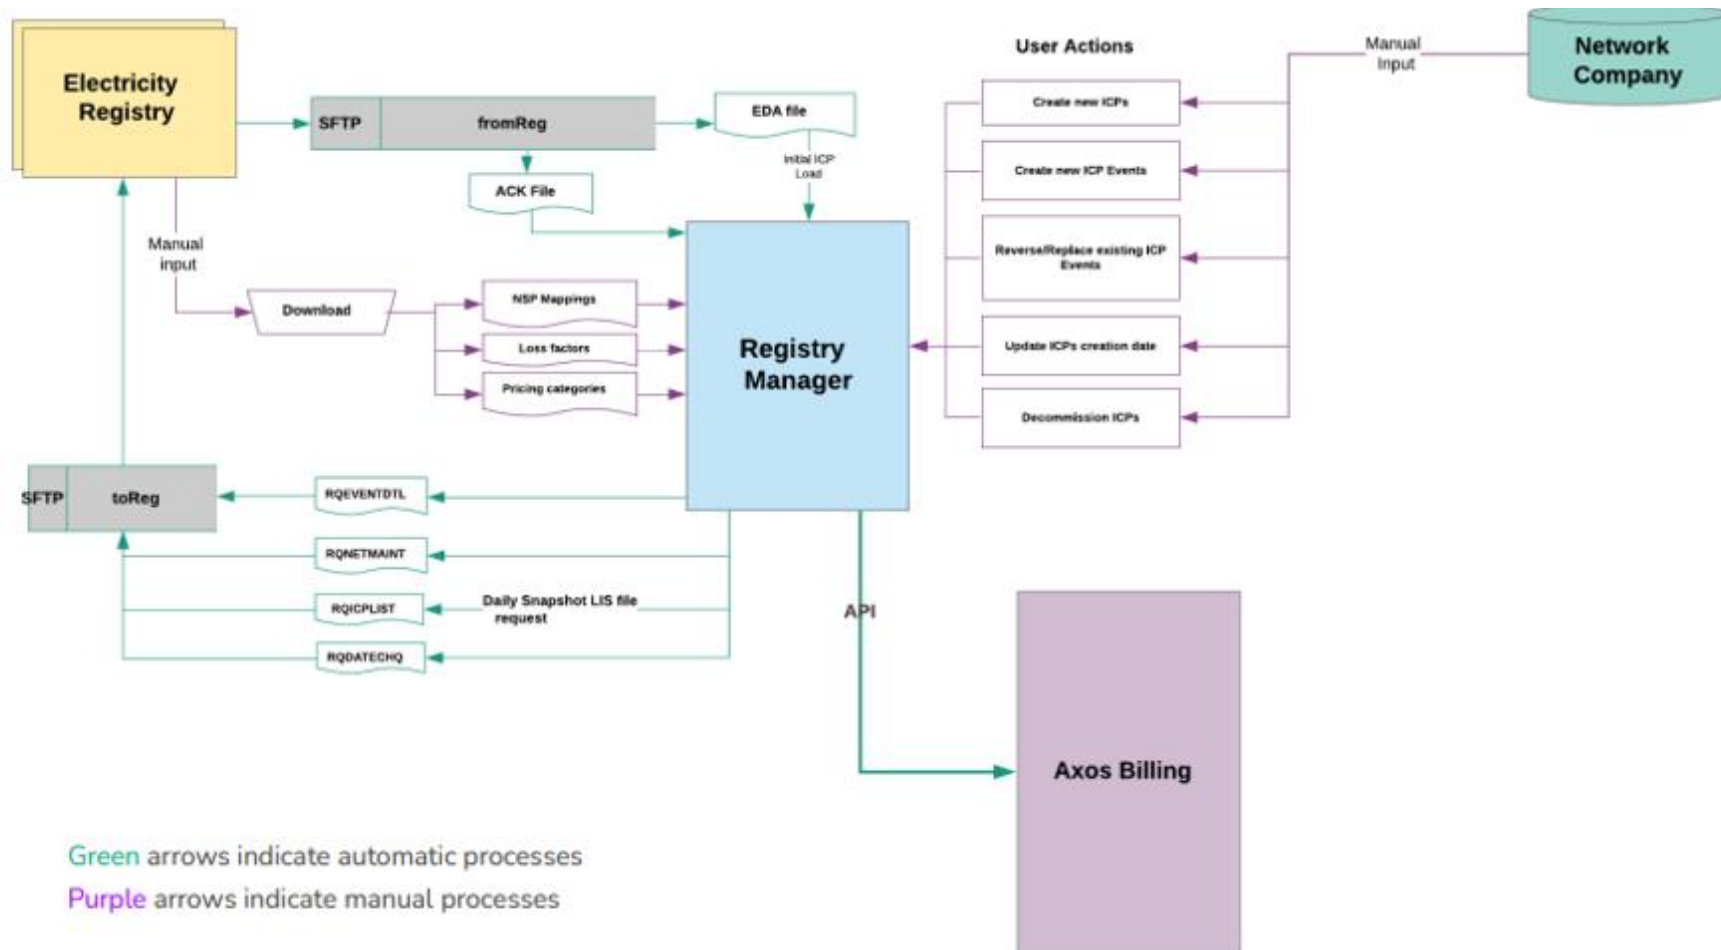
TLC provided the diagram below showing the integration of the Axos Registry Manager system with other systems and processes:

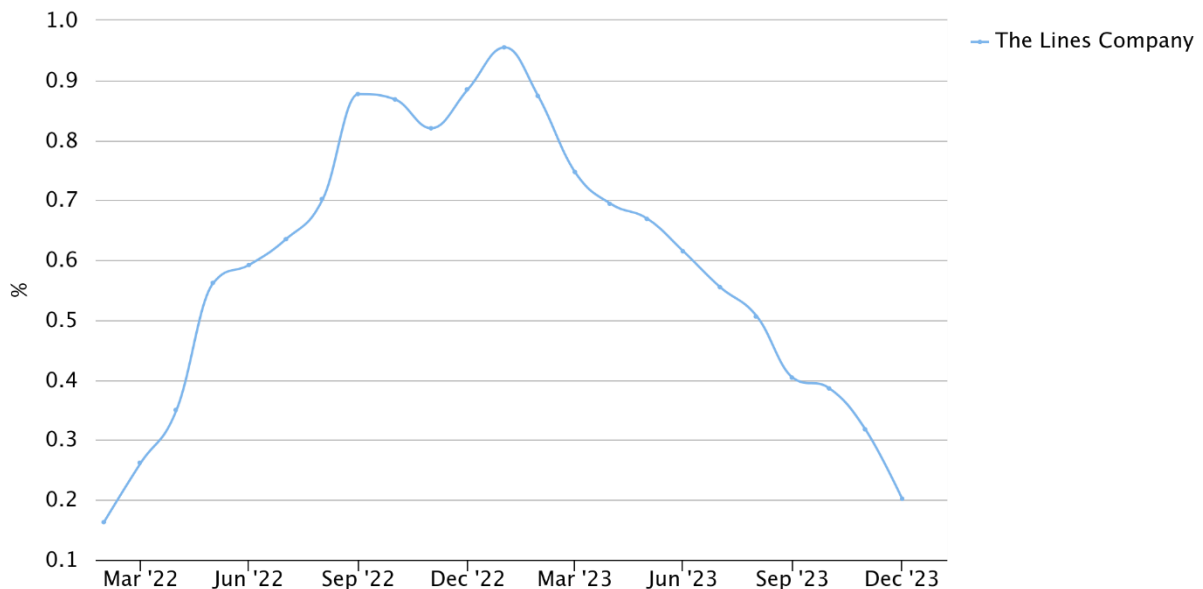
TLC UFE ratio (12 month rolling average)

I obtained the latest UFE information from the EMI website (see chart below) which confirms that UFE is tracking within the accepted +/-1% threshold.
