**ELECTRICITY INDUSTRY PARTICIPATION CODE  
DISTRIBUTED UNMETERED LOAD AUDIT REPORT**

**TAUPO DISTRICT COUNCIL  
AND MERIDIAN**

Prepared by: Steve Woods

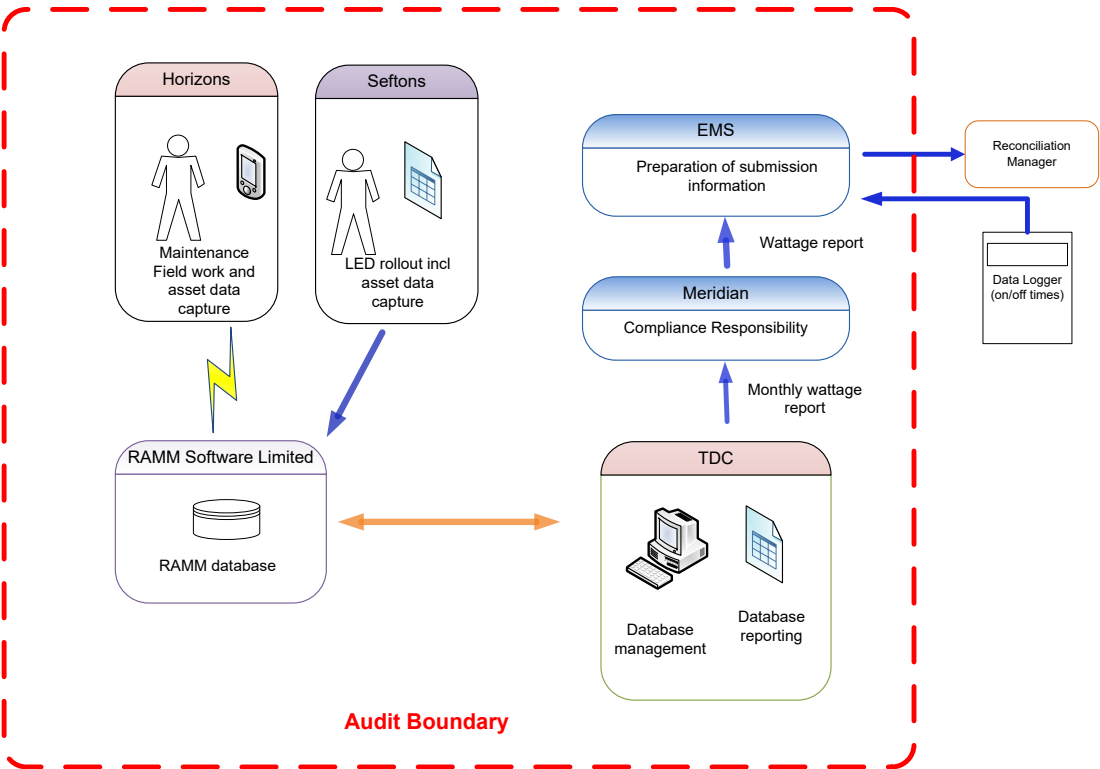
The scope of the audit encompasses the collection, security and accuracy of the data, including the preparation of submission information based on the database reporting. The diagram below shows the audit boundary for clarity.
