INDEX TO APPENDICES	
Document	Page
Appendix A - List of persons interviewed	001
Appendix B - List of documents reviewed	002
Appendix C - Terms of references	006
Appendix D - Contracting arrangements between Transpower and Omexom	009
Appendix E - Drawing TE37252	013
Appendix F - Beca report	019
Appendix G.1 - Press releases	040
Appendix H - Example Quality Assurance (QA) form	064
Appendix I - System operator report	068
Appendix J - Omexom procedure ELP-T414, Issue 5, dated 18 August 2022	112

Figure 1 - HEN-MDN A Tower 130 site layout and approximate location of tower post Incident

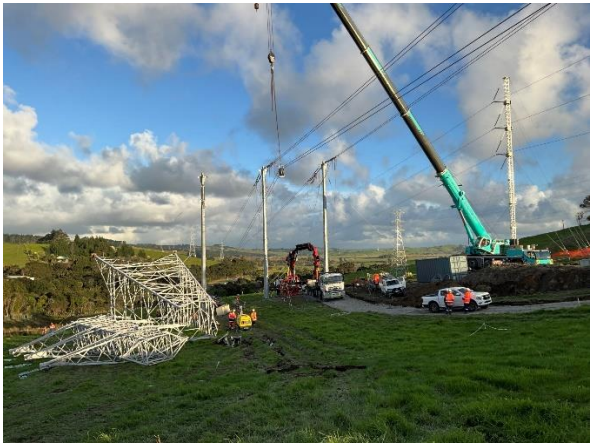
Photo A.1: Temporary restoration works. Western circuit supported by Lindsey tower (right), eastern circuit restoration using three steel monopoles in progress (middle), Tower 130 relocated from fallen location (left).

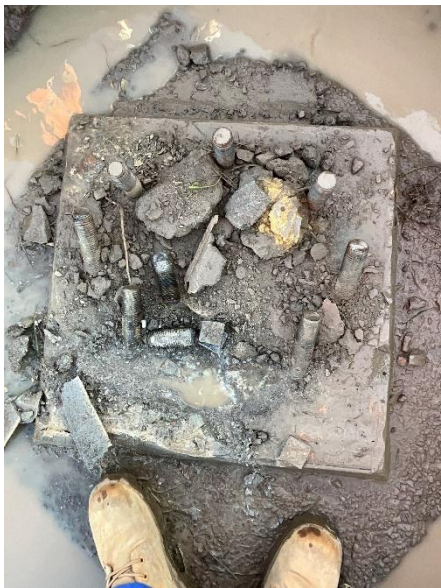
Photo A.9: Leg C foundation after being drained.

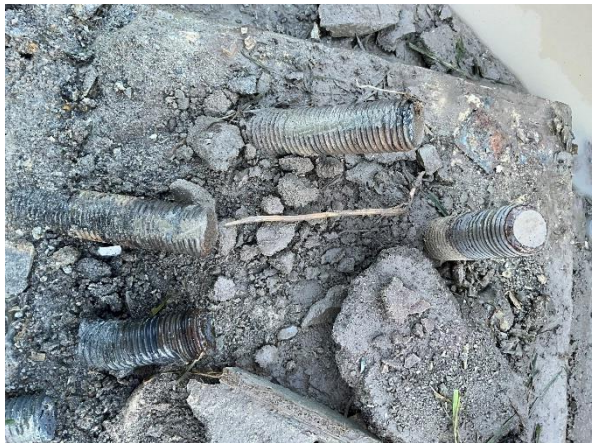
Photo A.10: Leg C foundation after being drained.

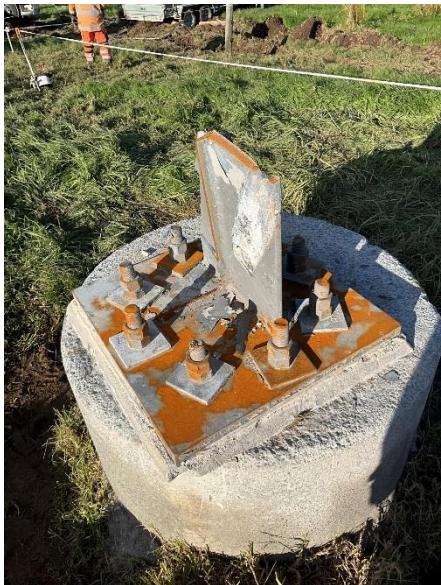
Photo A.11: Leg C foundation after being drained.

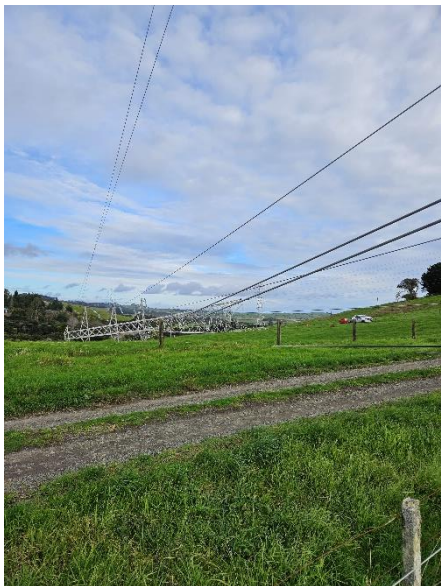
Photo B.1: Tower in the fallen location.

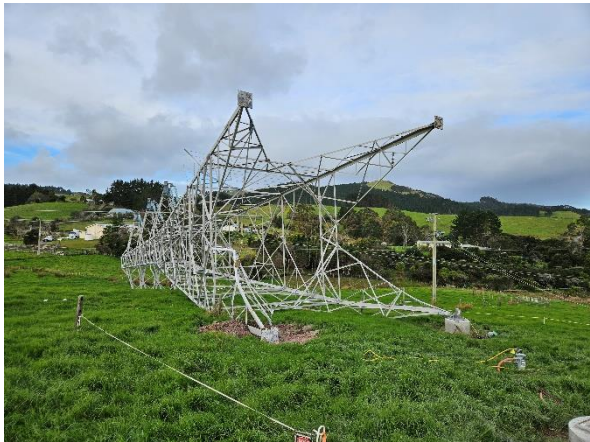
- Fallen tower legs C and D were located next to their foundations, which indicates the tower fell approximately in the transverse direction to the east, normal to the line, as shown in Figure 1.
- Eight nuts and eight square washers were tied with a rope to a bracing member on leg A. This shows that multiple nuts were removed at one time. However it is not clear whether these are from one leg or multiple legs.

Photo B.2: Tower in the fallen location. Legs C and D are in close proximity to foundations indicating the tower fell square with the line in the transverse direction.

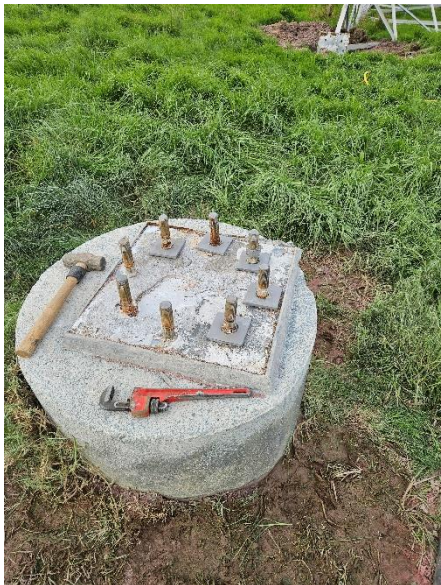
Photo B.4: Leg B foundation.

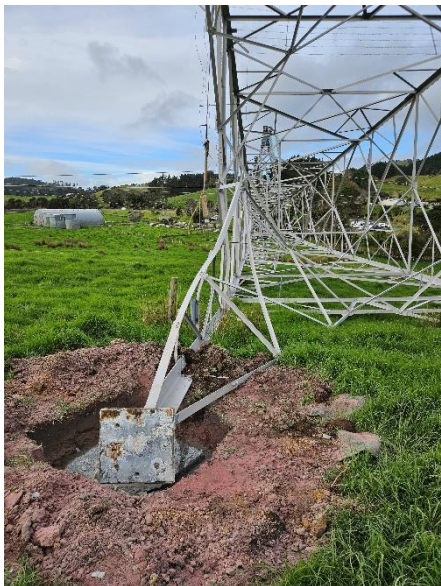
Photo B.5: Leg C leg and foundation.

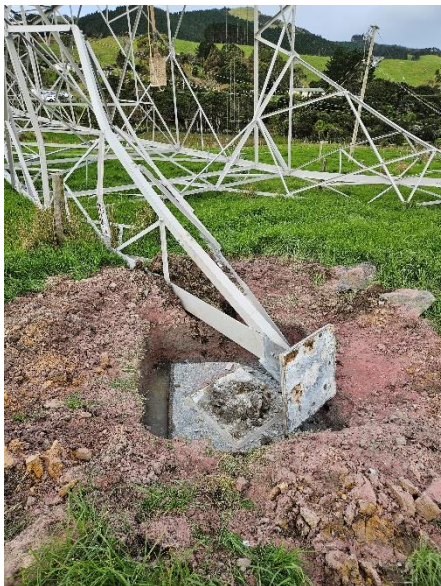
Photo B.6: Leg C leg and foundation.

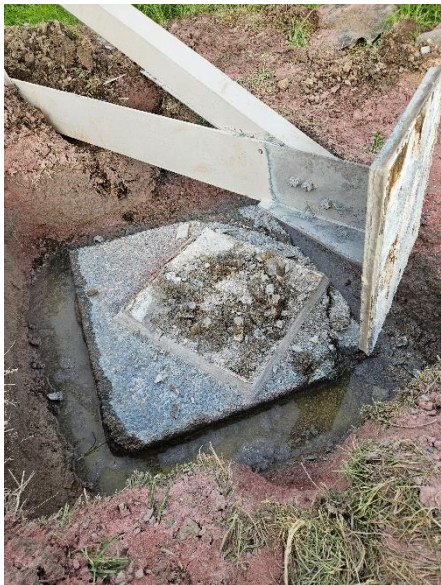
Photo B.7: Leg C leg and foundation.

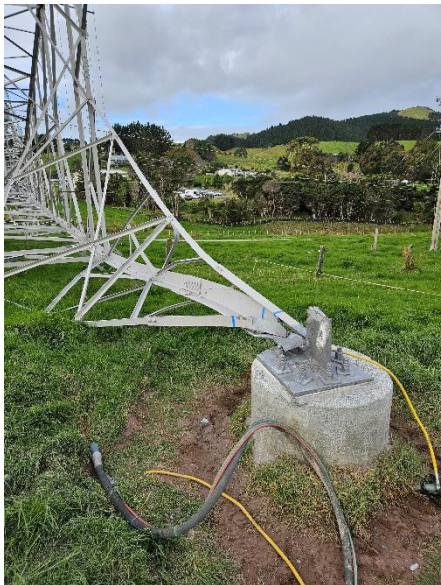
Photo B.8: Leg D ruptured leg and foundation.

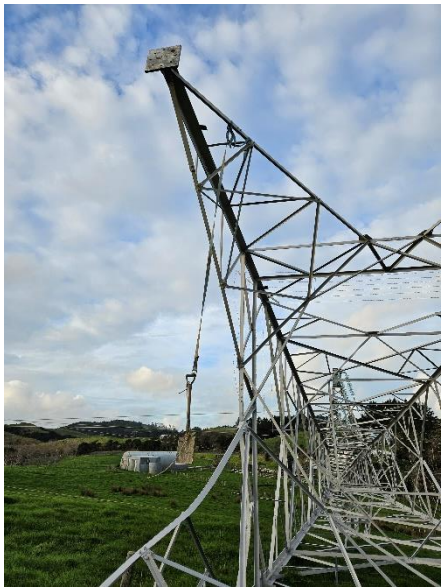
Photo B.12: Spade tied to leg B.

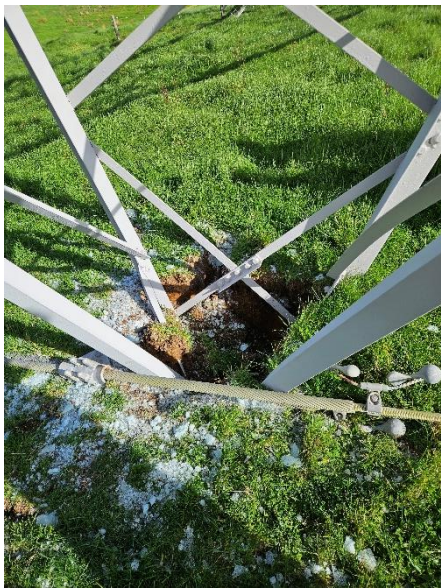
Photo B.13: Tower crossarm embedded in the ground from tower fall.
